Business Management System Inspection Report Gourikwa – GT21 Minor Inspection	Document Identifier	195/453	Rev	0
		Date	24/01/2023		
		Page	1 of 110

Document Type	Inspection Report
Outage ID	24390
Scope of Activity	GT21 Minor Inspection at Gourikwa Peaking OCGT
Purpose	This is a technical report on the “as found” condition, remedial action performed and final condition of plant or components.

Gourikwa GT21 was removed from service on 1 August 2022 in order to carry out Minor Inspection activities as identified in 240-136723367. Limited disassembly, intervention and reassembly activities were performed by site maintenance personnel, and inspections were performed internally by Eskom and ERI personnel, and were carried out from August 1st until August 5th. Areas inspected included: Filter house, Compressor Inlet, Compressor Exhaust, Combustion Chambers, Turbine Inlet and the Turbine Exhaust.

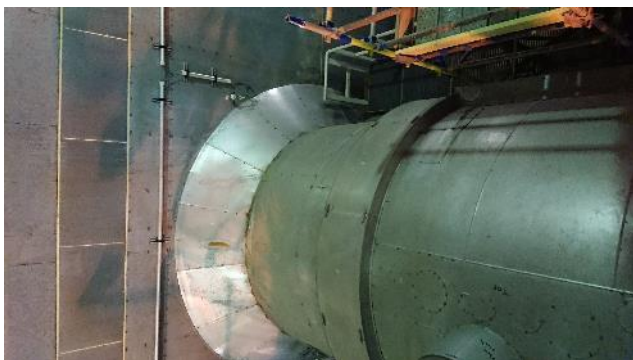
Figure 59: Loose pipe support

1. White residue on outside cladding.
2. General corrosion and flaking of paint noted on all burners.
3. Loose fire suppression system pipe below LHS CC platform.
4. DO return pipe bracket loose on RHS.
5. LHS ΔP pipe support slightly deformed.
6. Some seepage from premix bellow 2-6.

1. White residue on cladding was caused by water from the leaking roof.
2. No remedial action required – to be monitored during the next MI.
3. Site to reconnect pipe support⁵.
4. Site to correct pipe support.
5. No remedial action required – to be monitored during the next MI.
6. To be monitored during the next MI

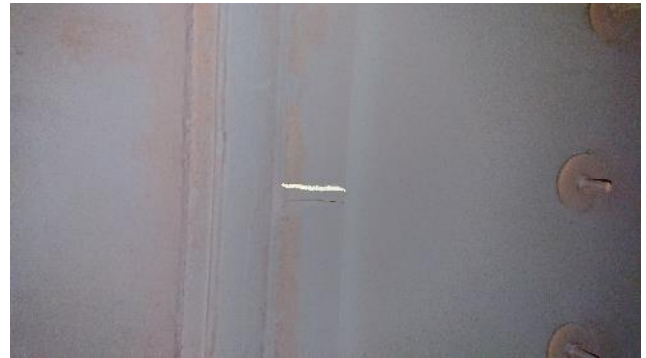
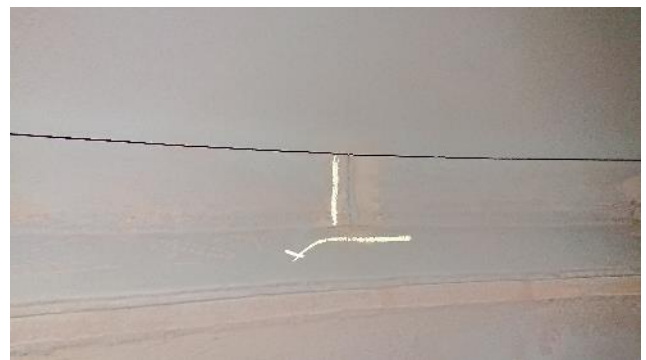
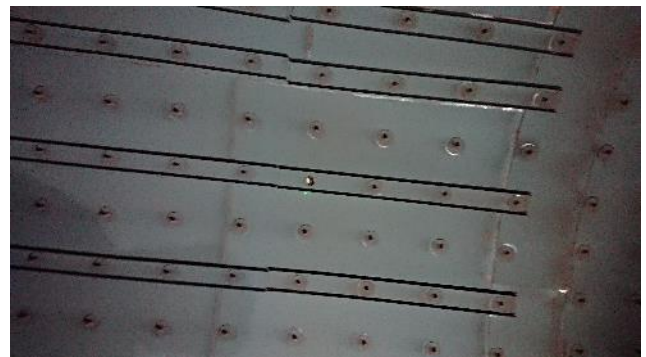
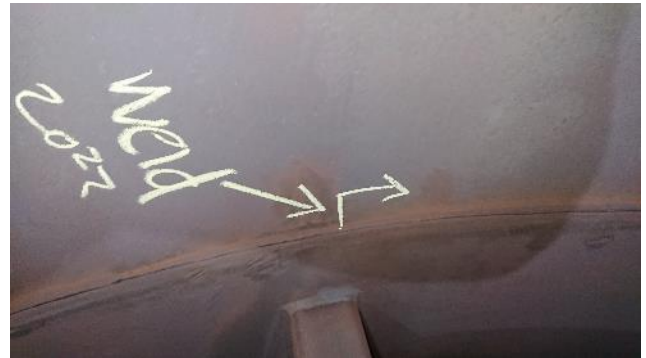
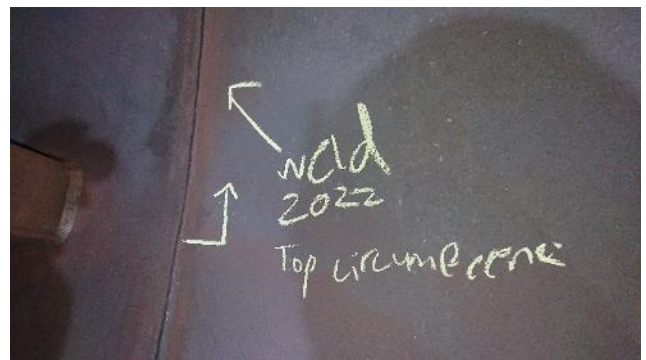
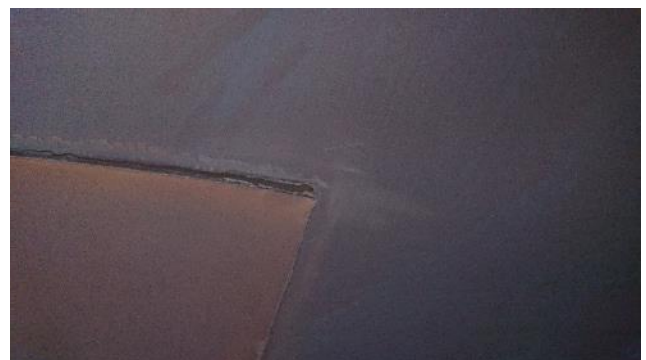
1. Cracks indications noted in several areas of the exhaust casing, expansion joint plates and turbine bearing hub.
2. Plate in exhaust that had been previously repaired found cracked loose.
3. Wear noted on turbine bearing hub cover plate, 1st and 2nd expansion joint plates.
4. Some insulation is visible out of the hub cover plate.

1. Several cracks were weld-repaired. To be monitored during the next MI.
2. Weld repairs executed by site.
3. No remedial action required – to be monitored during the next MI.
4. Site to raise contingency to manufacture and replace plate during the next MI.

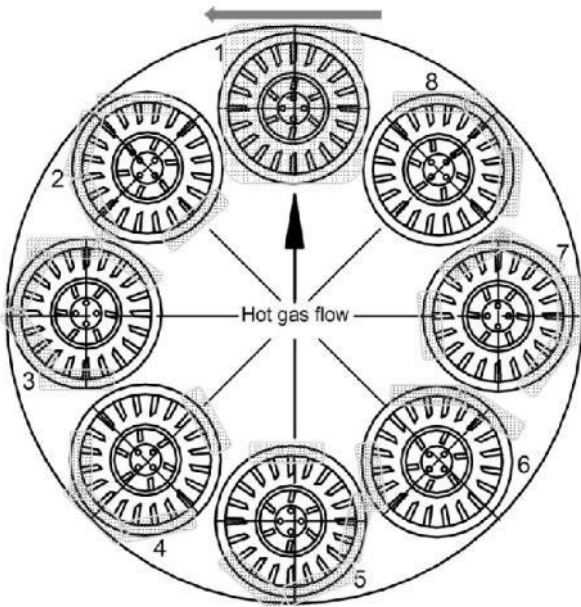
1. Minor signs of fretting noted between dome plates and burner inserts.
2. Cracks noted on burner insert ring 2-1 and 2-5.
3. Deformation noted of plate 2-2.

Remarks: BIR cracks: 2-1 & 2-5

1. No remedial action required – to be monitored during the next MI.
2. No remedial action required – to be monitored during the next MI. Site to consider application for reverse-engineering of Burner Insert Rings to alleviate replacement costs for the next MO.
3. No remedial action required – to be monitored during the next MI.

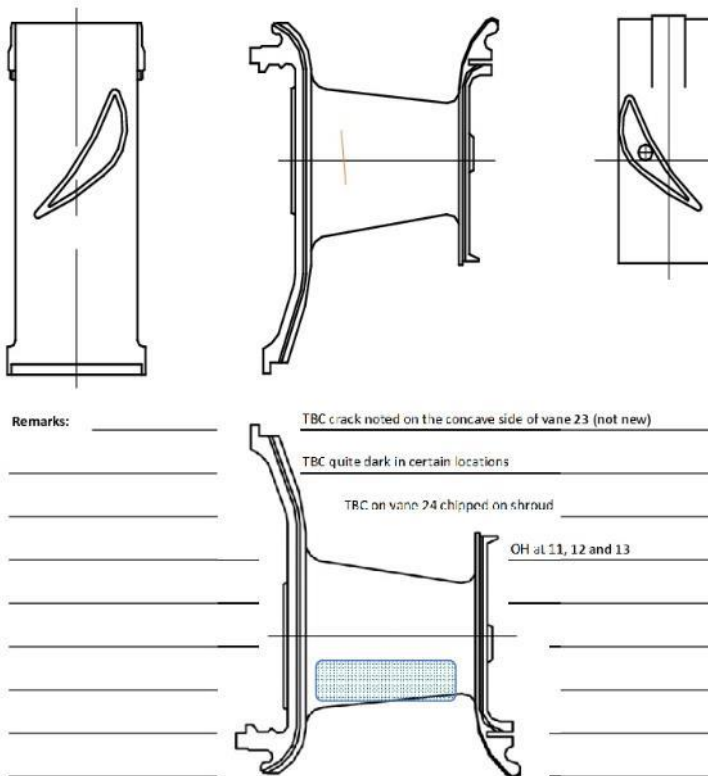
1. Normal discoloration of TLe1 and TLa1 TBC observed.
2. Minor flaking of TBC on some TLa1 blades observed.
3. Several TE radial blade tip clearances were measured to be tight – however there were no visible signs of rubbing.
4. LE radial blade tip clearance at the bottom an LHS top were measured to be tight – however there were no visible signs of rubbing.
5. Crack in TBC noted on vane 23 aerofoil.

TBC crack noted on the concave side of vane 23 (not new)
