Business Management System Inspection Report Gourikwa – GT12 Minor Inspection	Document Identifier	194/1352	Rev	0
		Date	23/01/2023		
		Page	1 of 96

Document Type	Inspection Report
Outage ID	23480
Scope of Activity	GT12 Minor Inspection at Gourikwa Peaking OCGT
Purpose	This is a technical report on the “as found” condition, remedial action performed and final condition of plant or components.

Gourikwa GT12 was removed from service on 12 September 2022 at 06:19 in order to carry out Minor Inspection activities as identified in 240-136723367. Limited disassembly, intervention and reassembly activities were performed by site maintenance personnel, and inspections were performed internally by Eskom and ERI personnel and were carried out from September 13th until September 16th. Areas inspected included: Filter house, Compressor Inlet, Compressor Exhaust, Combustion Chambers, Turbine Inlet and the Turbine Exhaust.

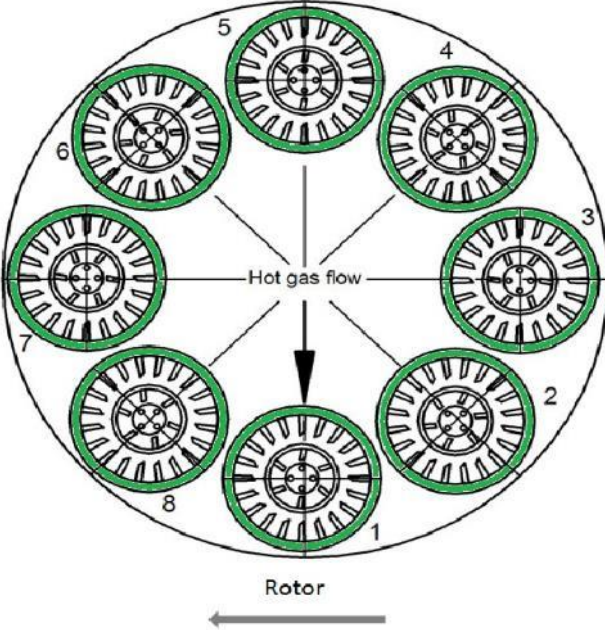
ESKOM GOURIKWA POWER STATION LHS CC Burner Assembly Visual Inspection	Unit #: GT12 Checksheet Reference #: V94-2-2012-1 Page #: 1 of 1 Project #: GOU.MI3
	Siemens SGT5-2000E Combustion	Relevant Procedures: 240-136723367

Remarks: BIR cracks on all
