Business Management System Inspection Report Gourikwa – GT13 Minor Inspection	Document Identifier	194/1354	Rev	0
		Date	30/01/2023		
		Page	1 of 120

Document Type	Inspection Report
Outage ID	24387
Scope of Activity	GT13 Minor Inspection at Gourikwa Peaking OCGT
Purpose	This is a technical report on the “as found” condition, remedial action performed and final condition of plant or components.

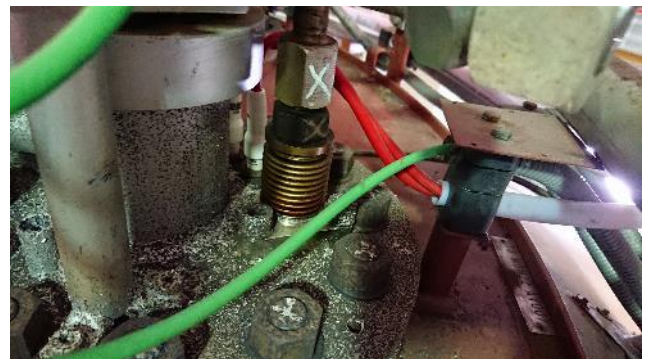
1. White residue on outside cladding.
2. Tags that are damaged / loose: 1-7, 2-6, 2-7.
3. Minor seepage at premix bellows of burners 1-7 & 2-6.
4. LHS ΔP pipe making contact with dome.
5. LHS fire suppression system support inadequate.

Figure 22: Cladding

1. White residue on cladding was caused by water from the leaking roof.
2. Site to replace tags.
3. No remedial action – to be monitored during the next MI.
4. Site to correct to prevent fretting damage.
5. Site to rectify.

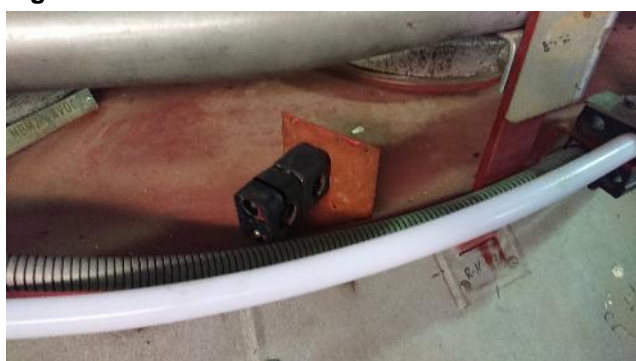
Figure 26: Loose support

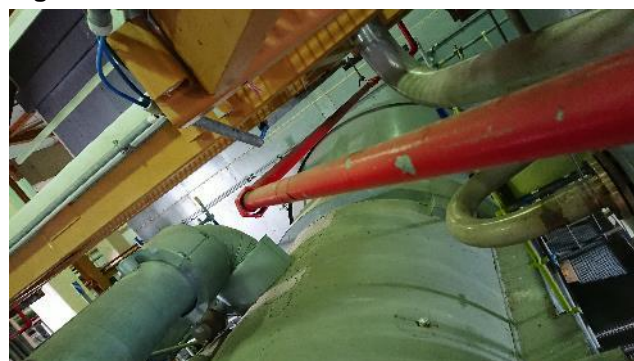
Figure 32: Fire suppression pipe

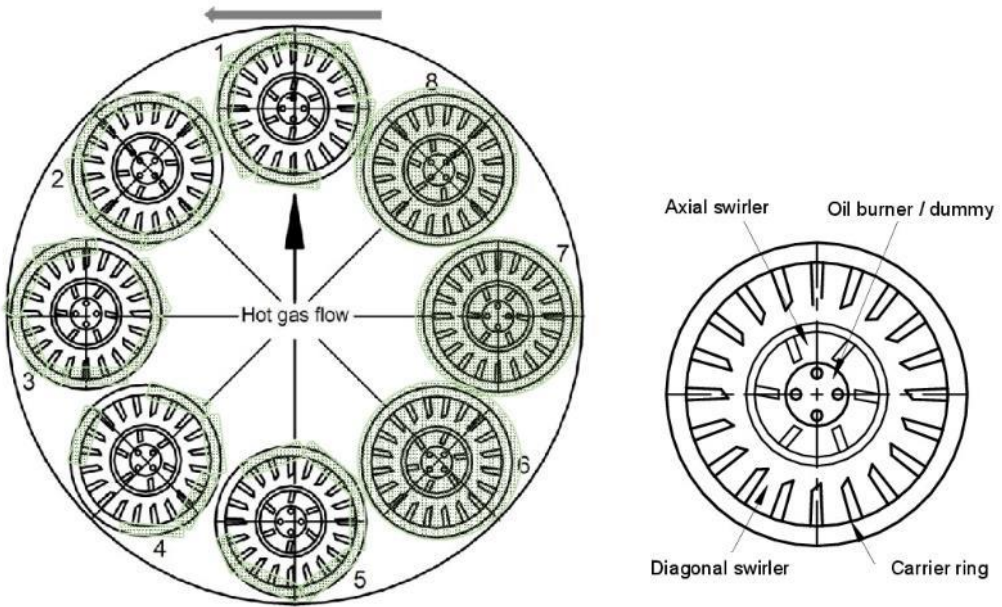
1. Minor signs of fretting noted between dome plates and burner inserts.
2. BIR cracks noted on burners 2-3, 2-4 and 2-6.
3. Minor deformation noted on plates 2-5, 2-6 and 2-7.

Remarks: BIR Cracks: 2-3, 2-4, 2-6

1. No remedial action required – to be monitored during the next MI.
2. No remedial action required – to be monitored during the next MI. Site to consider application for reverse-engineering of Burner Insert Rings to alleviate replacement costs for the next MO.
3. No remedial action required – to be monitored during the next MI.

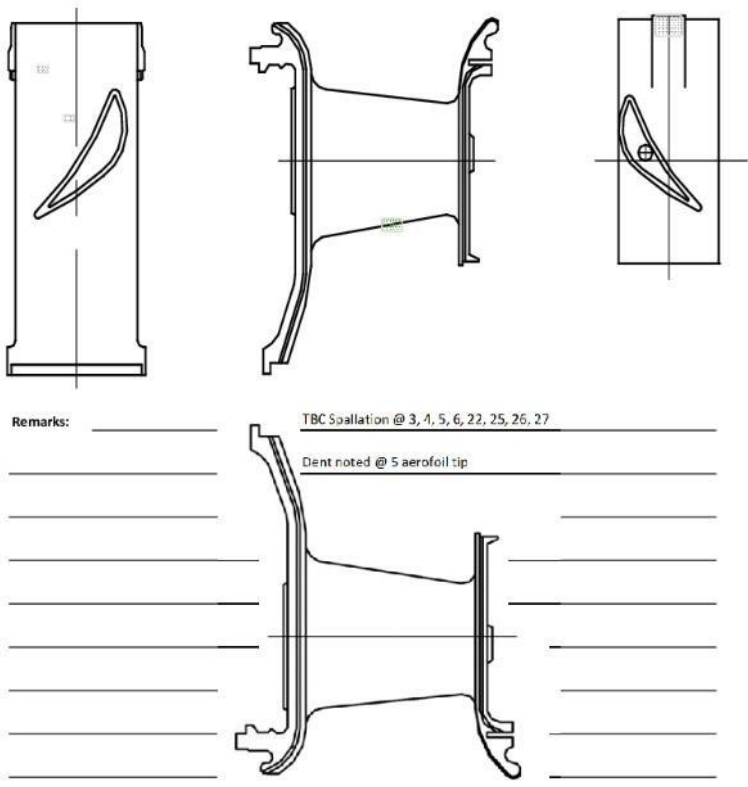
1. Minor flaking of TBC TLe1 vanes 3, 4, 5, 6, 7, 15, 22, 25, 26 and 27 observed.
2. Minor flaking of TBC on some TLa1 blades observed.
3. Almost all LE radial blade tip clearances were measured to be tight.
4. One off TLa1 noted with a dent on the TE of the aerofoil.

TBC Spallation @ 3, 4, 5, 6, 22, 25, 26, 27
