Business Management System Inspection Report Gourikwa – GT22 Minor Inspection	Document Identifier	195/454	Rev	0
		Date	30/01/2023		
		Page	1 of 101

Document Type	Inspection Report
Outage ID	24393
Scope of Activity	GT22 Minor Inspection at Gourikwa Peaking OCGT
Purpose	This is a technical report on the “as found” condition, remedial action performed and final condition of plant or components.

Gourikwa GT22 was removed from service on 10 October 2022 at 06:00 in order to carry out Minor Inspection activities as identified in 240-136723367. Limited disassembly, intervention and reassembly activities were performed by site maintenance personnel, and inspections were performed internally by Eskom and ERI personnel, and were carried out from 2022/10/11 until 2022/10/14. Areas inspected included: Filter house, Compressor Inlet, Compressor Exhaust, Combustion Chambers, Turbine Inlet and the Turbine Exhaust.

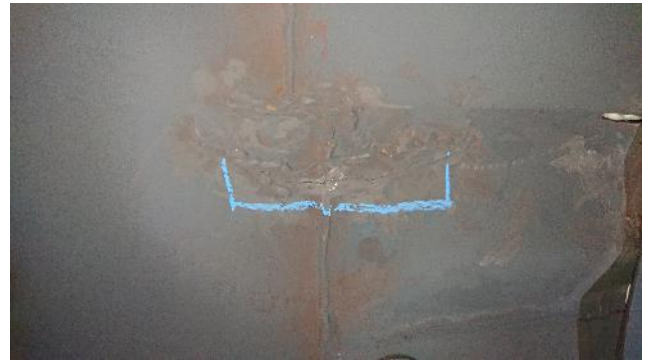
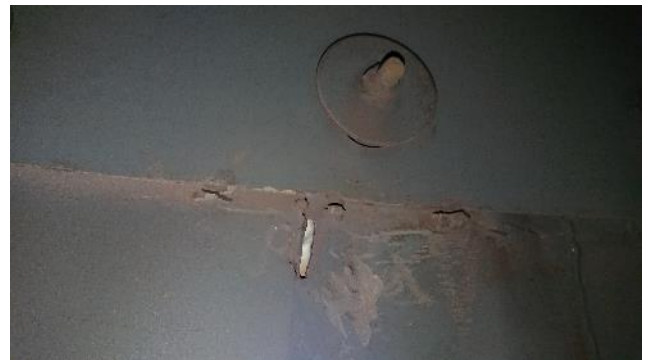
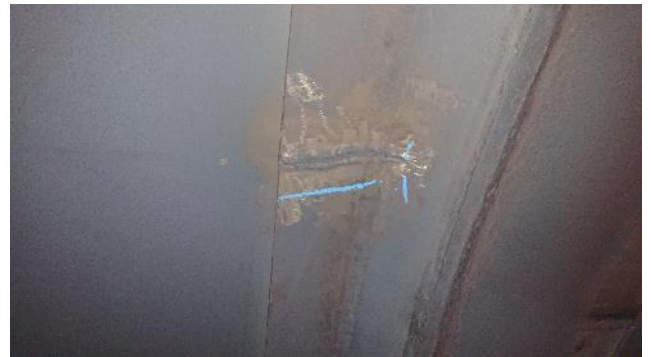
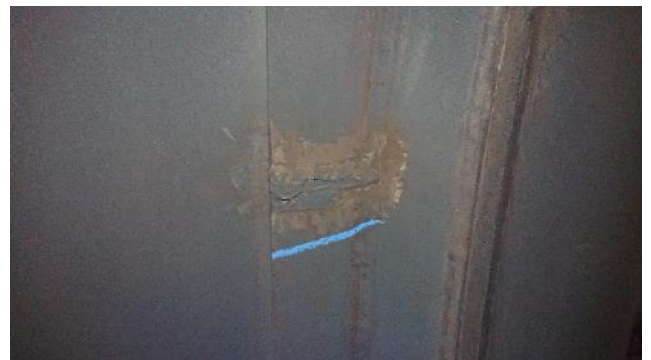
1. Cracks indications noted in several areas of the exhaust casing, expansion joint plates and turbine bearing hub.
2. Wear noted on turbine bearing hub cover plate, 1st and 2nd expansion joint plates.
3. Exhaust manhole door (from the Turbine Hall) is protruding – this may negatively affect the flow of working fluid in the exhaust.
4. Significant horizontal cracks noted with some areas that have missing material.
5. Exhaust cushion damaged.

1. Several cracks were weld-repaired. To be monitored during the next MI.
2. No remedial action required – to be monitored during the next MI.
3. Site to ensure that requisite components are available for amendments to be made during the next MO¹⁴.
4. Plate replacement and weld repairs executed by site.
5. Site to replace.

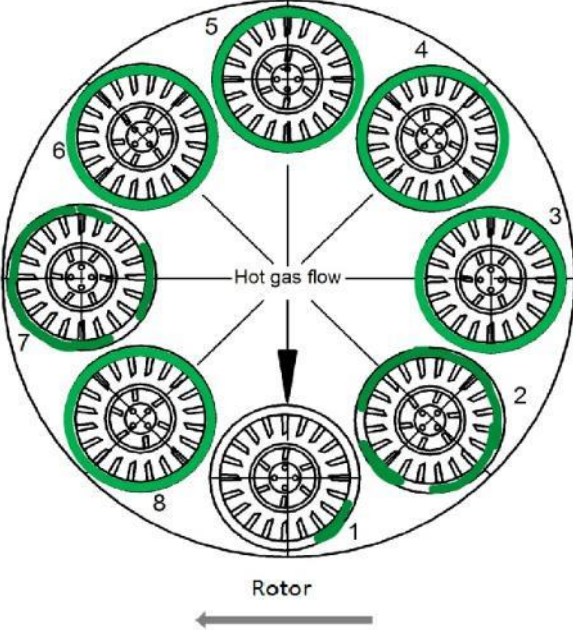
ESKOM GOURIKWA POWER STATION	Unit #:	GT22
	LHS CC Burner Assembly Visual Inspection	Checksheet Reference #:	V94-2-2012-1
		Page #:	1 of 1
		Project #:	GOU.MI3
Inspection	Siemens SGT5-2000E Combustion	Relevant Procedures:	03. Pre-disassembly inspections and measurements

1. Minor signs of fretting noted between dome plates and burner inserts.
2. Cracks noted on burner insert ring(s) on 1-3, 1-4, 1-5, 1-6⁴ and 1-8.
3. Slight deformation noted on plates 1-1, 1-3 and 1-6.

Remarks: Burnin Insert Ring (BIR) Cracks: 1-3; 1-4; 1-5; 1-6

1. No remedial action required – to be monitored during the next MI.
2. No remedial action required – to be monitored during the next MI. Site to consider application for reverse-engineering of Burner Insert Rings to alleviate replacement costs for the next MO.
3. No remedial actions required – to be monitored during the next MI.

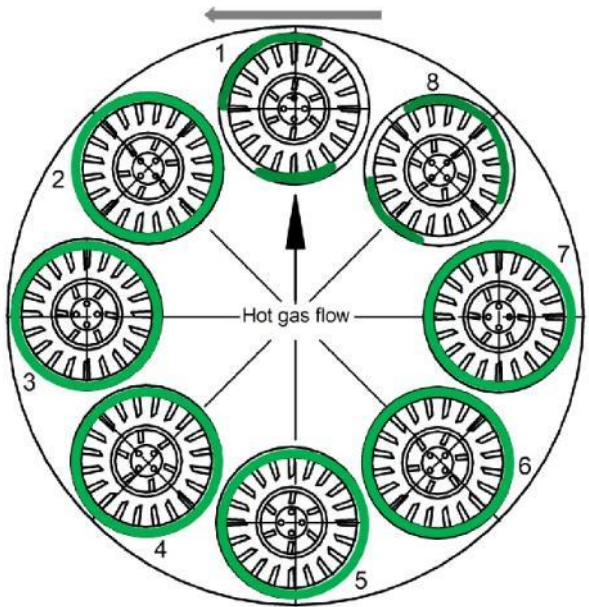
ESKOM GOURIKWA POWER STATION RHS CC Burner Assembly Visual Inspection	Unit #: GT22 Checksheet Reference #: V94-2-2012-2 Page #: 1 of 1 Project #: GOU.MI3
	Inspection Siemens SGT5-2000E Combustion	Relevant Procedures: 03. Pre-disassembly inspections and measurements

1. Minor signs of fretting noted between dome plates and burner inserts.
2. Cracks noted on burner insert ring 2-2, 2-3, 2-4, 2-6, 2-7 and 2-8.
3. Minor deformation noted on plate 2-5.

Remarks: BIR Cracks: 2-2; 2-3; 2-4; 2-6; 2-7; 2-8

1. No remedial action required – to be monitored during the next MI.
2. No remedial action required – to be monitored during the next MI. Site to consider application for reverse-engineering of Burner Insert Rings to alleviate replacement costs for the next MO.
3. No remedial action required – to be monitored during the next MI.
