Business Management System
Inspection Report
Gourikwa – GT11 Minor
Inspection

Document Identifier	194/1353	Rev	0
Date	30/01/2023		
Page	1 of 113

Document Type	Inspection Report
Outage ID	24377
Scope of Activity	GT11 Minor Inspection at Gourikwa Peaking OCGT
Purpose	This is a technical report on the “as found” condition, remedial action performed and final condition of plant or components.

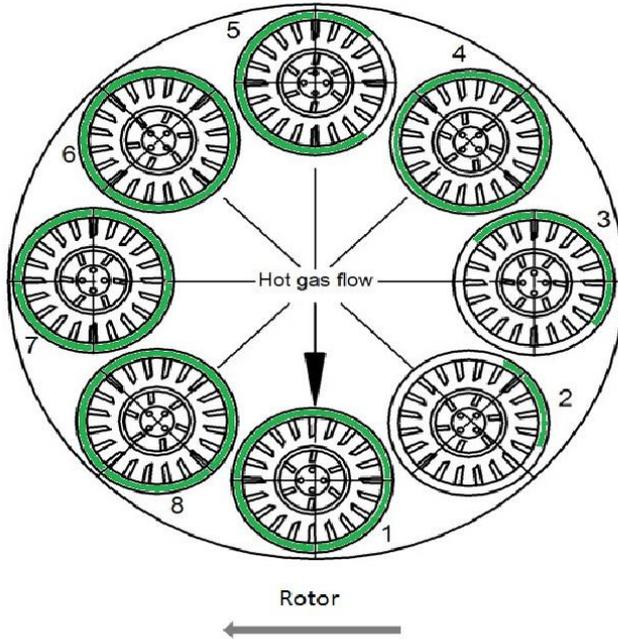
ESKOM GOURIKWA POWER STATION	Unit #:	GT11
	LHS CC Burner Assembly Visual Inspection	Checksheet Reference #:	V94-2-2012-1
Inspection	Siemens SGT5-2000E	Page #:	1 of 1
	Combustion	Project #:	GOU.MI3
		Relevant Procedures:	240-136723367

- Minor signs of fretting noted between dome plates and burner inserts.
- Cracks noted on burner insert ring(s) on 1-1, 1-4, 1-6, 1-7 and 1-8. Mechanical damage on BIR 1-1 was also observed.
- Deformation noted of hot-side dome plates 1-1, 1-4, 1-6, and 1-7.

Remarks: BIR cracks: 1-1, 1-4, 1-6, 1-7, 1-8

1-6 cracks seem deep - replace at next MO

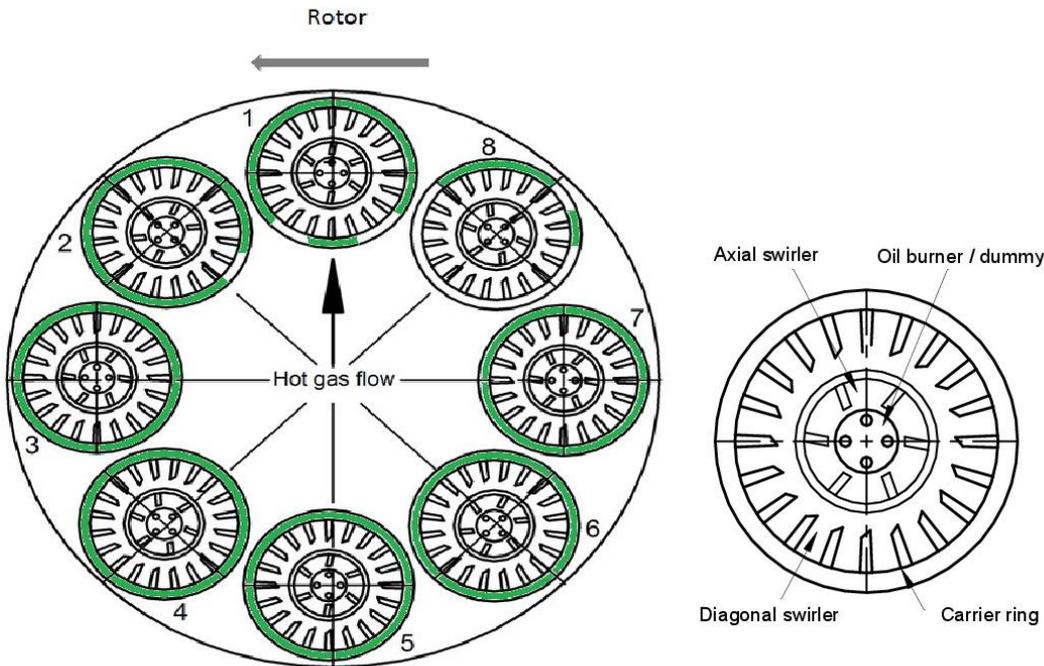
ESKOM GOURIKWA POWER STATION	Unit #:	GT11
	RHS CC Burner Assembly Visual Inspection	Checksheet Reference #:	V94-2-2012-2
Inspection	Siemens SGT5-2000E	Page #:	1 of 1
	Combustion	Project #:	GOU.MB
		Relevant Procedures:	240-136723367

Remarks: BIR cracks: 2-3, 2-4, 2-7

2-4 will require replacement in the next MO

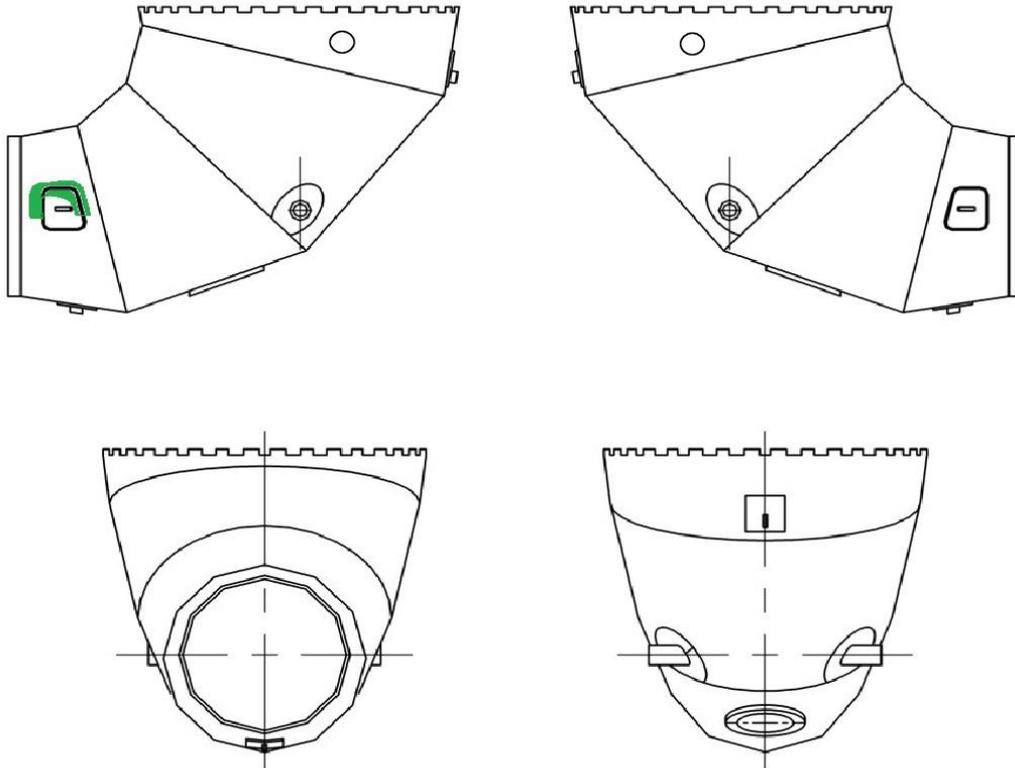
ESKOM GOURIKWA POWER STATION	Unit #:	GT11
	RHS Mixing Chamber Inspection	Checksheet Reference #:	V94-2-2011-2
Inspection	Siemens SGT5-2000E	Page #:	1 of 3
	Combustion	Project #:	GOU.MB
		Relevant Procedures:	240-136723367

Remarks: Very good condition

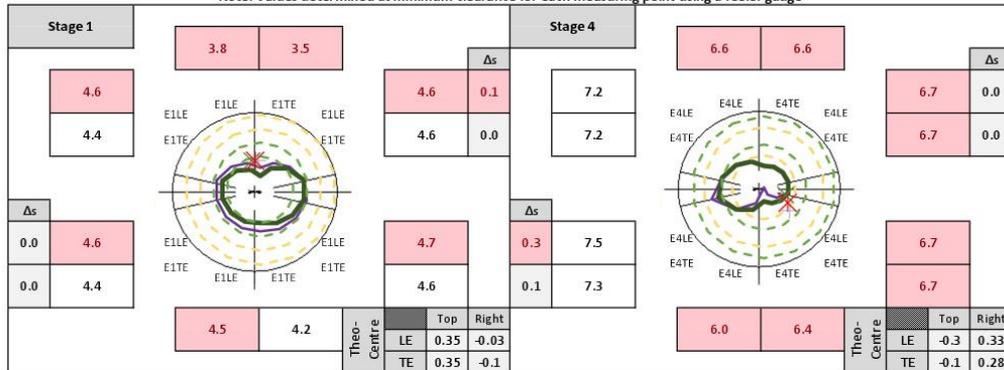
Remarks: Stage 1 - no signs of rubbing noted - values similar to previous outage

unit hot when stage 4 was measured - no signs of rubbing noted
