Specification

**TRANSNET NATIONAL PORTS AUTHORITY
PORT OF CAPE TOWN**

Caisson groove repairs on Sturrock Dry Dock in the Port of Cape Town

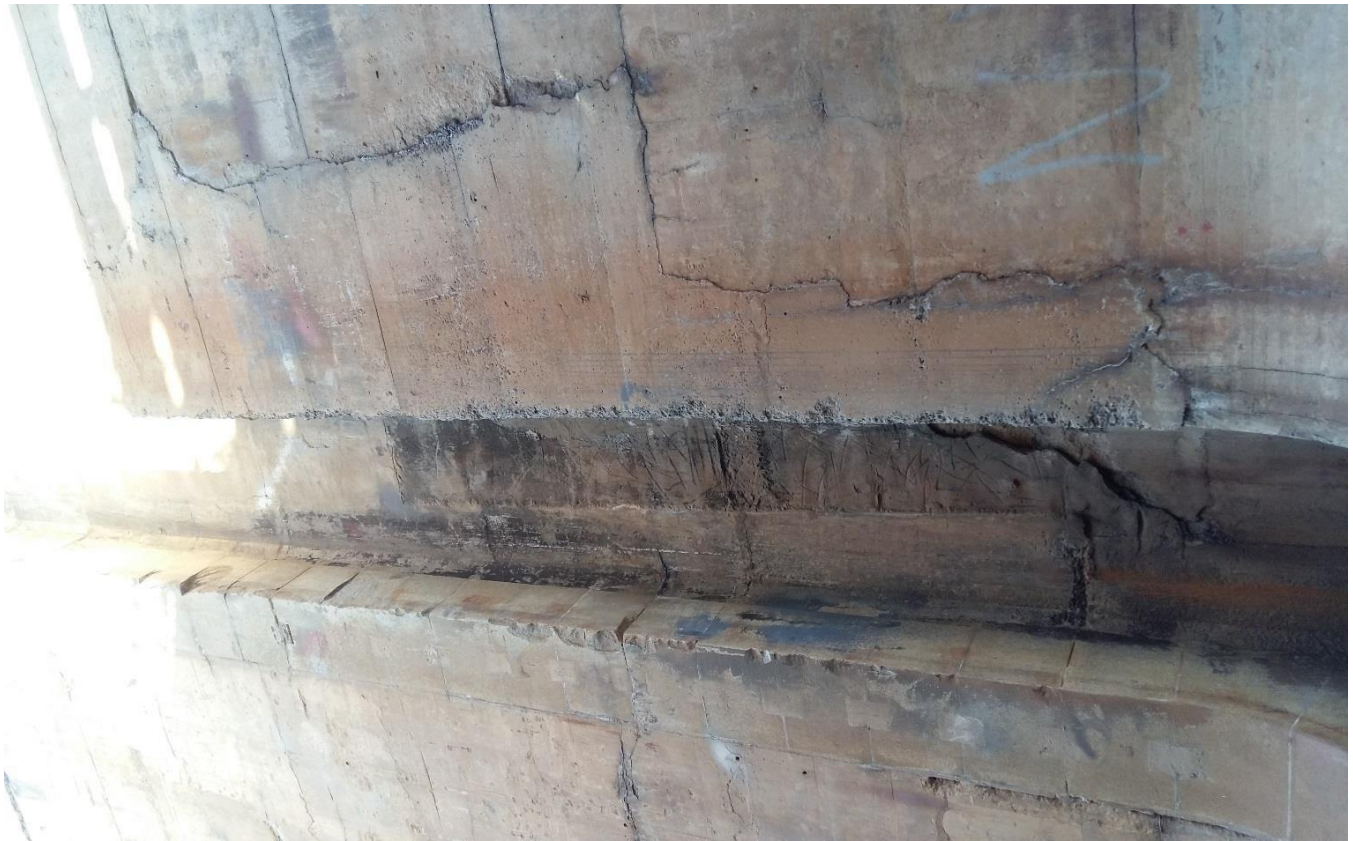
Figure 1-1: cracks showing from the vertical side of caisson groove

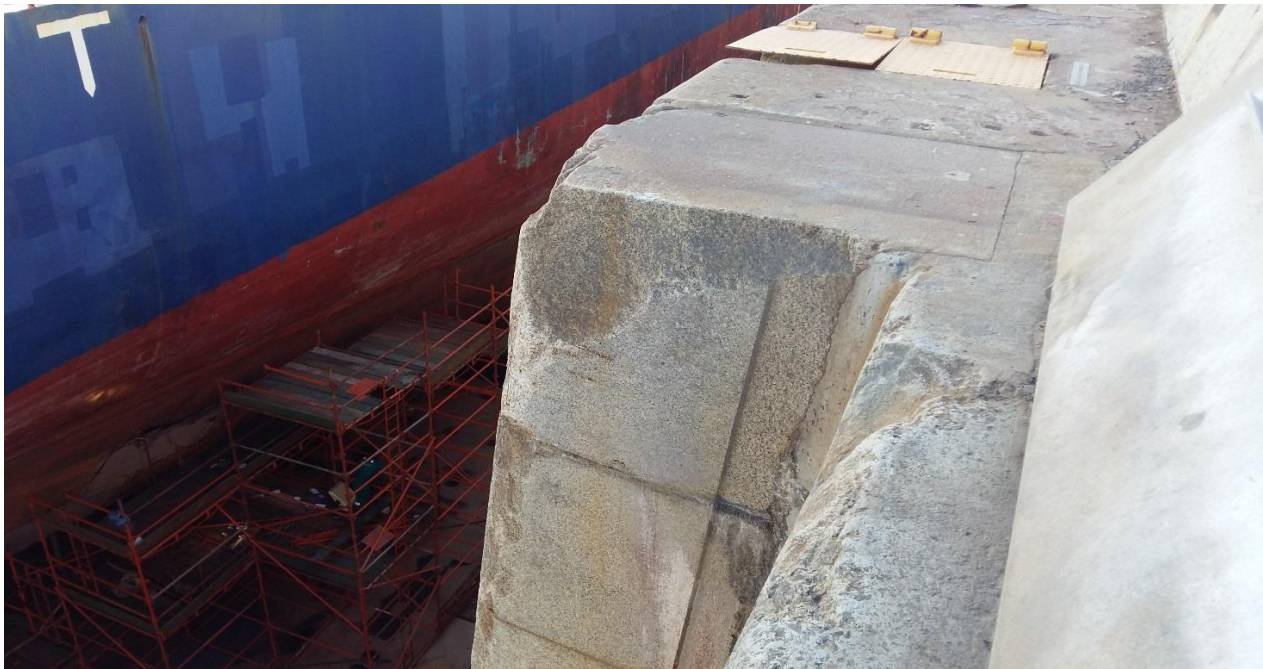
Figure 1-2: granite edge breaks showing from the vertical side of caisson groove

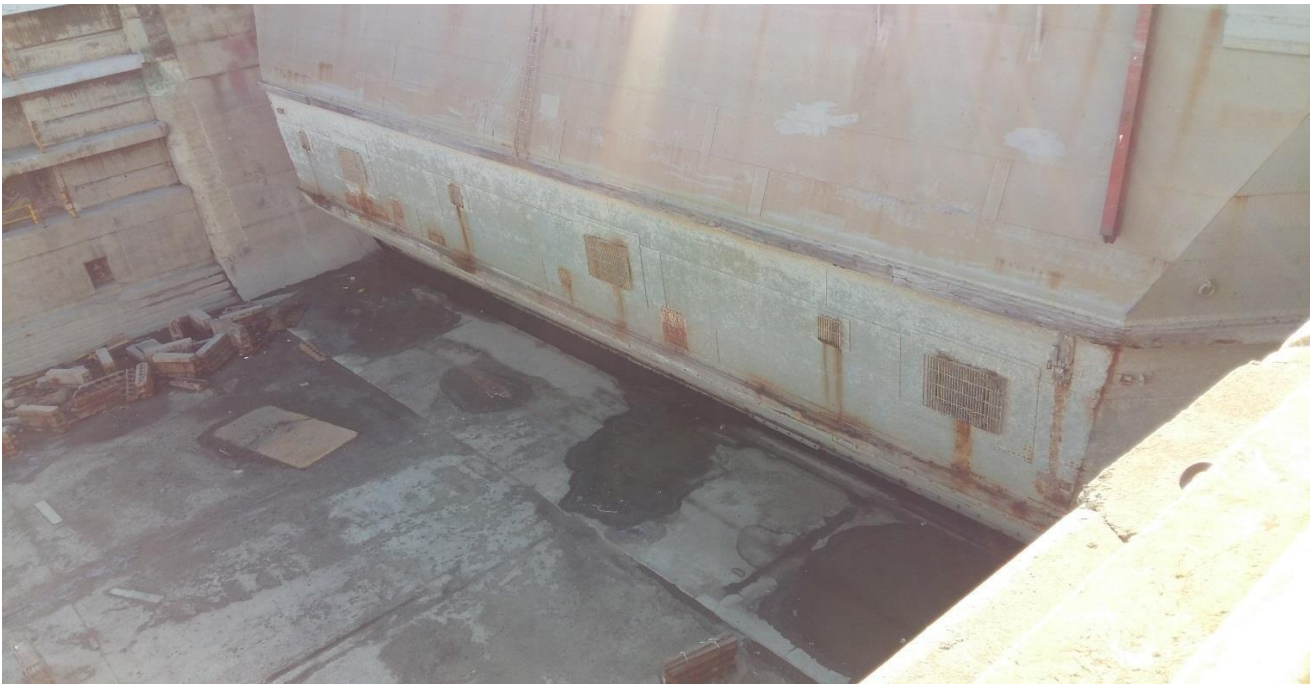
Figure 1-4: caisson gate showing some water leakage

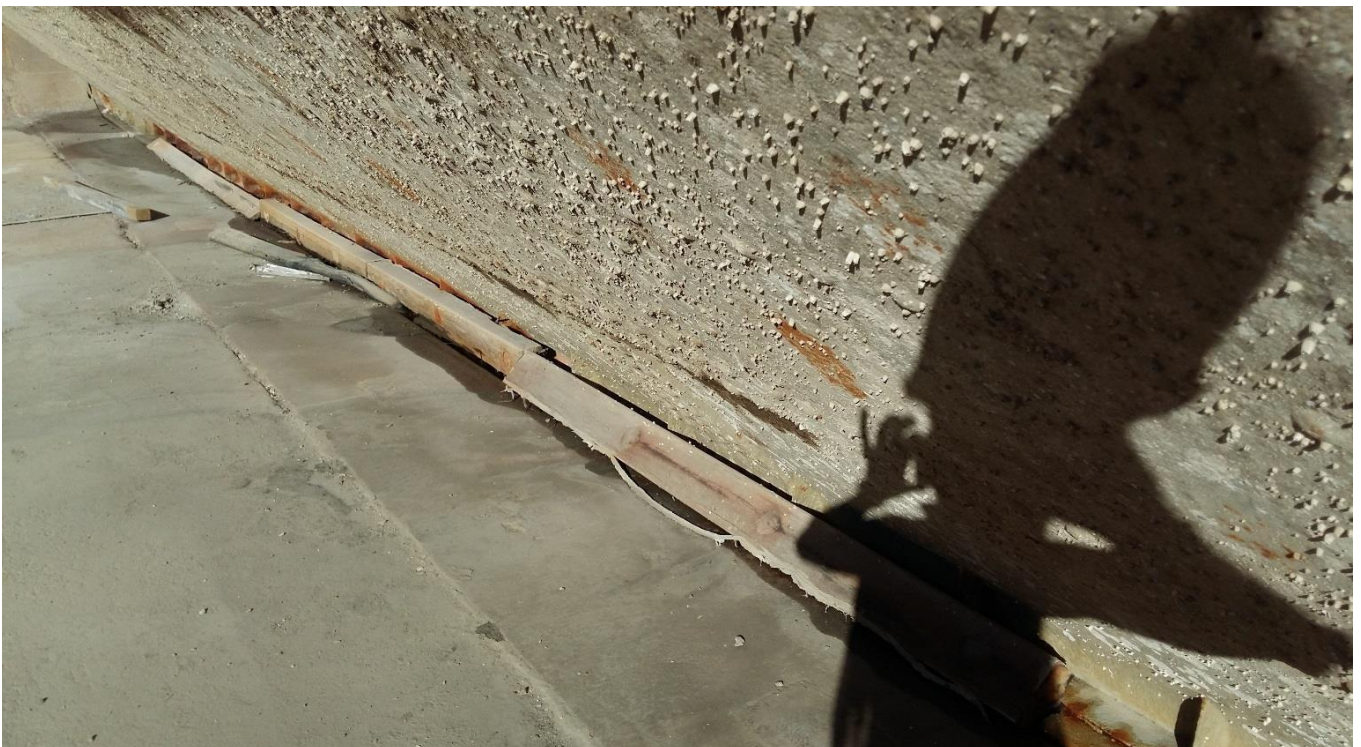
Figure 1-5: planks used as temporary stoppage or seal for caisson gate

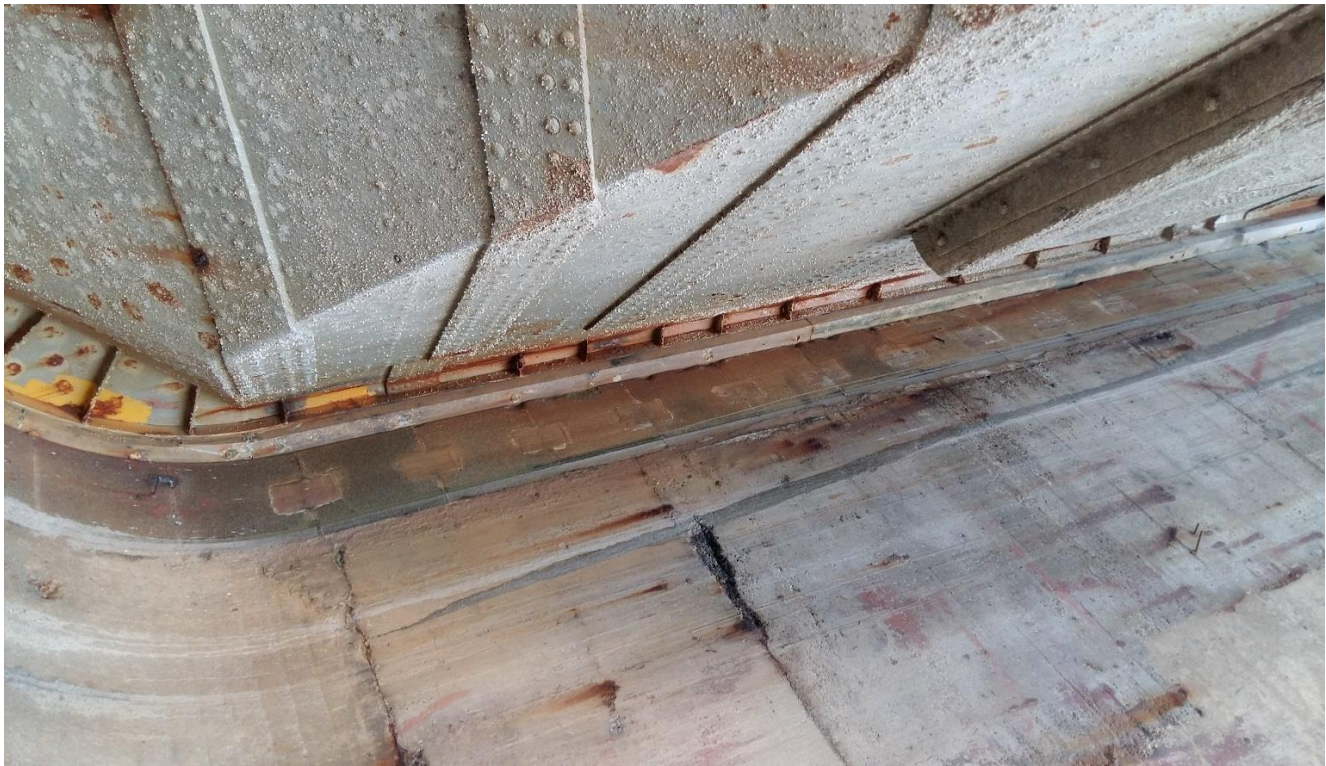
Figure 1-6: overview of caisson gate seal against caisson groove

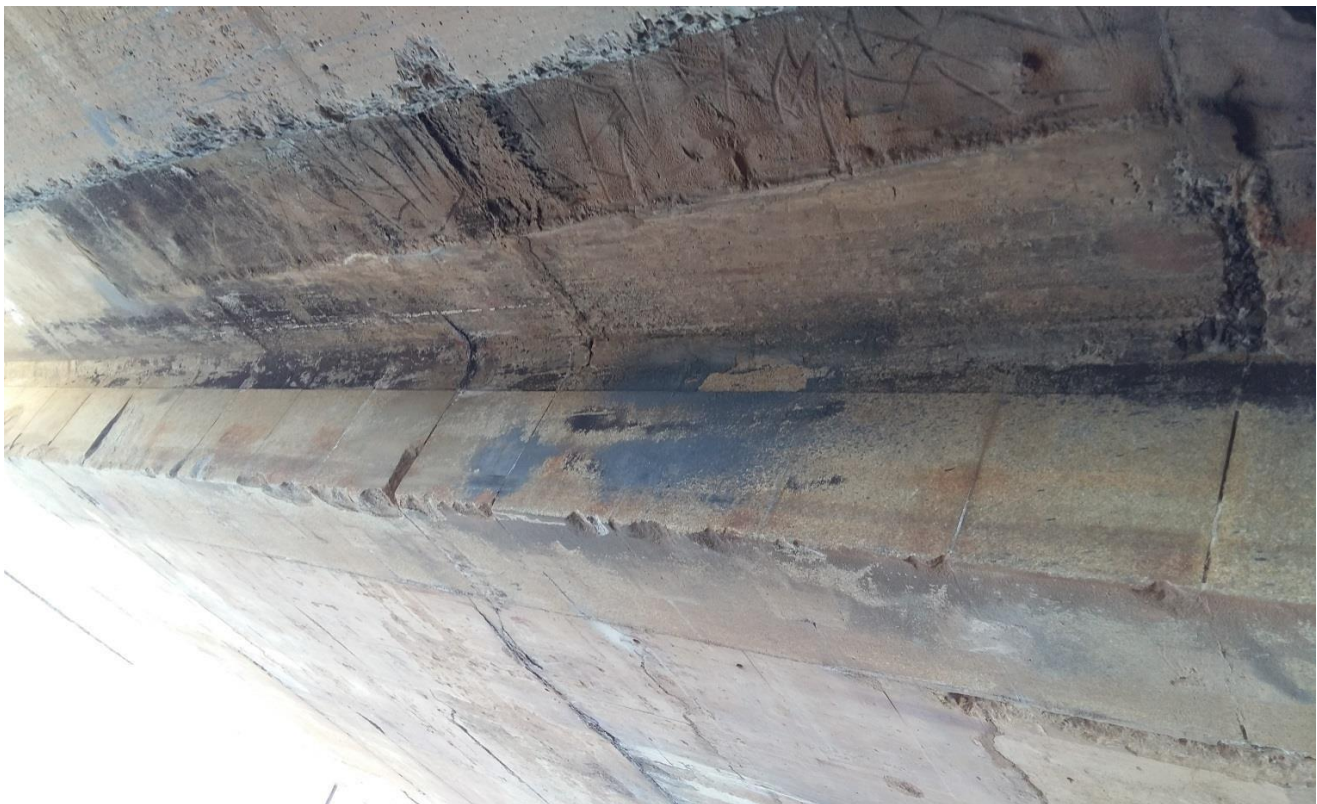
Figure 1-7: granite and concrete deterioration in the caisson gate

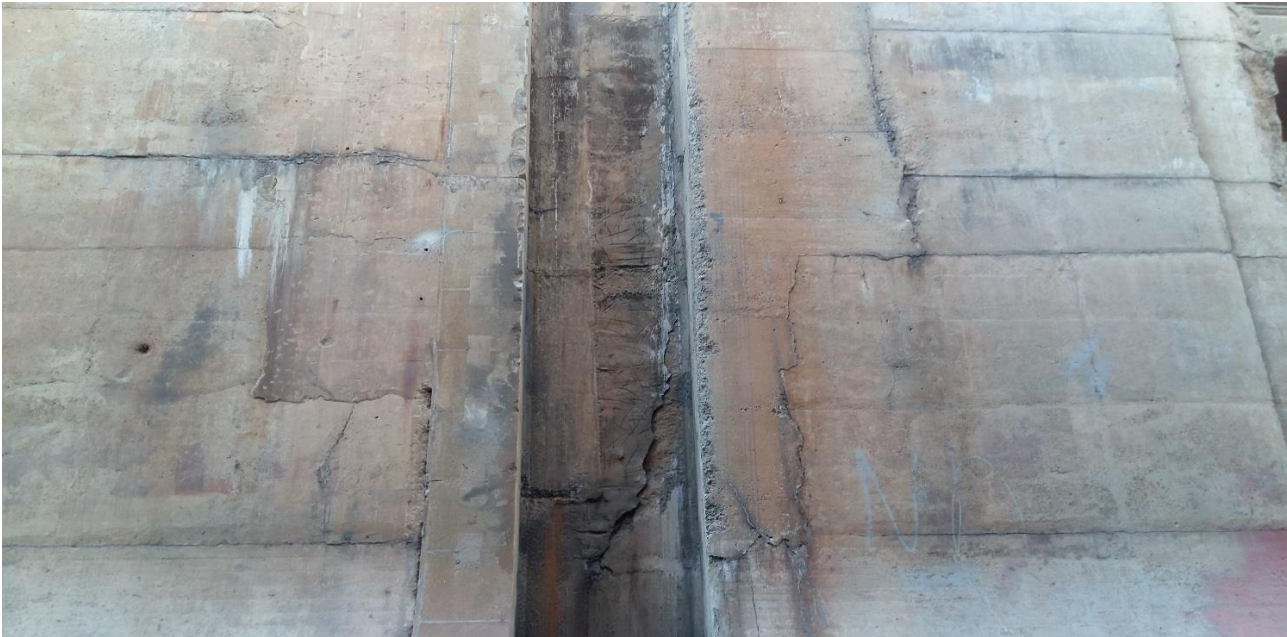
Figure 1-8: surface deterioration inside the caisson groove

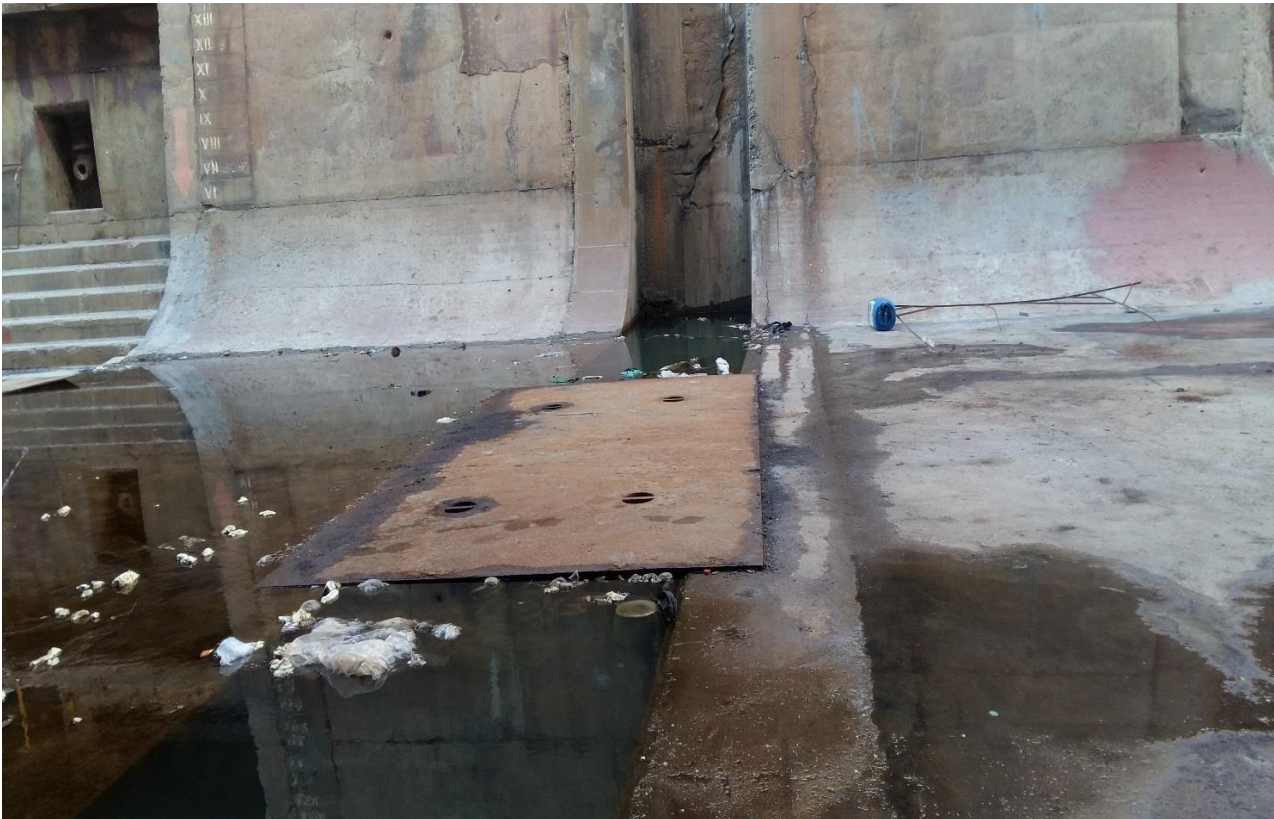
Figure 1-9: groove filled with water and debris
