MOKOLO CROCODILE WATER AUGMENTATION PROJECT PHASE 2 (MCWAP-2)

ROADS AND TRAFFIC BASELINE ASSESSMENT REPORT

February 2022

Project No: GP084

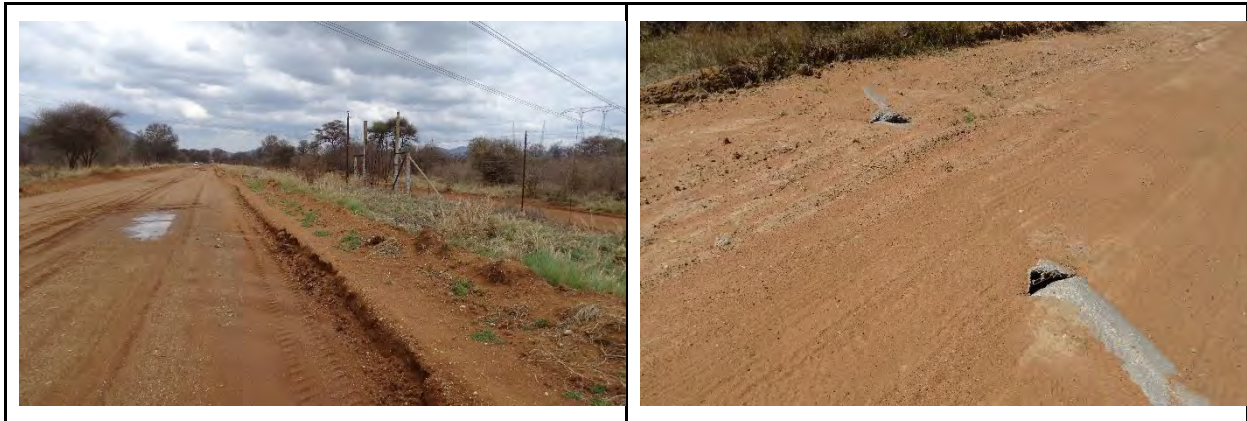
In summary, most of the gravel roads lack profile/shape to facilitate stormwater drainage from the roadway combined with all channels and formal drainage being totally ineffective.

Photo 1: Ineffective drainage of roadway

Photo 2: Culvert exposed and damaged

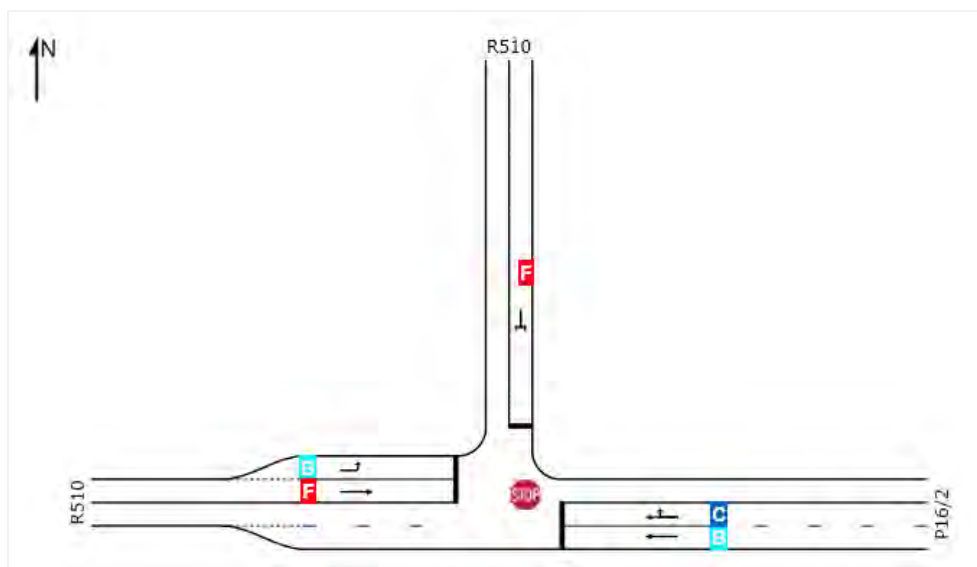
Figure 1-4 R510/P16/2 Intersection layout and LOS summary

The overall intersection LOS results were considered acceptable for all intersections except for Intersection No. 8 R510/P16/2. It is recommended that the intersection is monitored during the construction period and should queues greater than 4 vehicles form on any of the approaches (signal warrant as per SARTSM Vol. 3) then a temporary signal is installed by the Contractor.

Although a signal might be required under current conditions it is recommended that the local municipality is first consulted as they may not have the capacity or resources to maintain the signal. It was noted during the site investigation, that one of the signals along this section of road was switched off and the intersection had reverted to an AWSC, which could be owing to the aforesaid lack of resources.

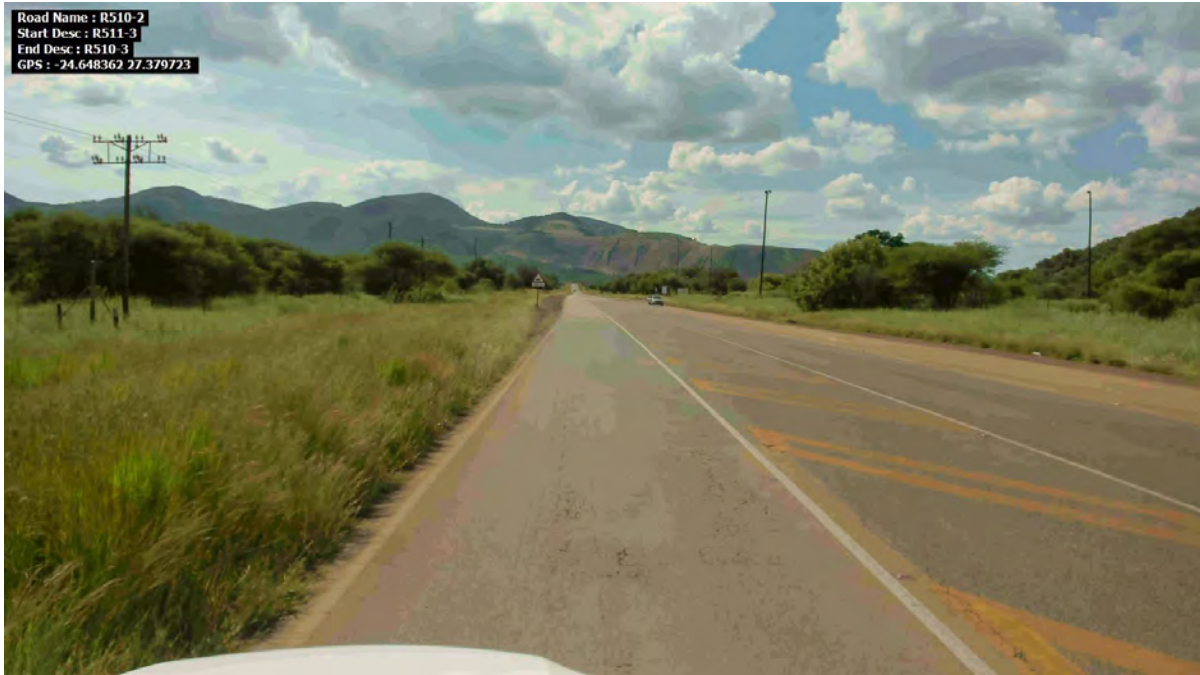
Photo 3.1: Road R510-2 (km 29,6): Surface cracks

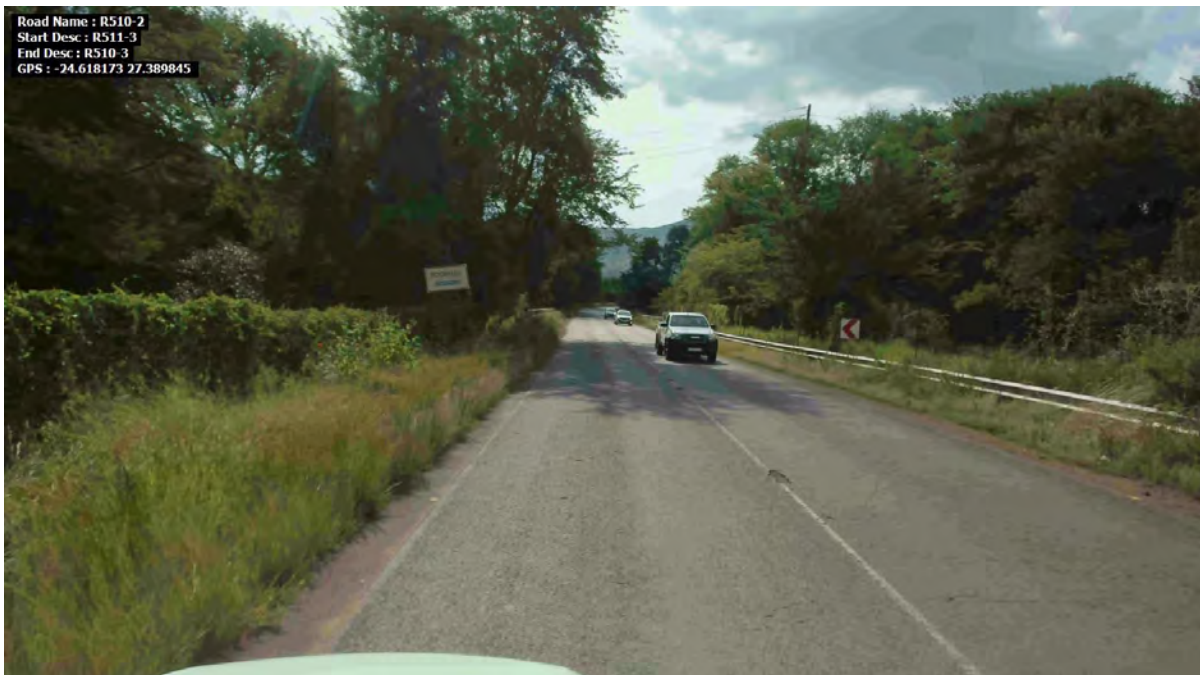
Photo 3.2: Road R510-2 (km 33,7): Surface cracks, surface failures and transverse cracks

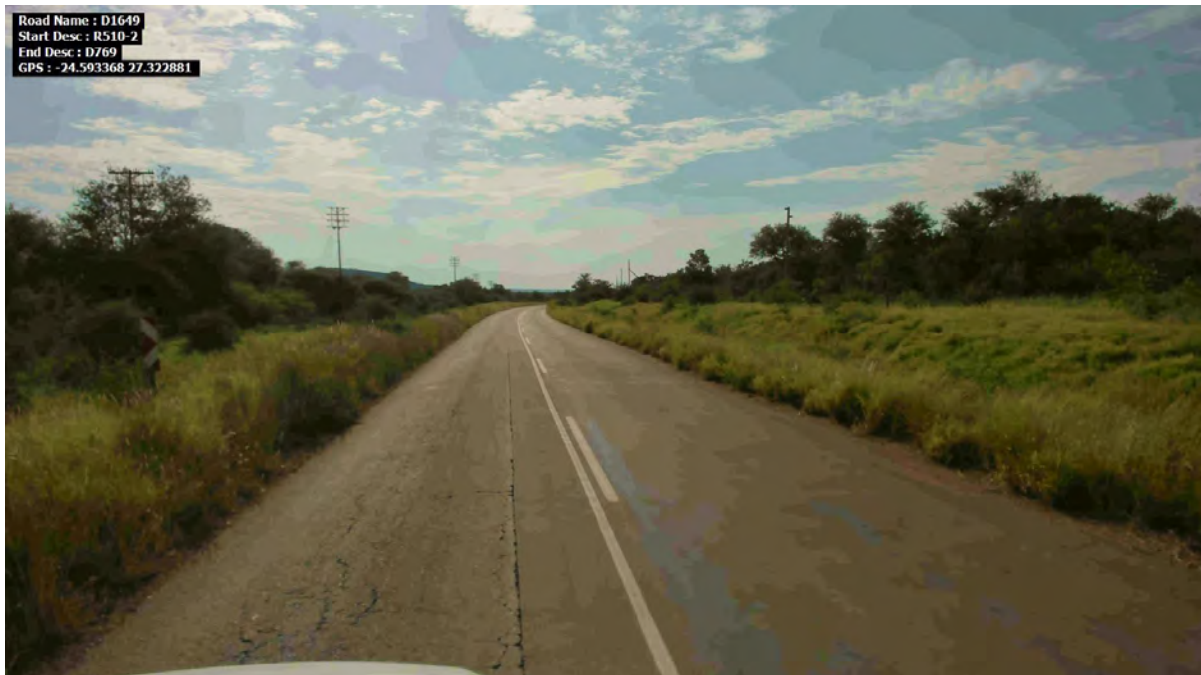
- Similar to Road D2701, the seal surfacing along Road D1649 also appears dry and brittle. Flushing of the binder, although low degree, was also recorded. Block- and crocodile cracking with degree 1-3 are evident along most of the extent with localised transverse cracks as shown in Photo 3.3.

Photo 3.3: Road D1649 (km 6,88): Longitudinal crack as well as crocodile/surface cracks

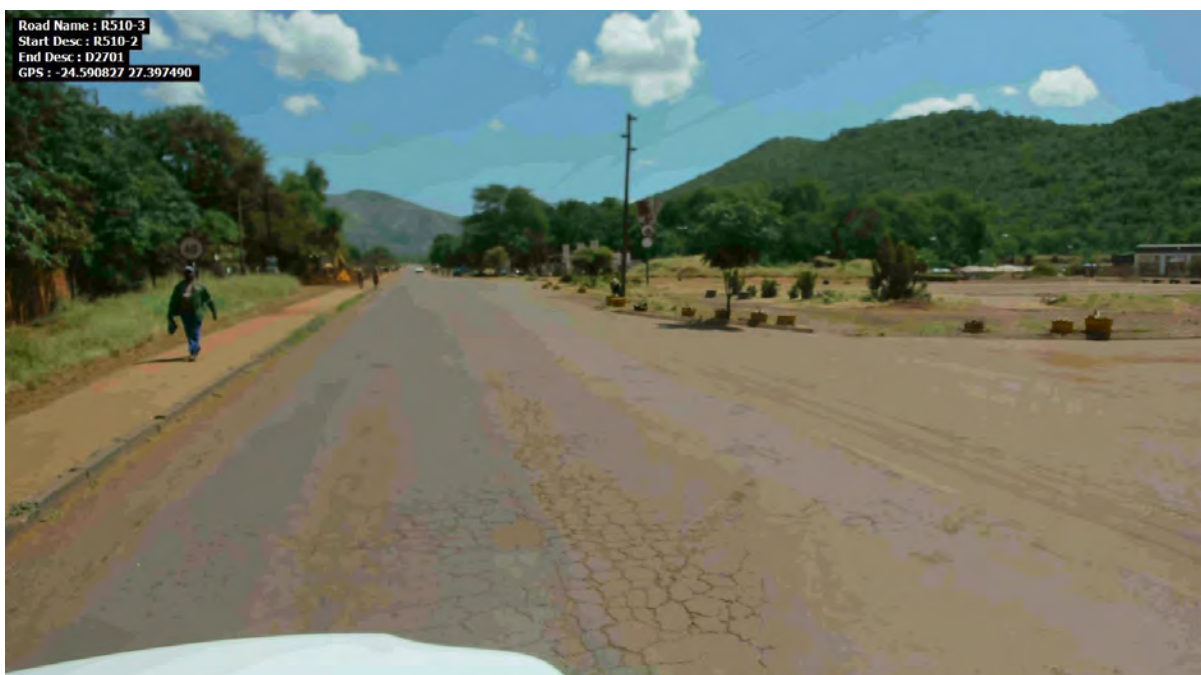
Photo 3.4: Road R510-3 (km 0,1): Surface cracks

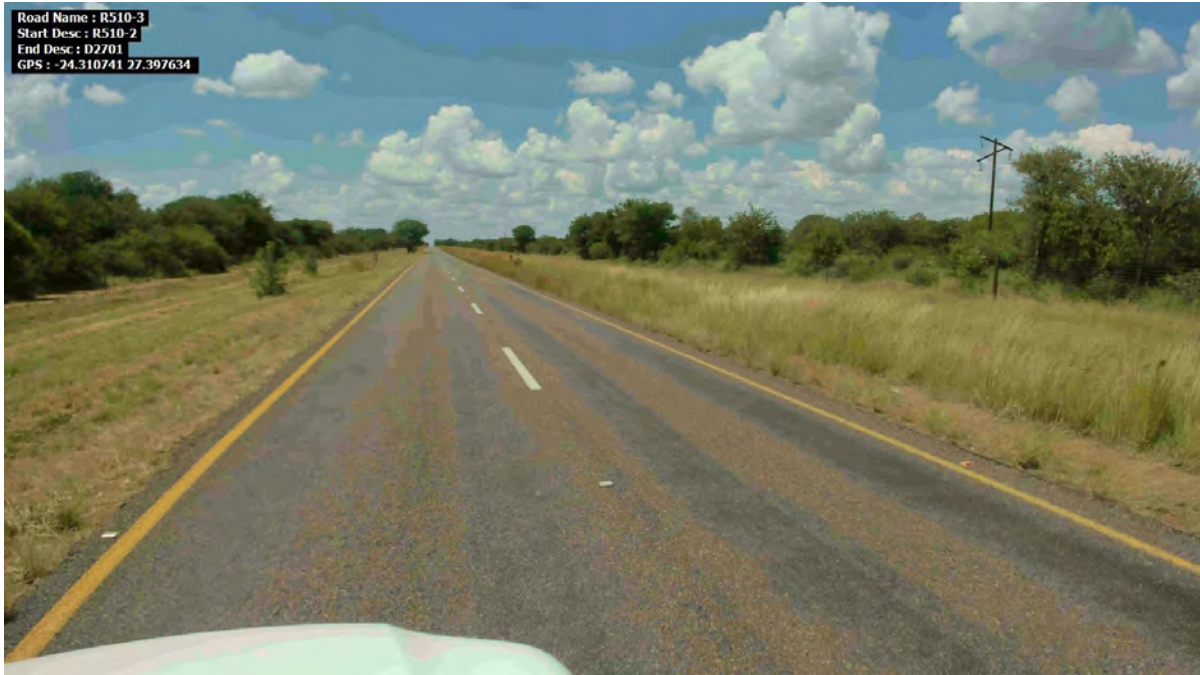
Photo 3.5: Road R510-3 (km 33,1): Flushing in wheel tracks along both lanes

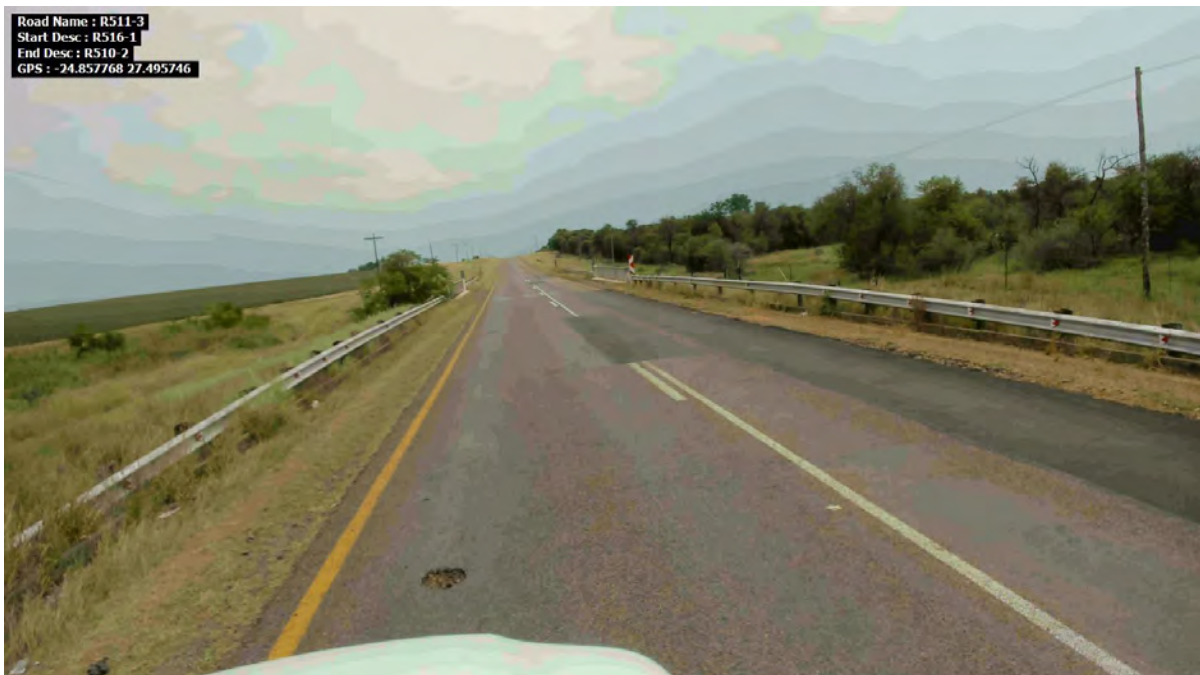
Similar to Road R510-3, **Road R511-3** is also classified as good to very good and also has a seal surfacing. The assessment revealed localised surface related distress (Photo 3.6), limited structural cracking (transverse and crocodile cracking, degree 1&2) as well as undulation (degree 1-2).

Photo 3.6: Road R511-3 (km 100,6): Surface failure in left lane and surface patches along right lane

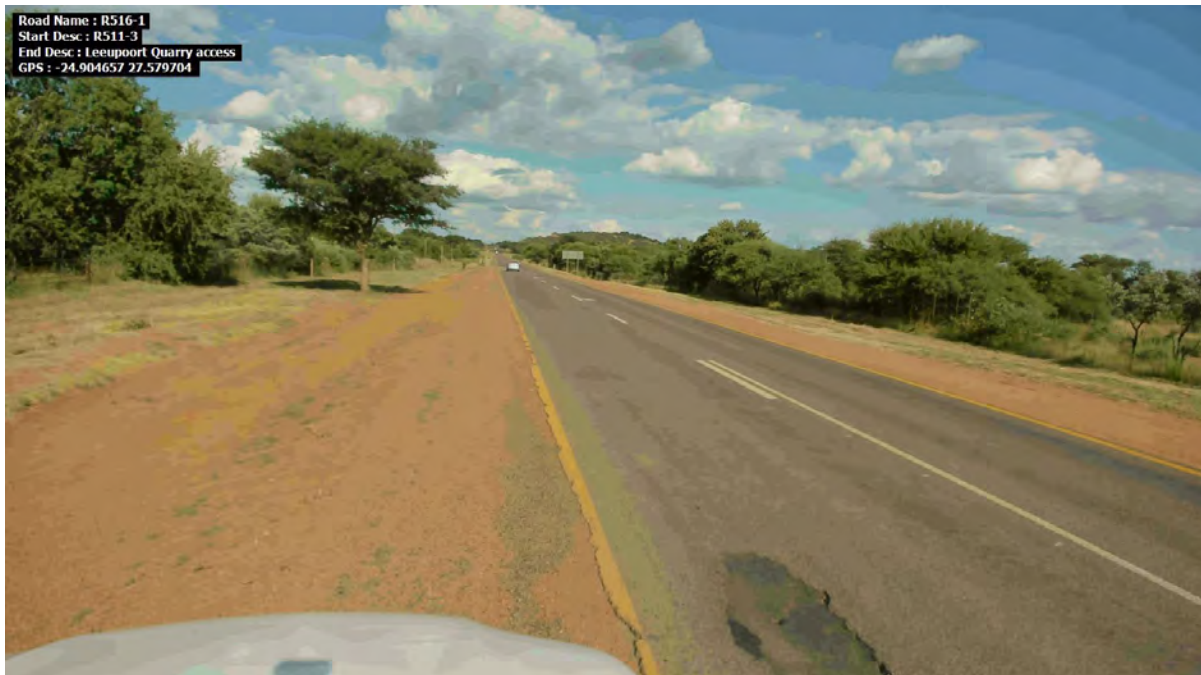
Road R516-1 consists of a seal surfacing and is classified as poor to very good. This section of road shows distress in the form of surface failures (degree 2-3), and frequent longitudinal, block, transverse, and crocodile cracking (degree 2-4). Pumping of fines were visible in many of these cracks and are normally associated with structural failure of the pavement structure. Examples of distress are shown in Photo 3.7 and Photo 3.8. It should however be noted that this section of road forms part of an improvement project currently in design phase. SANRAL have appointed BVi Consulting Engineers for this improvement project.

Photo 3.7: Road R516-1 (km 5,37): Surface failure and longitudinal cracks.

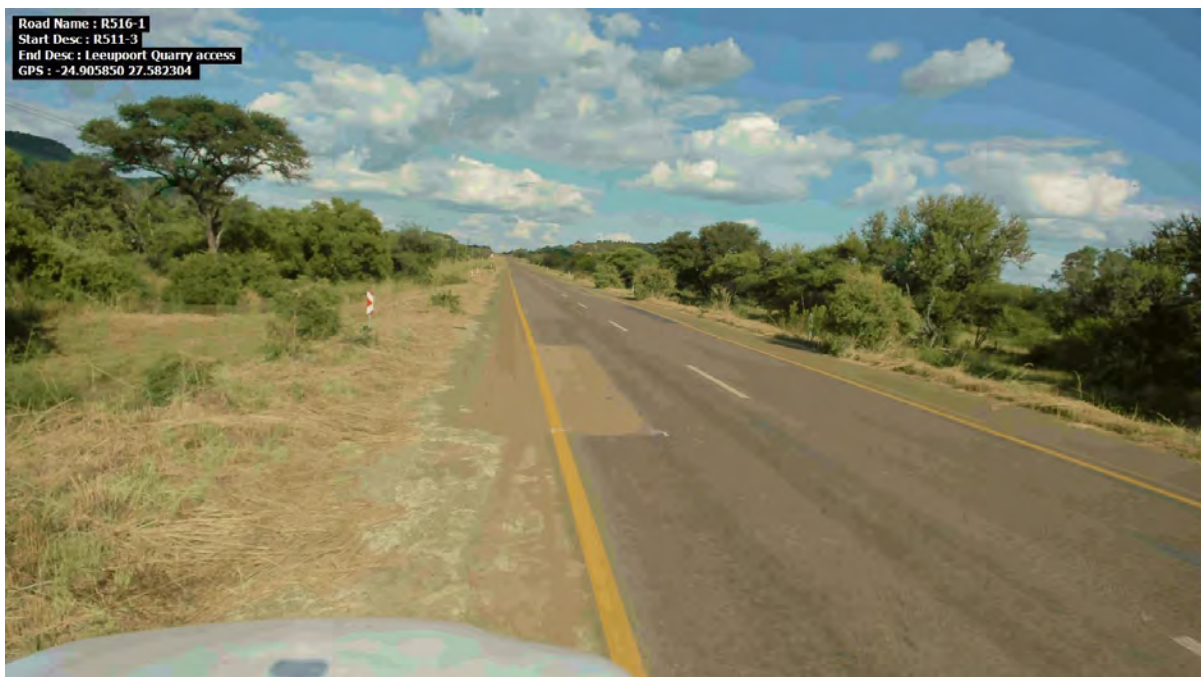
Photo 3.8: Road R516-1 (km 5,67): Crocodile cracking and pumping

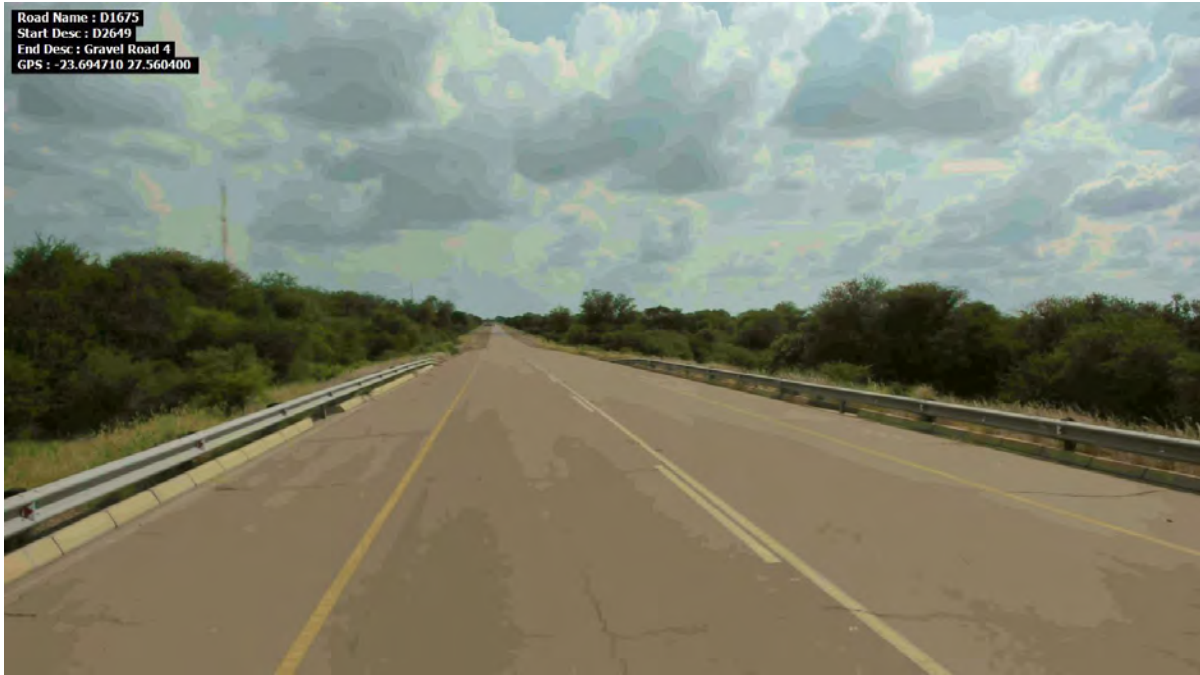
The asphalt section shows distress in the form of block- (degree 2-4) and very localised longitudinal- and crocodile cracking (degree 3); an example of block cracks is indicated in Photo 3.9.

Photo 3.9: Road D1675 (km 3,0): Block cracks along asphalt section

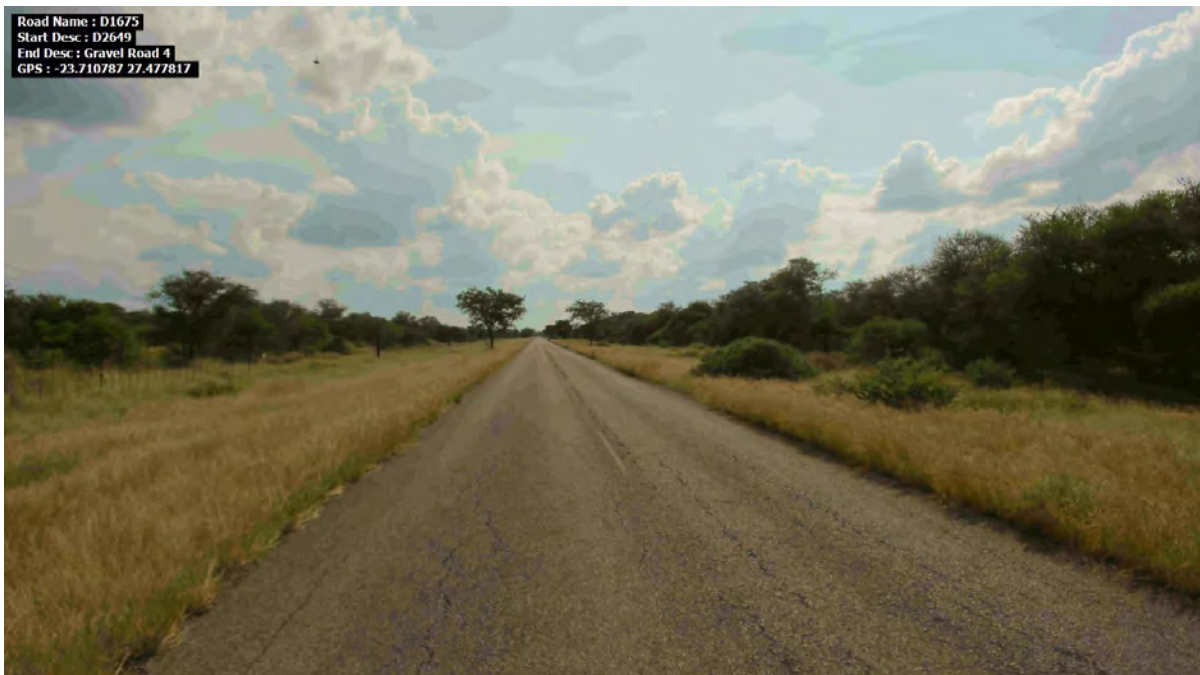
Road D1675 consists of an asphalt surfacing along the first 8,8 km, whereafter it changes to a seal surfacing. This also represents the limit of two uniform sections with the asphalt portion classified as being in good condition while the seal portion is classified as poor to good. The assessment showed that the seal section contains distress in the form of surface failures. Block-, long- (Photo 3.10) and crocodile cracking with degree 3 are also frequent together with rutting with a degree of 3 to 4. Patching and potholes are also present.

Photo 3.10: Road D1675 (km 11,6): Longitudinal cracks along seal section

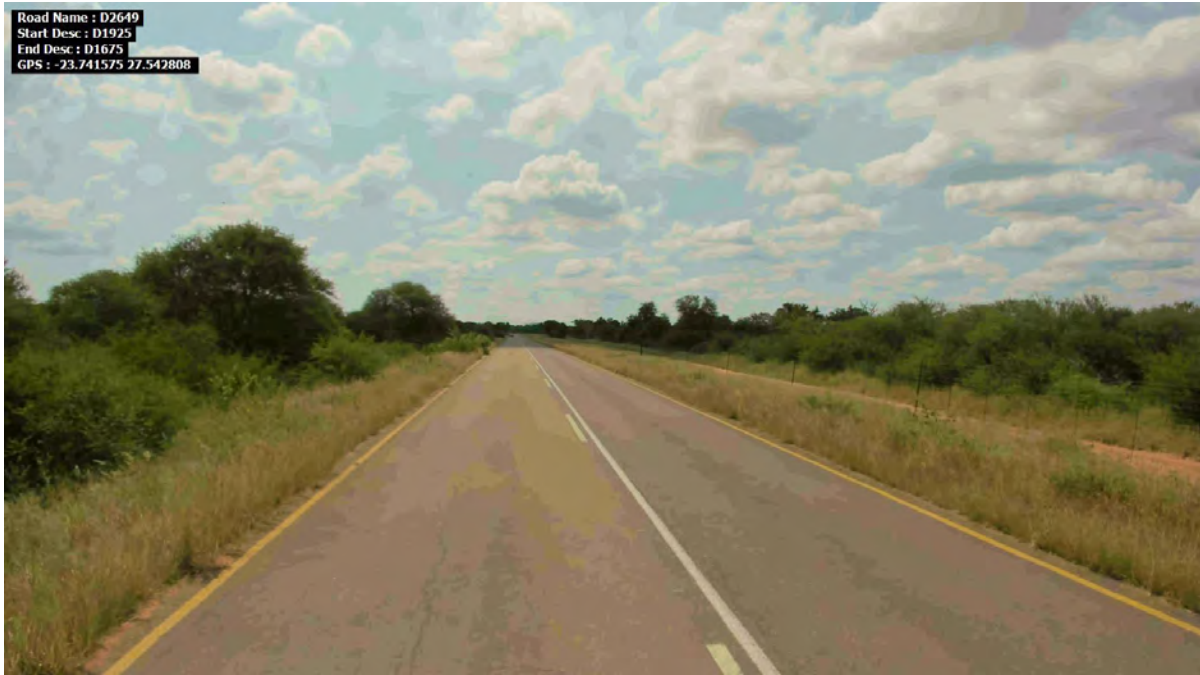
Road D2649 is classified as good to very good. It consists of a seal surfacing with localised surface failures and surface patches. Flushing of the binder is visible along most of the road section. Localised block-transverse and longitudinal cracks (degree 2), as shown in Photo 3.11 are visible. Minor undulation (degree 2) is visible especially along the last 2 km of this road section. Localised patching and potholes were also noted.

Photo 3.11: Road D2649 (km 0,15): Longitudinal crack in middle of left lane

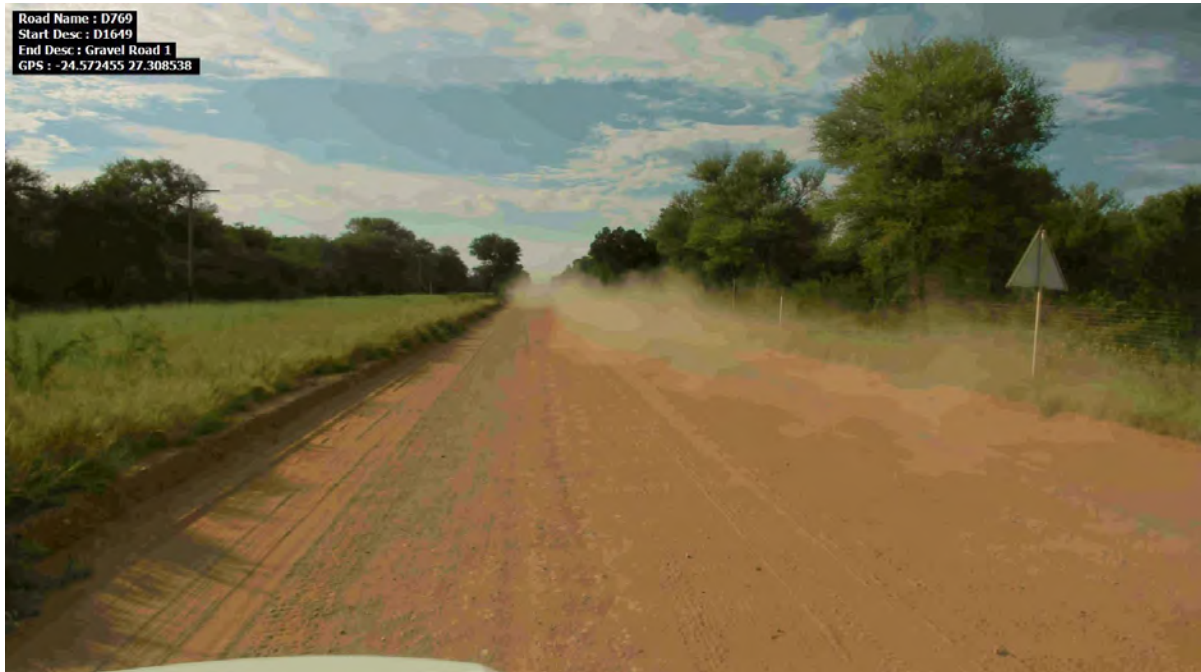
Loose material, which leads to dustiness as shown in **Photo 3.12** is also evident.

Photo 3.12: Road D769 (km 0,6): Dustiness and loose material

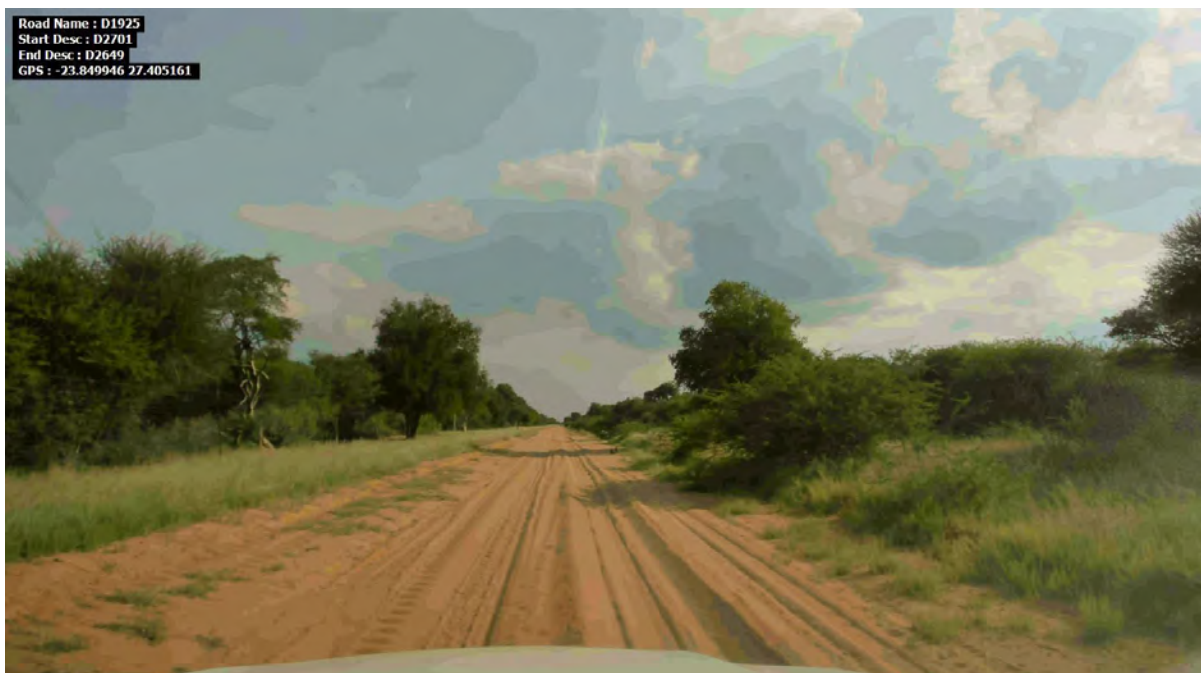
It should be noted that the visual assessment along **Road D1925** was carried out shortly after the area experienced heavy rainfall, which caused a dam wall to break resulting in surface flow. Severe erosion was noted along this road section between km 4.0 and km 14.0 as a result thereof. This section of road has subsequently partially been repaired. Loose material along this section of road is shown in Photo 3.13

Photo 3.13: Road D1925 (km 19,8): Loose material, overgrown

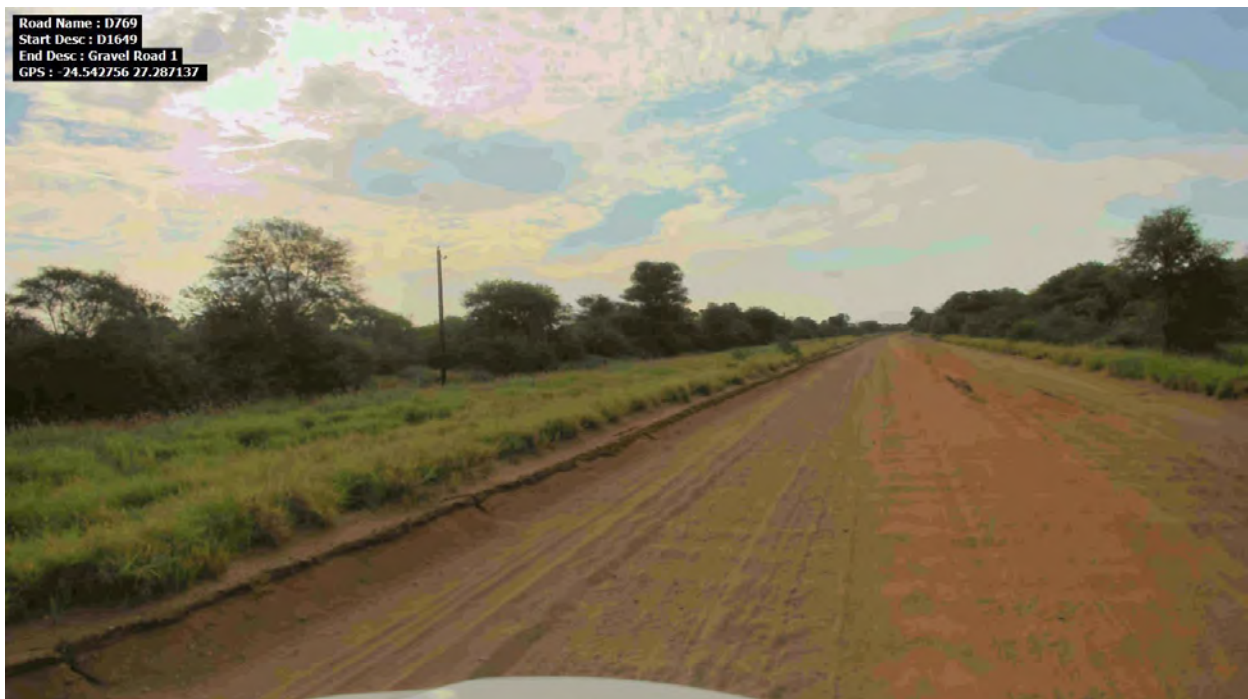
It was noted during the assessment that six of the unsurfaced roads should be raised in order to improve drainage. One of the main contributing factors to this situation is the loss of wearing course material, which is discussed in more detail in the following section. In general terms, the gravel wearing course is driven off over time, which is dependent on material quality, climate, and traffic volume. As wearing course material is driven off, it tends to end up in windrows along the sides of the road with the road level lower than the original design. If these windrows are not bladed frequently, they limit effective drainage of the road surface, and the road becomes a channel as indicated in Photo 3.14.

Photo 3.14: Road D769 (km 4,6): Loose material, corrugation, and windrows of gravel material along edge

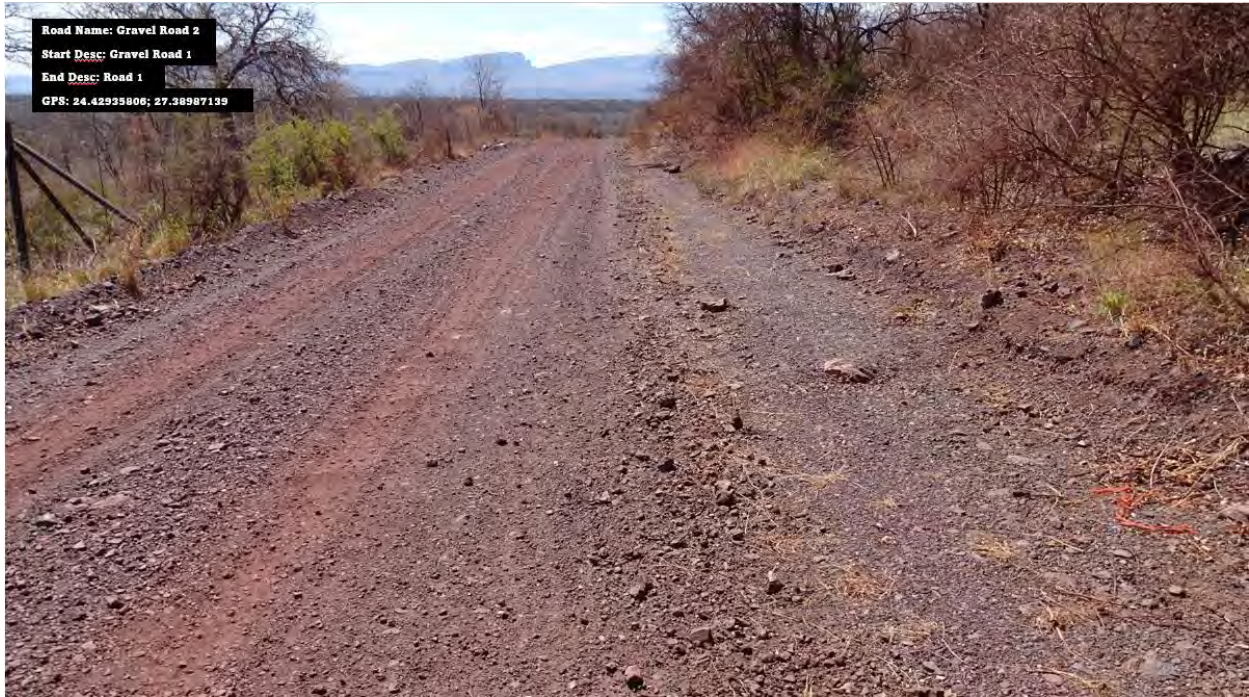
A section of **Gravel Road 2** has a rough surface with little evidence of a wearing course layer as indicated in Photo 3.15. Whilst this section of road is trafficable, it by no means provides a smooth driving surface. Essentially the coarse subgrade layer serves as the driving surface.

Photo 3.15: Gravel Road 2 (km 1,8): Large rocks in roadway

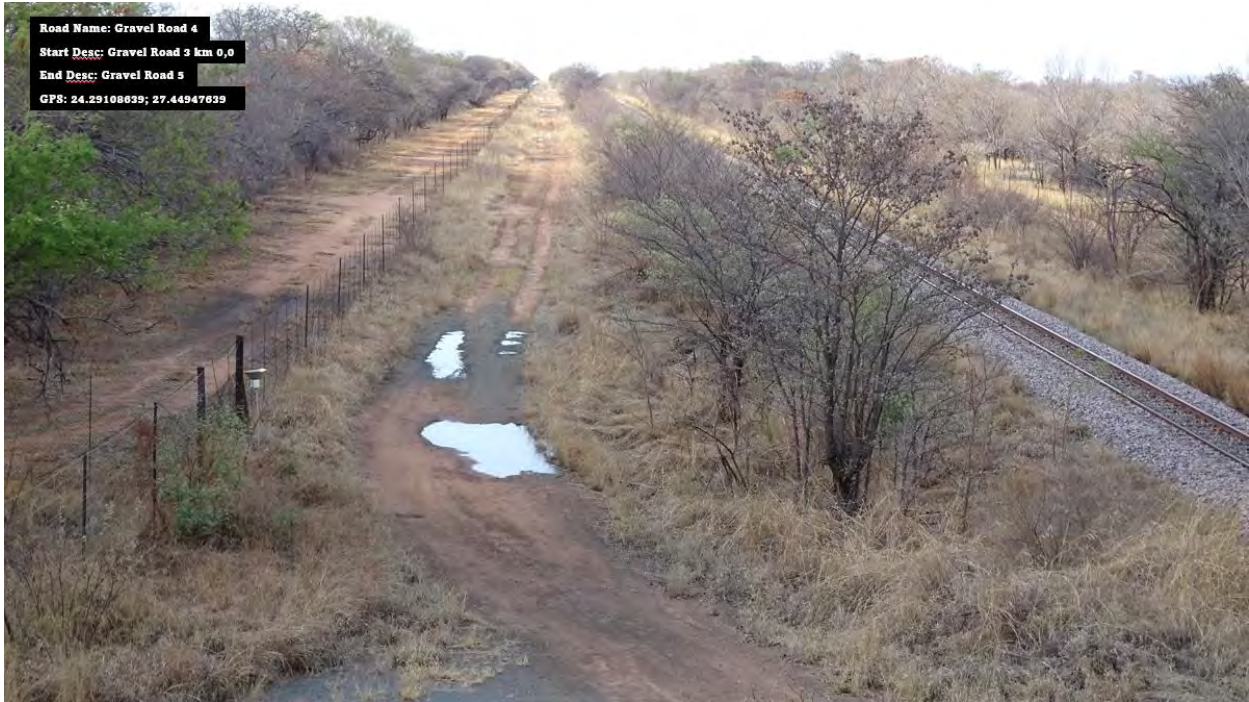
Photo 3.19: Gravel Road 4 (km 0.00) Photo taken facing the North-direction, Potholes and damage seen along roadway

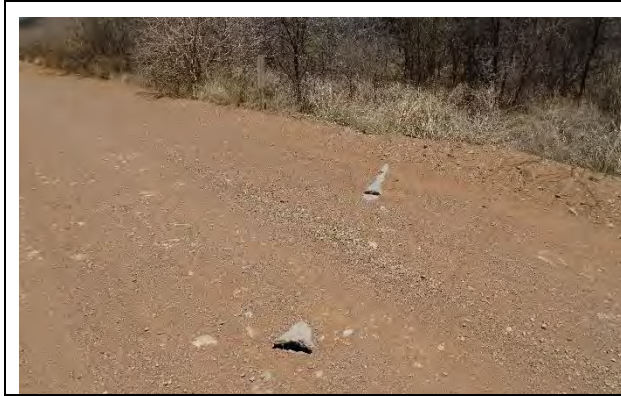
A: Top of culvert exposed and damaged on roadway

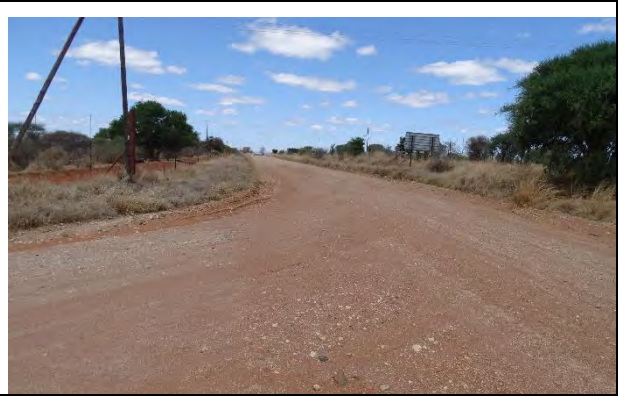
B: Sandy roadway

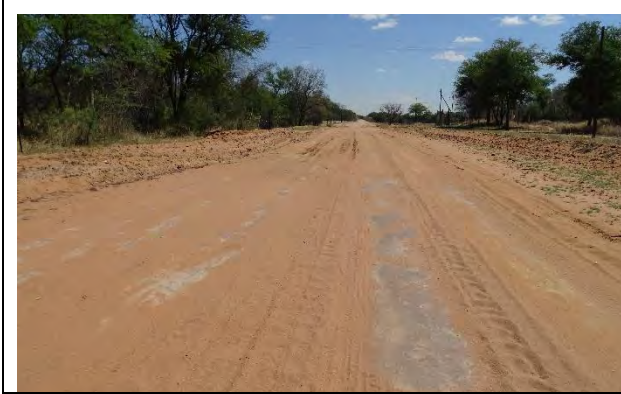
Like most of the gravel roads, **Road D1925** has little shape or profile with the road itself serving as a drainage channel during rainy periods. Windrows are evident over various sections of the road, together with sections showing advanced erosion. As for the other roads, culverts are blocked, and in some instances damaged due to the lack of gravel cover. Road D1925 will prove difficult to traverse with normal vehicles during rainy seasons.

A: Sandy roadway

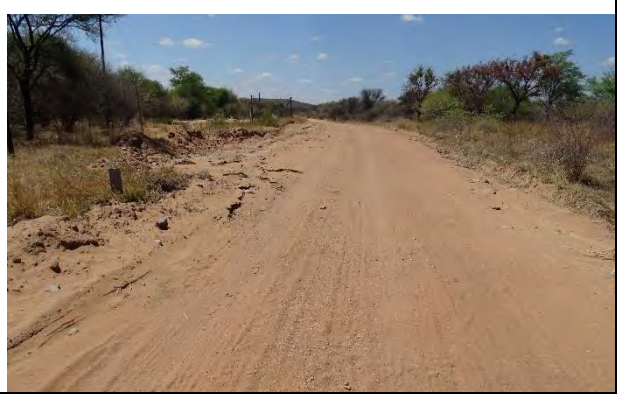
B: Sandy roadway showing water damage

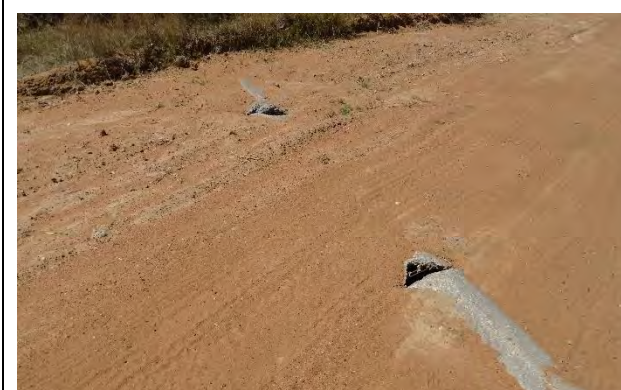
C: Top of culvert exposed and damaged on roadway

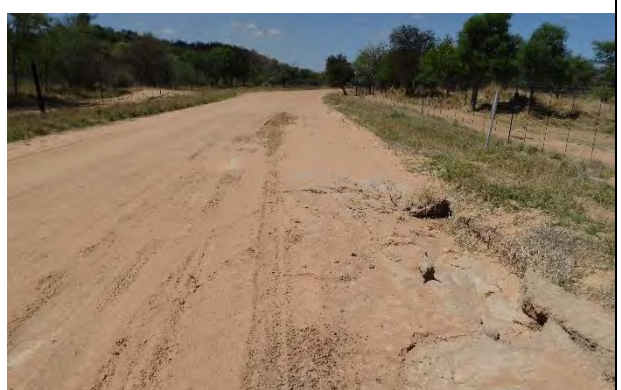
D: Sandy roadway showing water damage

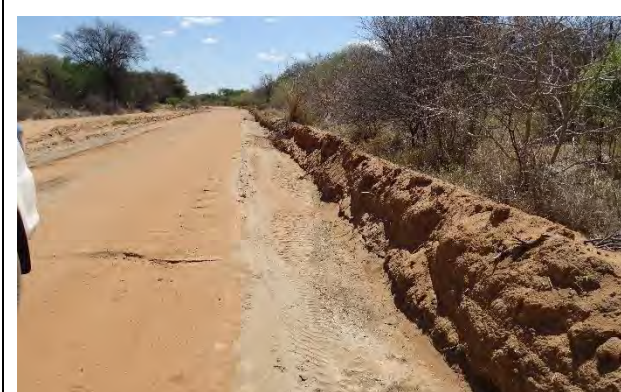
E: Windrows scoured away by stormwater

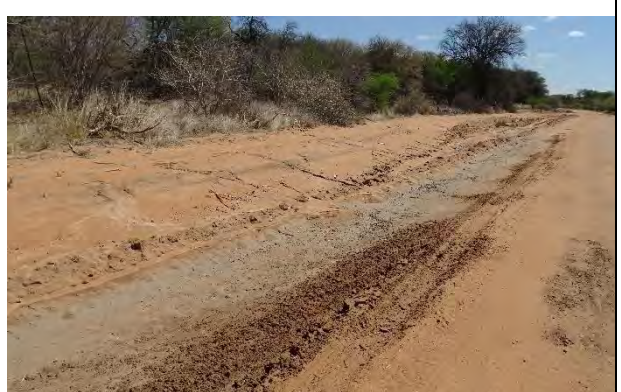
F: Roadway damaged by stormwater
