<p style="text-align: center;"><b>SOW</b></p>	<p style="text-align: center;"><b>Camden Power Station</b></p>
---	---	--

Title: **Water Treatment Plant Clarifier Tanks structural Repairs** Document Identifier: **240-150130392**

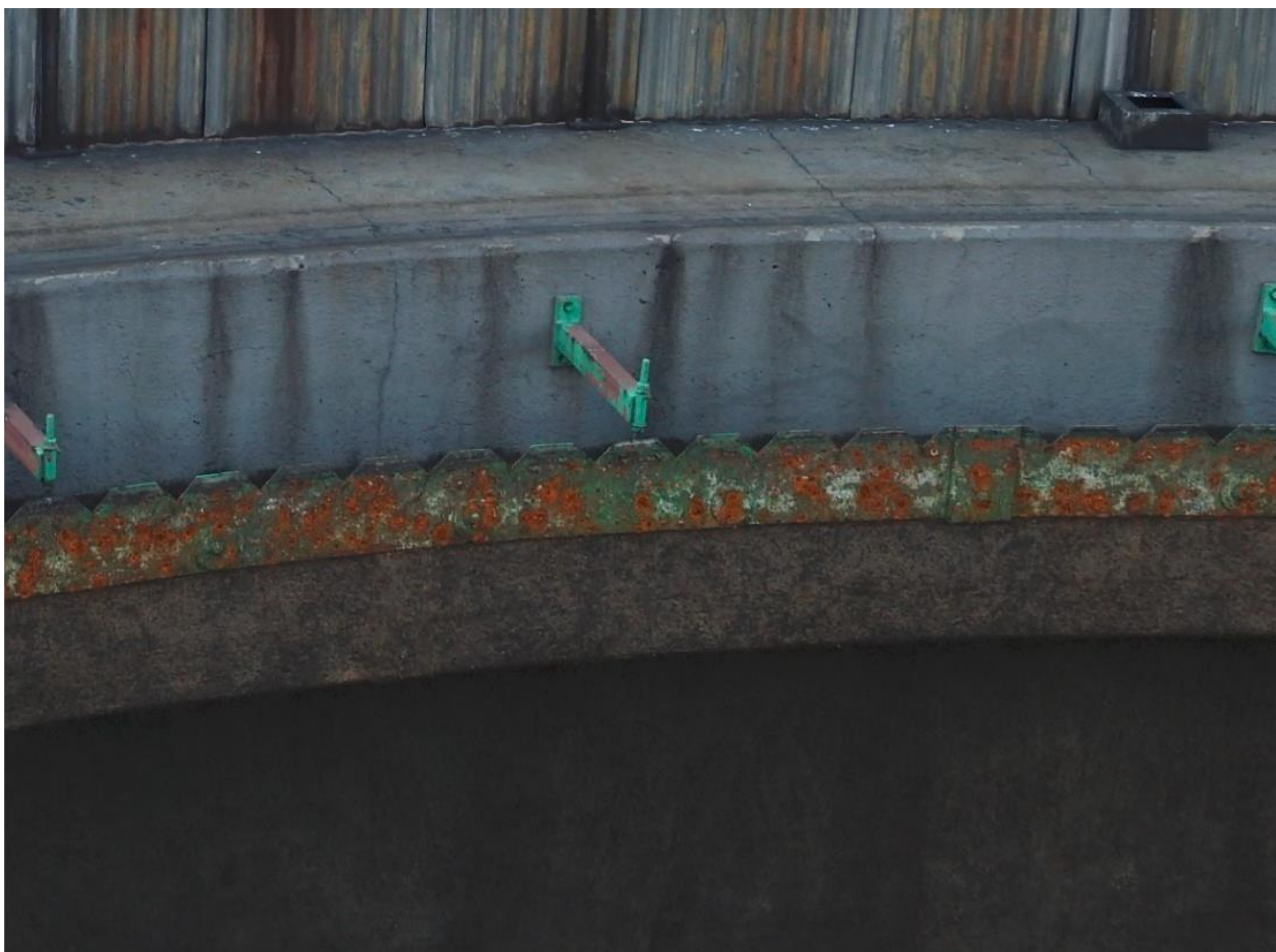
**Figure 2: Internal structure for clarifiers**

**Figure 2 shows corrosion on the Clarifier tanks cladding, handrail and minor concrete cracks**

- Clean all structural steel frame members and brush off minor corrosion with mechanical wire brushing or by sand blasting.
- Apply corrosion inhibitor on the steel members such as red oxide and there after apply corrosion resistant paint.
- Severely corroded vastrap plate must be replaced with hot dipped galvanized vastrap plate.

- Damaged handrailing on walkways and stairs to be replaced with 316 stainless steel similar to MS 90.

- The damaged iron cladding over clarifier tanks should be removed and replaced when replacing the corroded handrailing.

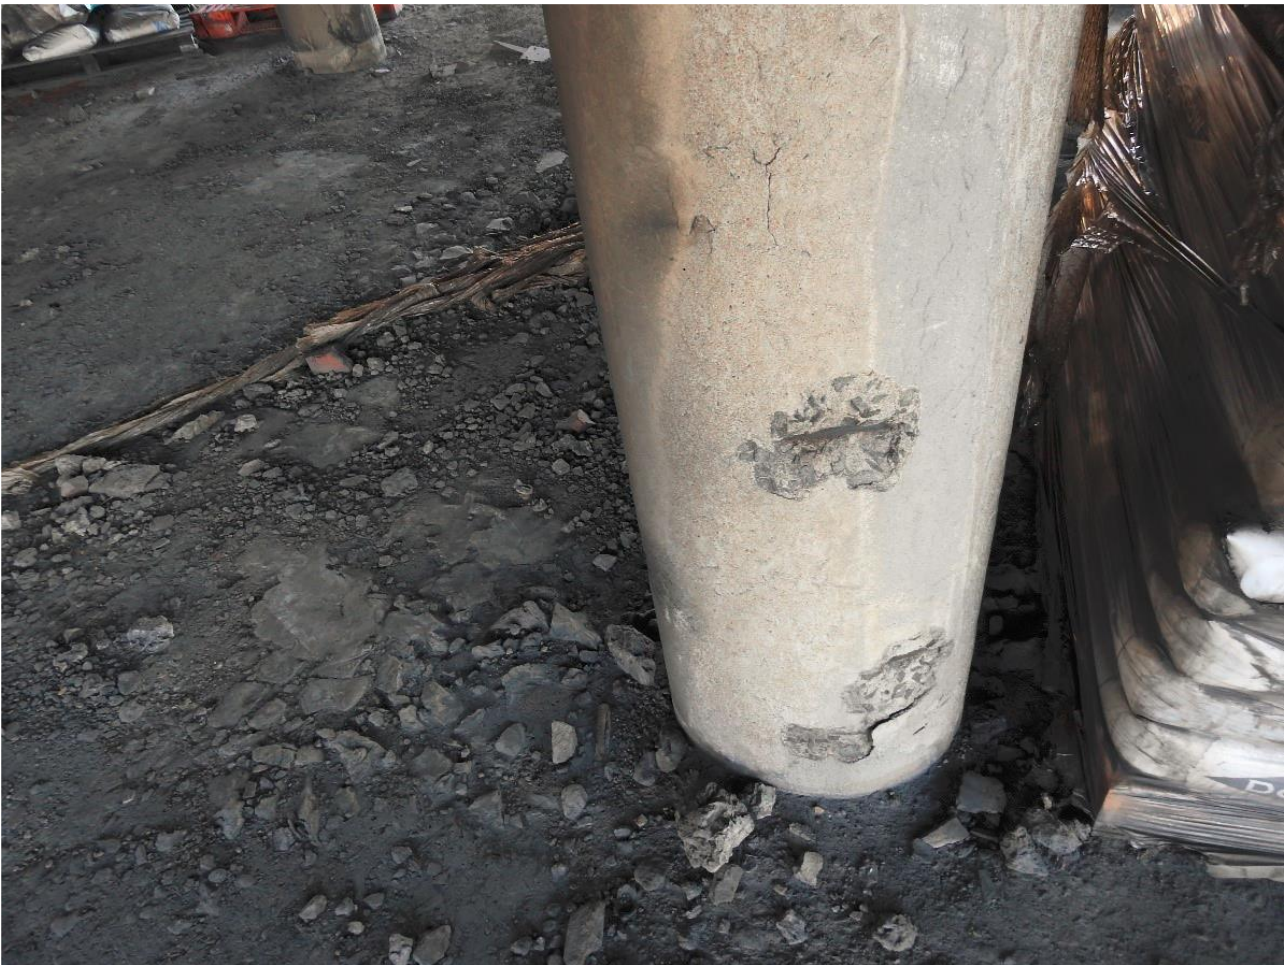
**Figure 3: Circular columns for clarifiers**

**Figure 3 above shows the thermal cracks that are evident on the columns of the clarifiers structure.**

- Drill holes on both side of the crack and clean the holes.
- Stitch the crack with U shape metal with short legs.
- Anchor the legs of the stitching U shape metal in the holes with a non-shrink grout or an epoxy resin-based bonding system. Inject the crack with epoxy or crack filler.

- The minor & moderate cracks shall be injected with *Sikadur* structural epoxy or similar product using a hydraulic pump, paint pressure pots, or air-actuated caulking guns.
- For vertical/inclined cracks, inject the entry port at the lowest elevation until the epoxy level reaches the entry port above.
- For horizontal cracks, injection shall be from one end of the crack to the other end in a similar manner as in the vertical/inclined crack.
- Cut or grind the surface after the injected epoxy has cured.
