Defect Photo Report

Region	Northern Region
Authority	SANRAL
Route	R023
Road ID	R02302N

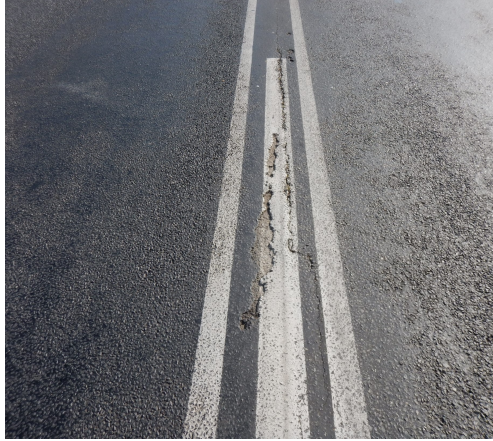
Structure ID - R023_02N_B1930
 Structure Name - Road over Rail at Greylingstad
 Road ID - R02302N
 Photo Direction - N
 Inspection Date - 2016-06-23
 Description - DSCN0071.JPG - Reapply surface at Span 1
 Photo Number -

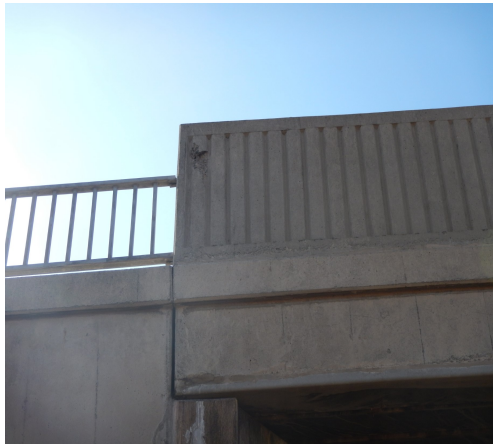
Structure ID - R023_02N_B1930
 Structure Name - Road over Rail at Greylingstad
 Road ID - R02302N
 Photo Direction - E
 Inspection Date - 2016-06-23
 Description - DSCN0082.JPG - Spall on Parapet A2 Abument
 Photo Number -

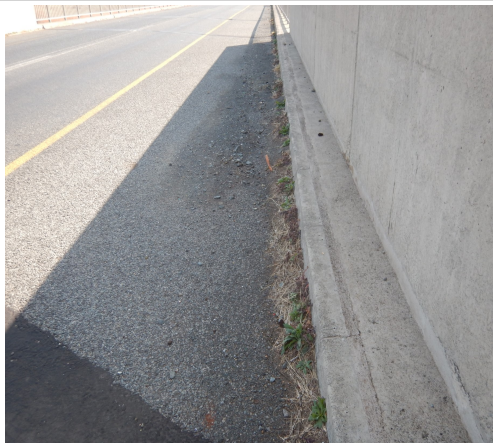
Structure ID - R023_02N_B1930
 Structure Name - Road over Rail at Greylingstad
 Road ID - R02302N
 Photo Direction - N
 Inspection Date - 2016-06-23
 Description - DSCN0072.JPG - Clear debris from deck surface AS
 Photo Number -

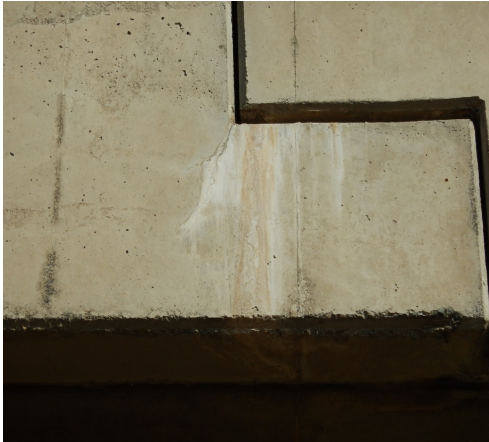
Description - DSCN0078.JPG - Various cracks on Deck Slab AS

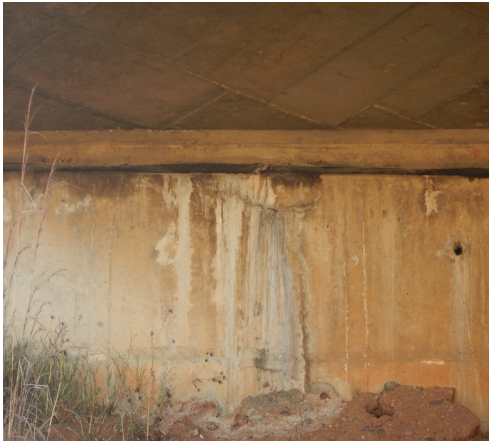
Description - DSCN0075.JPG - Spall on A2 Abutment

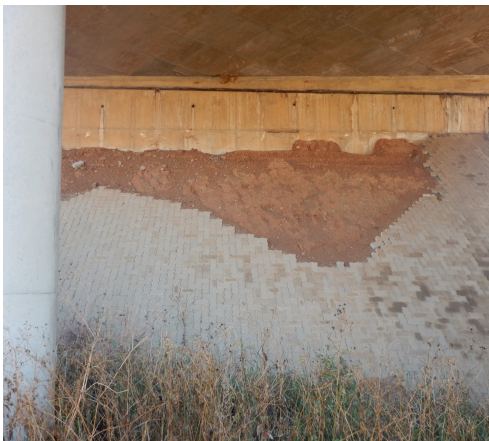
Description - DSCN0076.JPG - Replace Approach Embankment brick paving A2 Abutment

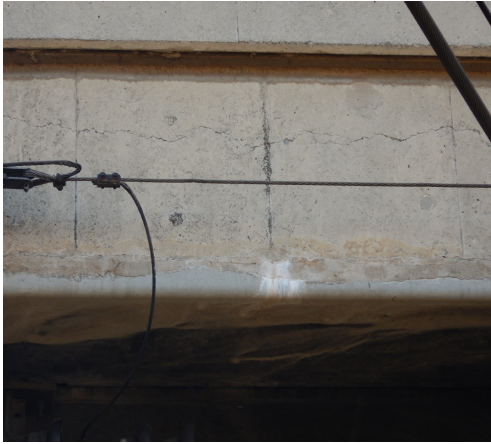
Description - DSCN0084.JPG - Various crack on Deck Slab AS

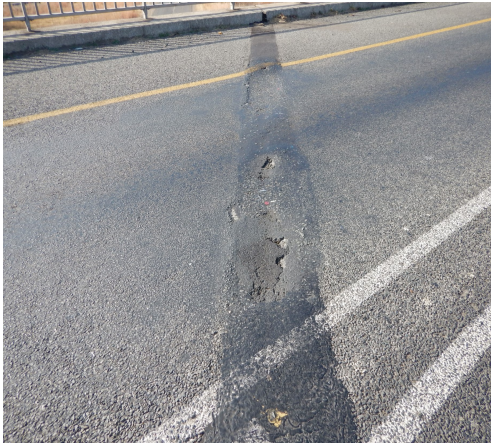
Description - DSCN0067 - 1.JPG - New Asphalt Plug A1 Abutment

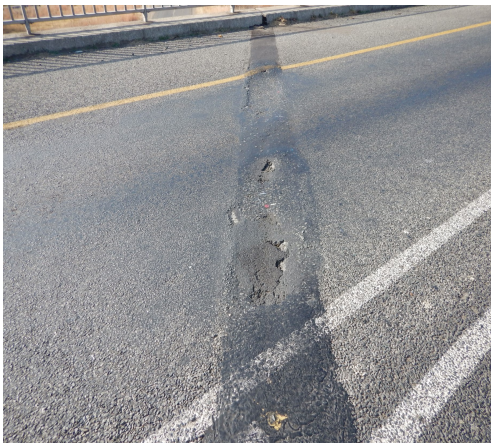
Description - DSCN0067.JPG - New Asphalt Plug P1, P2, P3
