## Defect Photo Report

<b>Region</b>	Northern Region
<b>Authority</b>	SANRAL
<b>Route</b>	R023
<b>Road ID</b>	R02302N

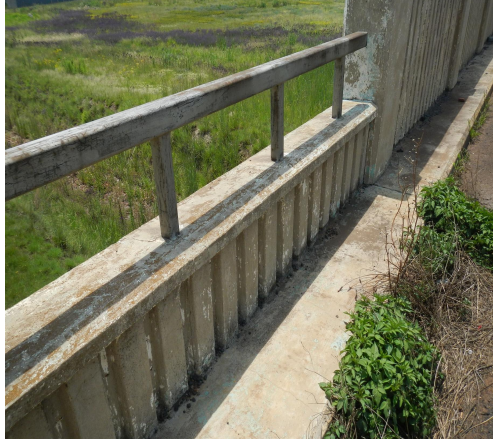
Structure ID - R023\_02N\_B1929  
 Structure Name - Road over Rail at Balfour  
 Road ID - R02302N  
 Photo Direction - E  
 Inspection Date - 2011-12-27  
 Description - DSCN3496.JPG apply protective coating to handrail and balustrade  
 Photo Number - S02

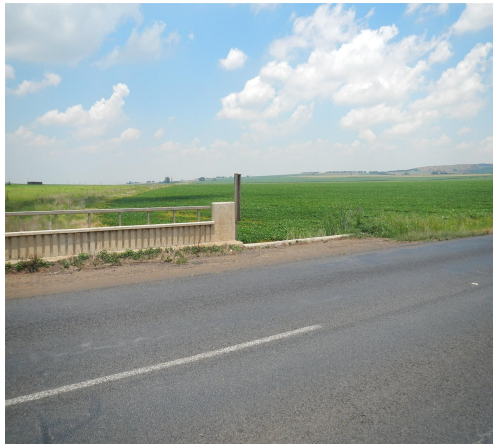
Structure ID - R023\_02N\_B1929  
 Structure Name - Road over Rail at Balfour  
 Road ID - R02302N  
 Photo Direction - W  
 Inspection Date - 2011-12-27  
 Description - DSCN3499.JPG missing guardrail on approaches  
 Photo Number - S04

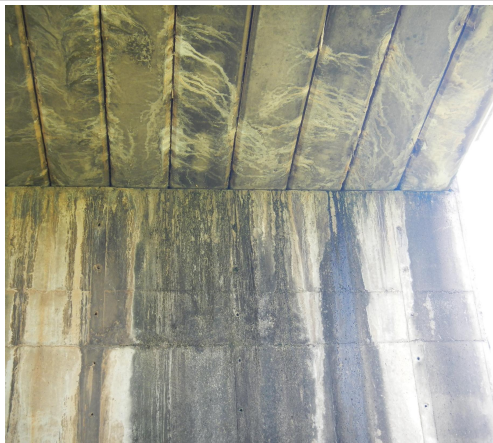
Structure ID - R023\_02N\_B1929  
 Structure Name - Road over Rail at Balfour  
 Road ID - R02302N  
 Photo Direction - N  
 Inspection Date - 2011-12-27  
 Description - DSCN3504.JPG abutment leaks  
 Photo Number - S06

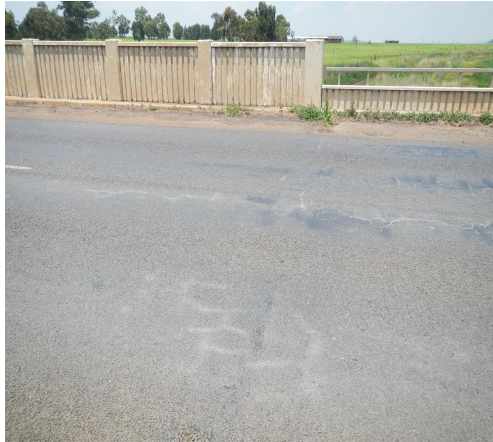
Photo Number - S03

Description - DSCN3497.JPG roadway joint

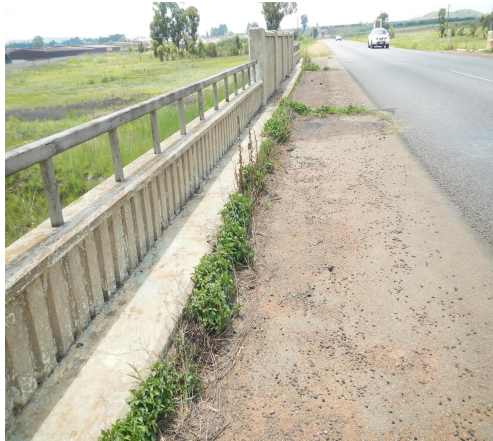
Photo Number - S00

Description - DSCN3494.JPG clear siltation

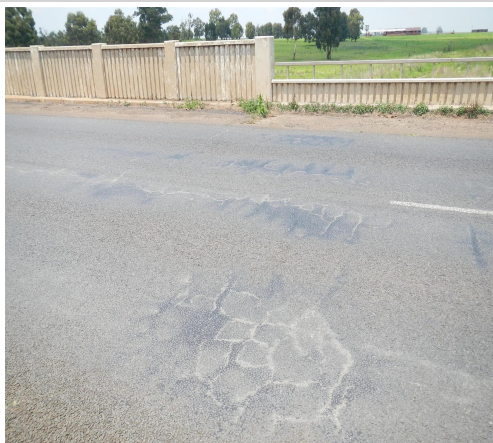
Photo Number - S01

Description - DSCN3495.JPG resurface deck

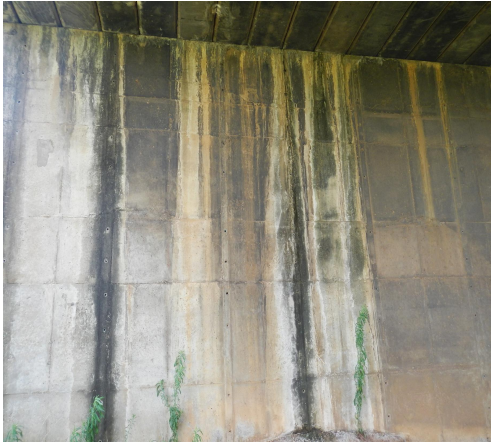
Photo Number - S05

Description - DSCN3503.JPG abutment leaks
