Title: SCOPE OF WORKS ALPHA
 BETA 1 765KV TOWER 672 GUY
 ANCHOR FAILURE

Unique Identifier: 240-98155775

This document shall apply to Alpha Beta Line 1 765kV tower 672.

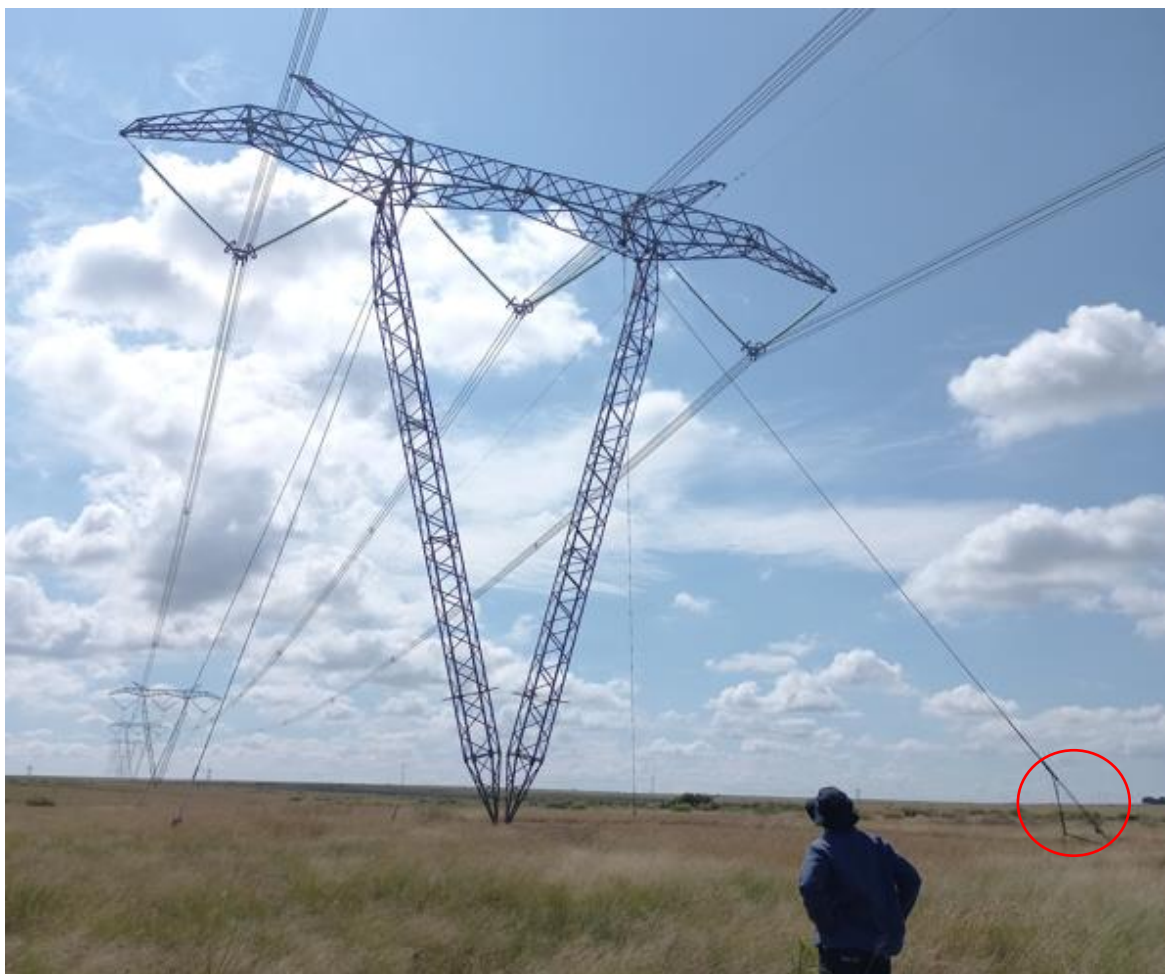
A site inspection was conducted by Lines engineering services (LES) on the 7 March 2022 to inspect the guy anchor shown in Figure 3 on the Alpha Beta 1 765kV line. The purpose of the site visit was the following:

Due to the remaining anchors being in a similar ground condition the assumption is that the existing anchors are also compromised.

Figure 3: Tower 672 (701B) failed guy anchor

close proximity to live lines and warrants an Authorized Person in terms of the OSH (Occupational health and safety) Act. The objective of the site visit conducted was to determine the scope of work for tower 672 (Alpha Beta 1 765kV Line). The failed guy anchor will need to be replaced with a new foundation in addition with the remaining guy anchors. The remaining anchors will require replacement to prevent failure at a later stage.

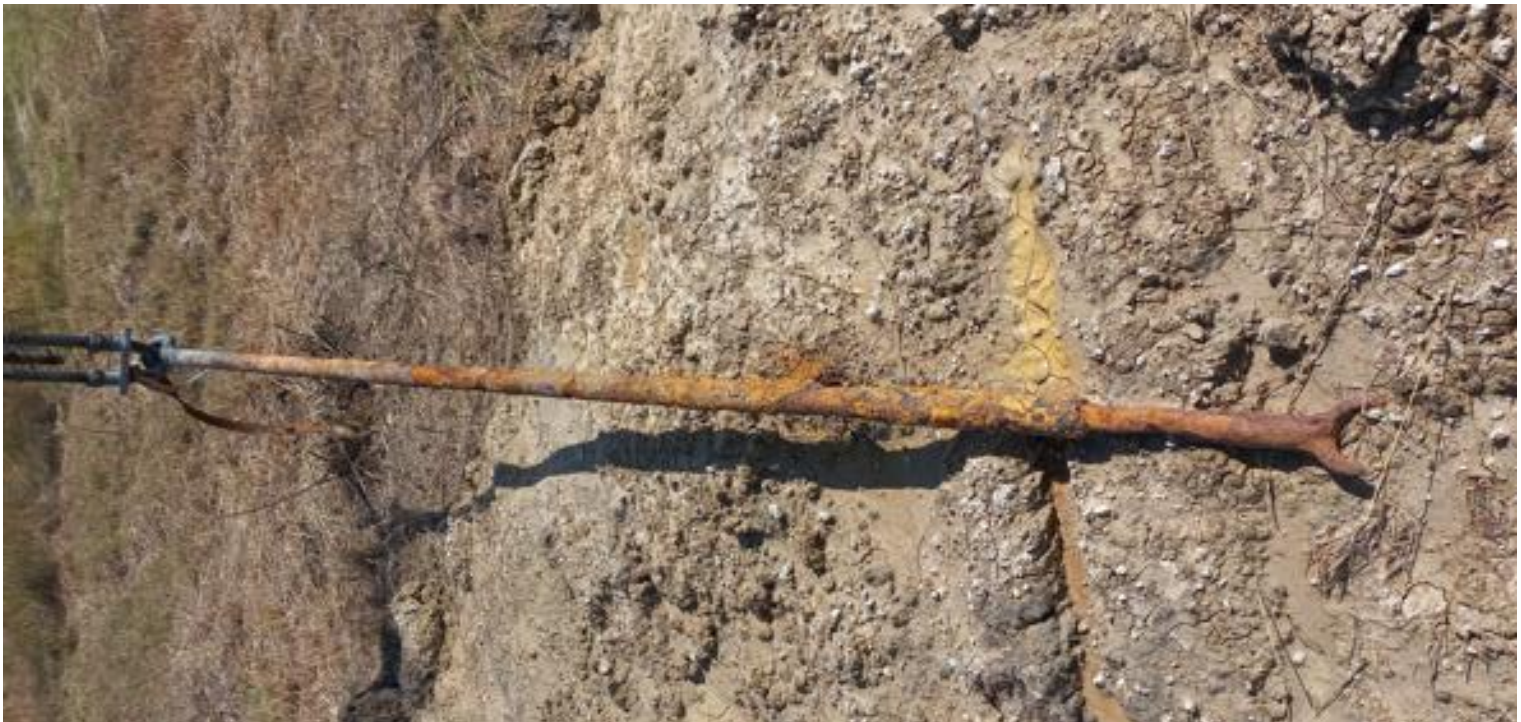
- Figure 4 below shows the failure of the eye link which occurred between the eye link and foundation connection point. The first 1 m of the link connected to the U-bolt assembly showed very little evidence of corrosion but going further down the link the rate of corrosion increased significantly.

- From the preliminary inspection and discussion with subject matter expert's (LES) the following conclusions were made:
 - It appears the corrosion at the point of failure had occurred and was present for some time before pulling out.

- After pulling out no evidence of shearing was noticed.
- Figure 5 below shows the failed eye link and figure 6 below shows the failure zone on the foundation.

Figure 4:Failed guy anchor

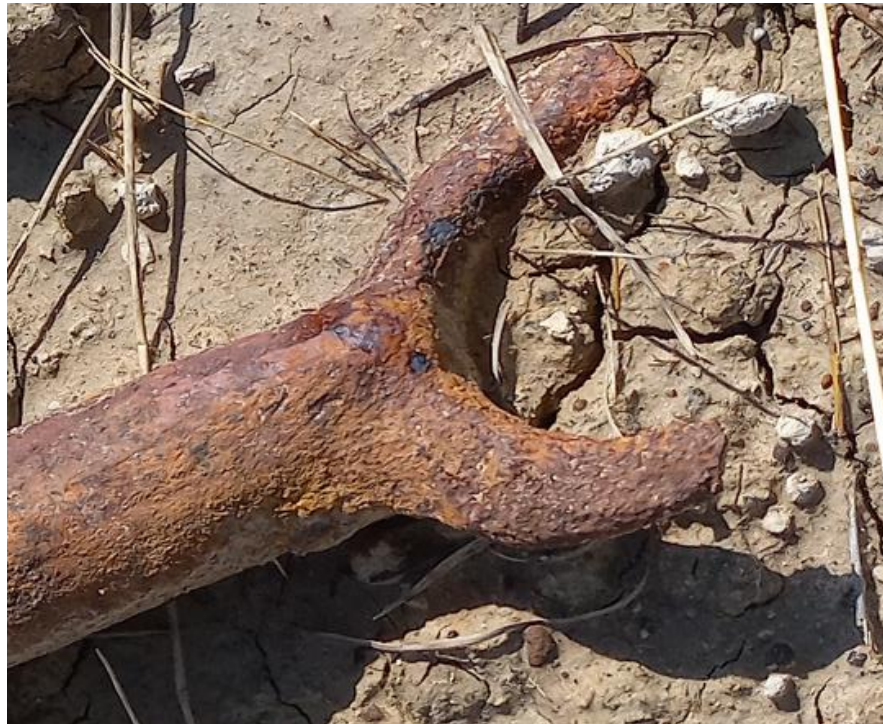
Figure 5: Corroded eye link

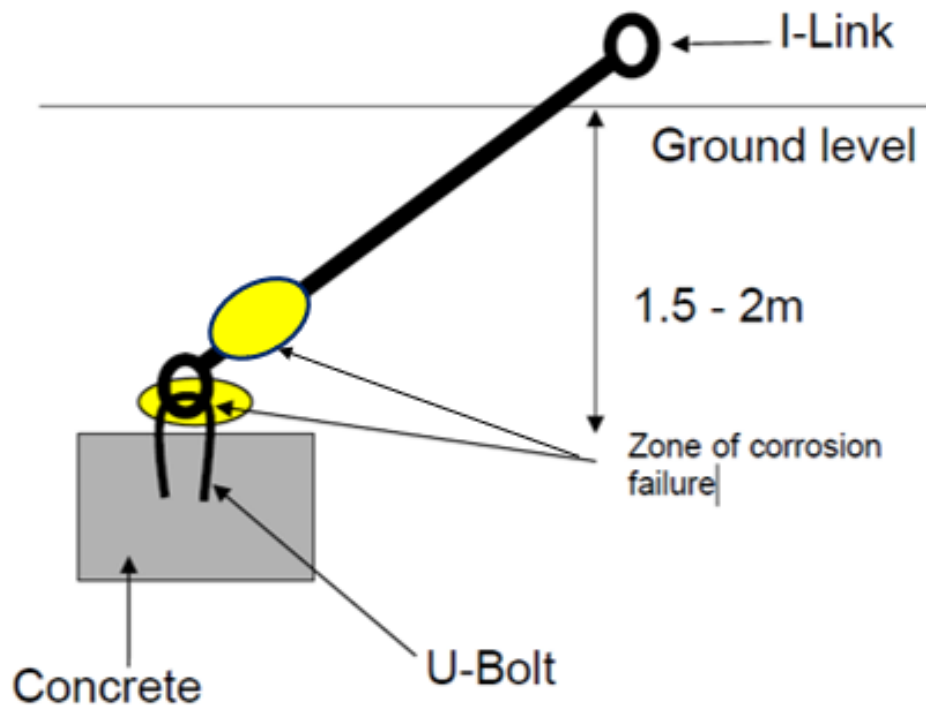
Figure 6: schematic illustration of failure zone

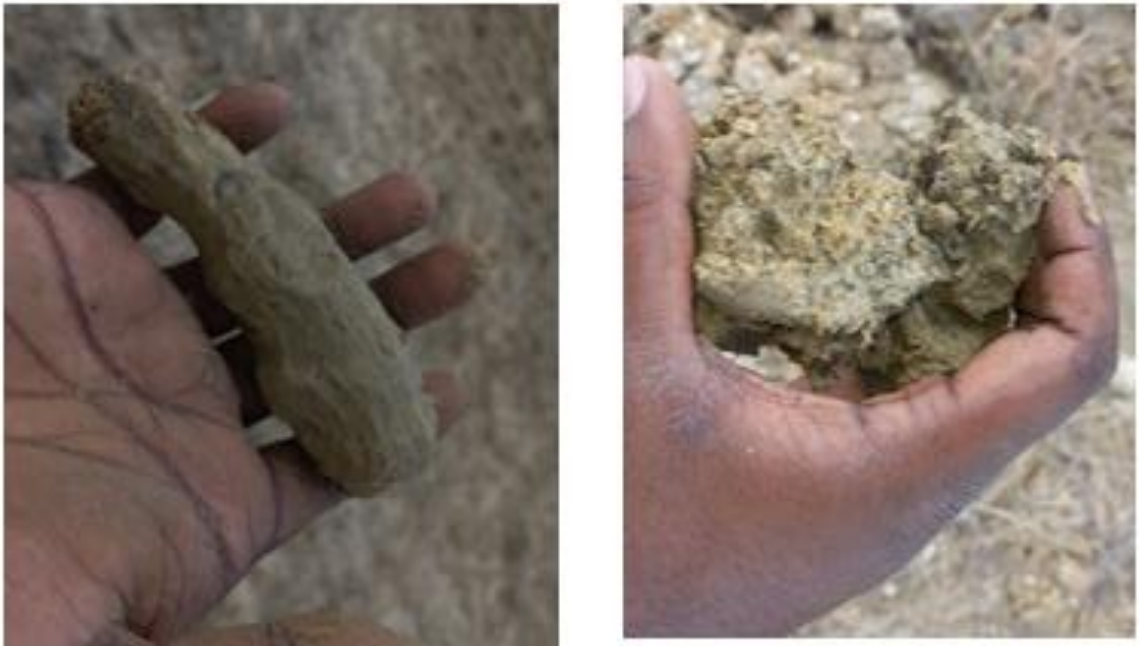
- High-level geotechnical parameters:
 - Figure 7 below shows the Sausage test conducted on in-situ soils on the surface at natural moisture content(i.e. no water added). The soils retained the sausage shape when compressed without crumbling and breaking.

- Indication of cohesive fine-grained material.
- Figures 8,9 and 10 below show ponding of water around the guy anchors and center mast foundations

Figure 7:Sausage test

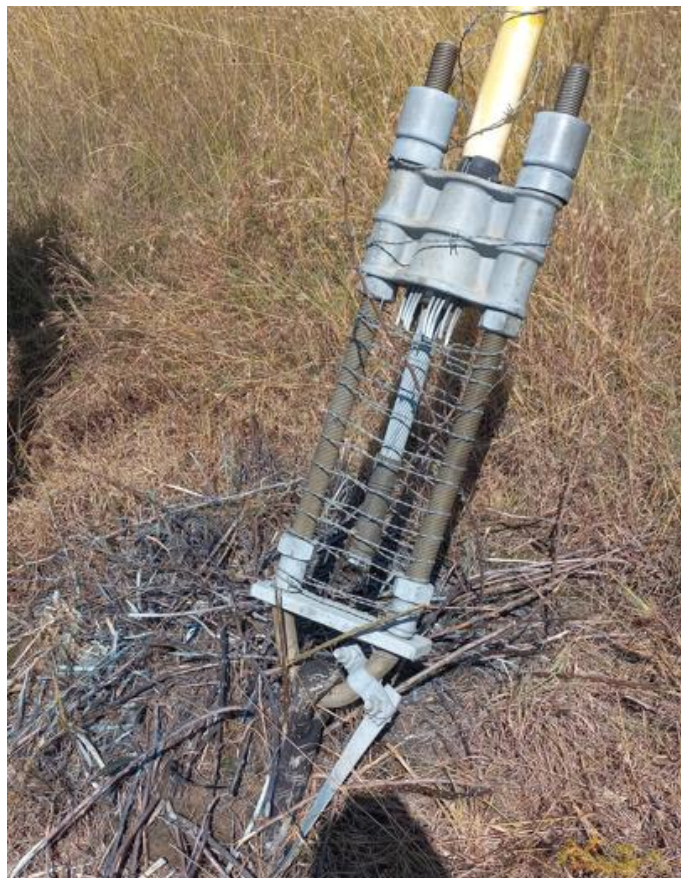
Figure 8:Existing guy anchor

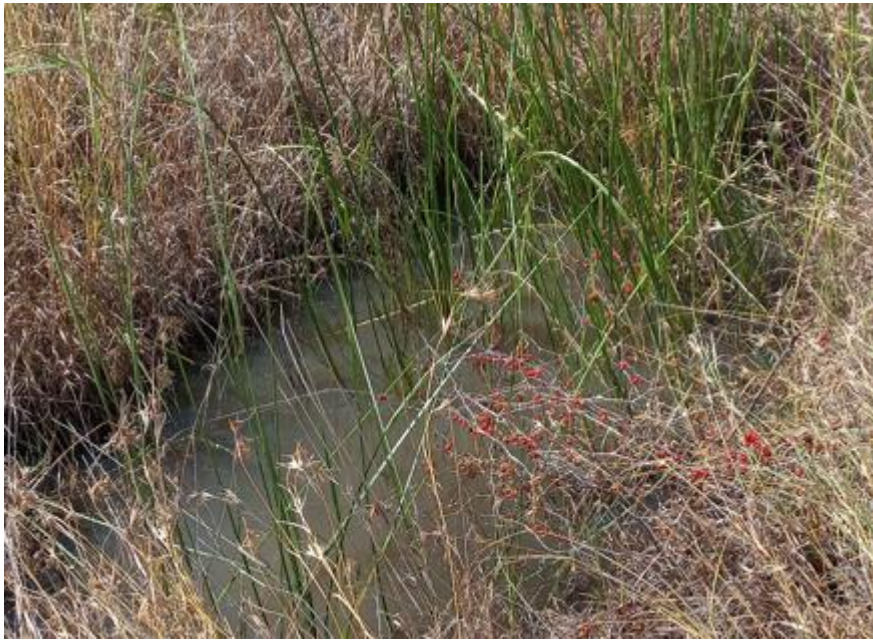
Figure 9: Ponding of water by existing guy anchor links

- Securing of all four guy anchors, installation of new foundations for all guys and transferring of old guys to new foundations.
- Removal of old foundation guy links.
- Re-shaping of ground around the centre mast and guy anchors to prevent water from ponding.

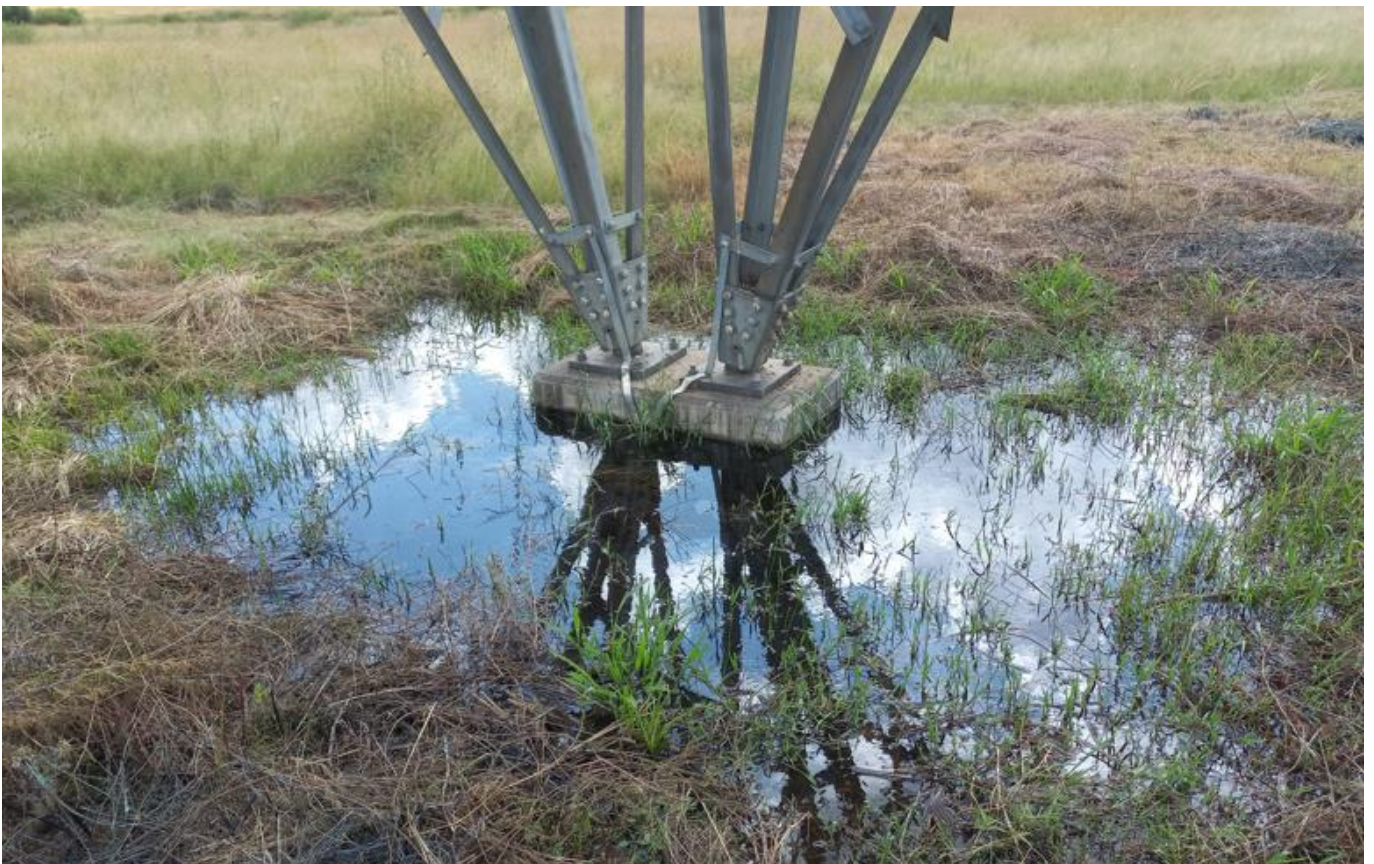
Figure 10: Ponding of water around the centre mast of tower 67

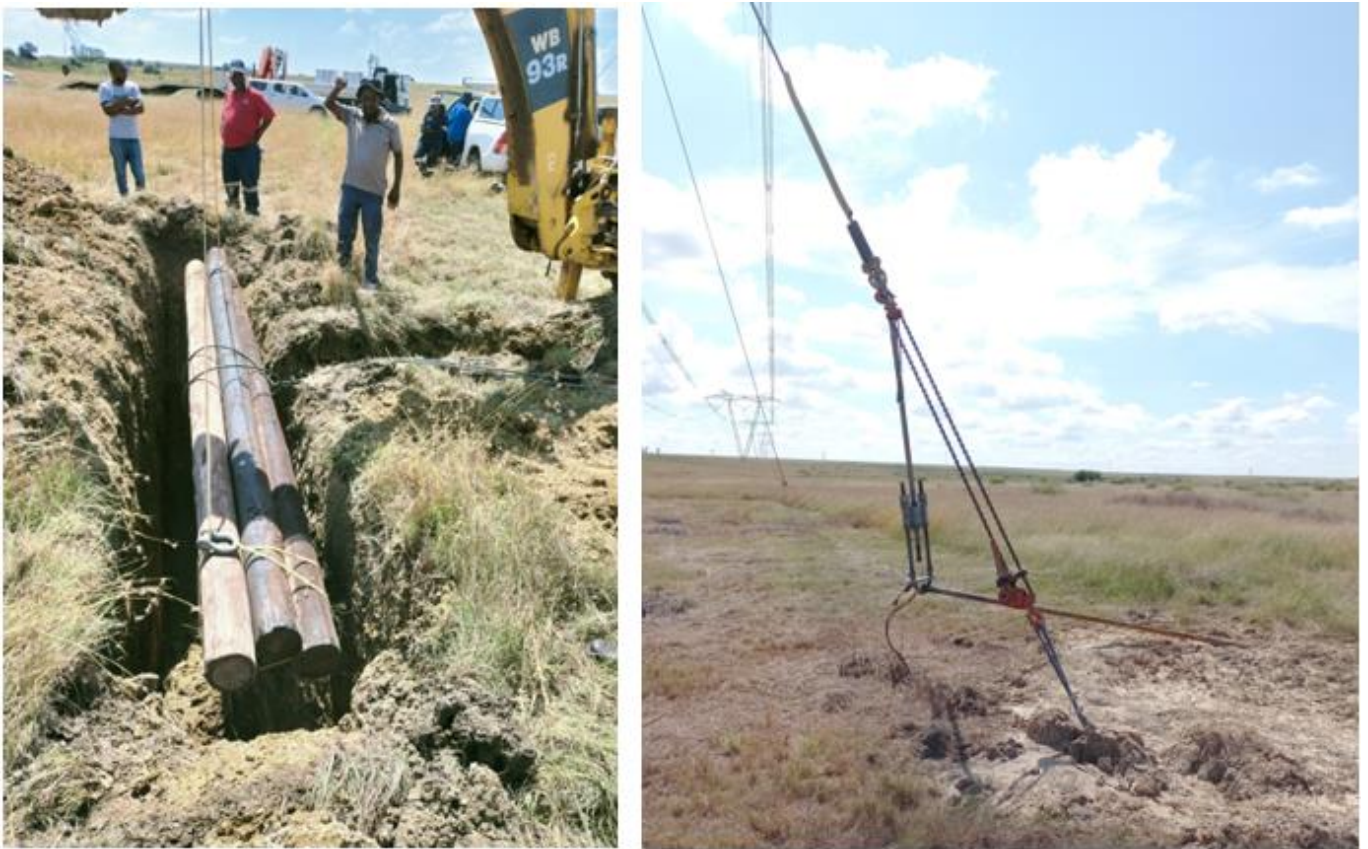
Figure 11 below shows the temporary backstay of the failed anchor. The approximate position of the temporary anchor is shown in figure 12 below.

Figure 11: Temporary backstay

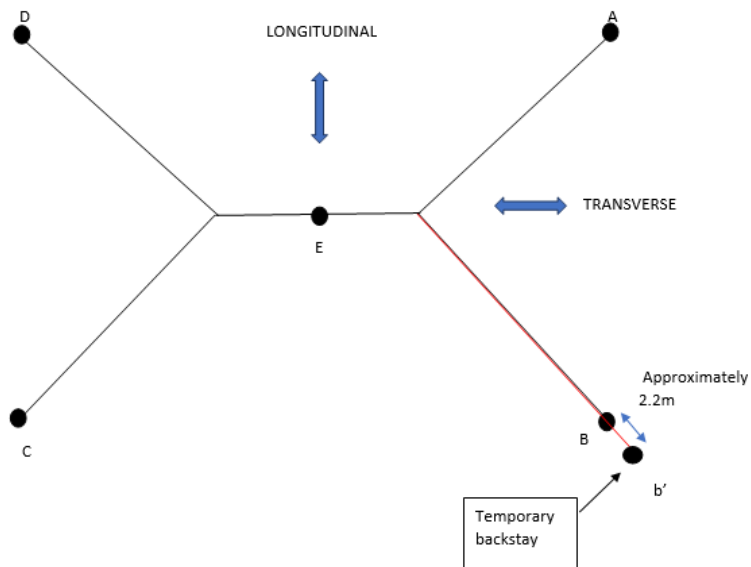
Figure12: Approximate location of the temporary backstay

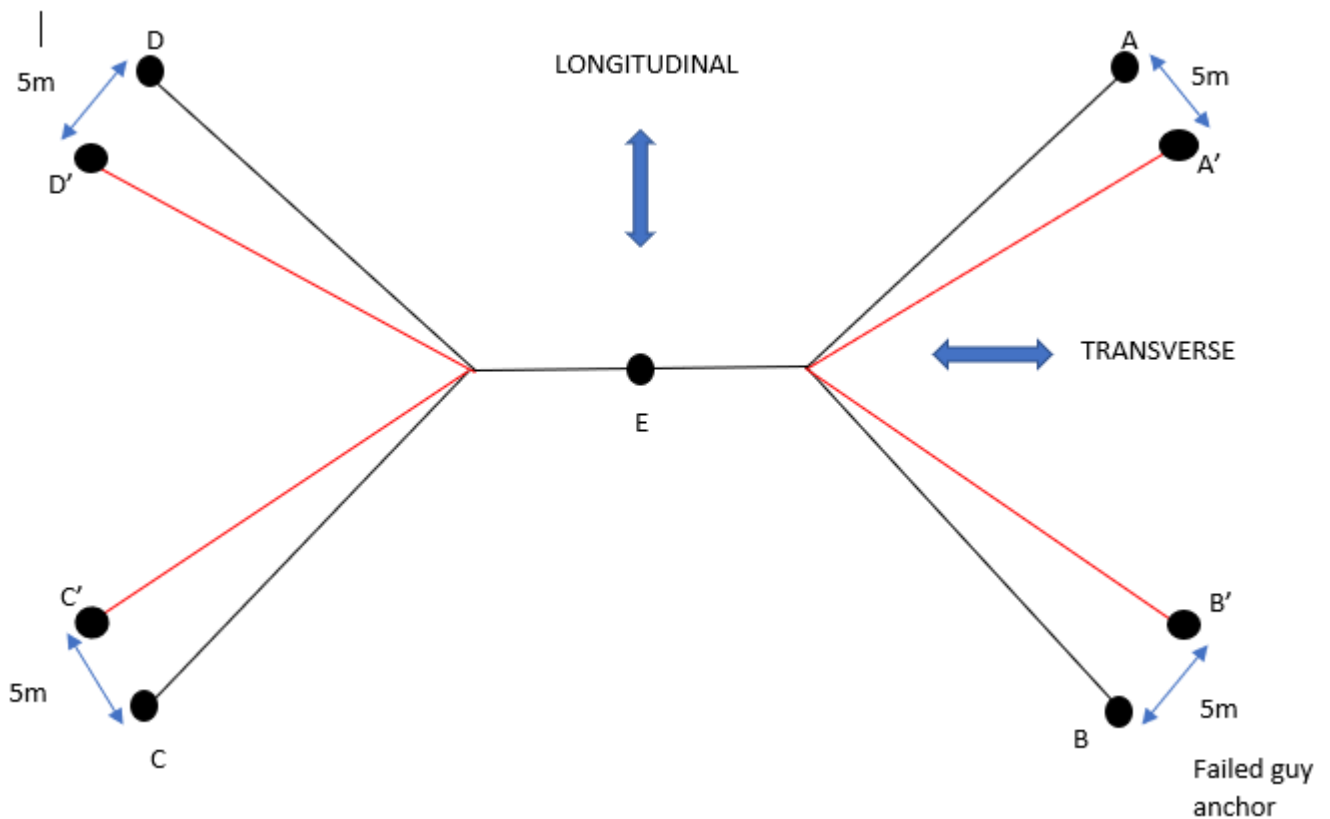
Figure 13: Proposed new guy anchor position

A new guy anchor foundation will need to be installed for all four anchors. Figure 13 below shows the new anchor position(A',B',C',D') in respect to the existing foundation position(A,B,C,D).

The new position should be determined such that the same stay rope can be used. The new location (highlighted using the red line) is at a point rotated approximately 5 m (Maximum rotation distance to not exceed 5.5 meters, any changes need to be discussed with LES) towards the transverse direction of the line as shown in Figure 13 below. The contractor will be required to use a professional surveyor to peg the correct position and alignment of the new anchors.

The new guy anchor foundations will be located approximately 5m (Maximum rotation distance to not exceed 5.5 meters, any changes need to be discussed with LES) away. The new foundation will be constructed at the same radius distance as the original foundation.

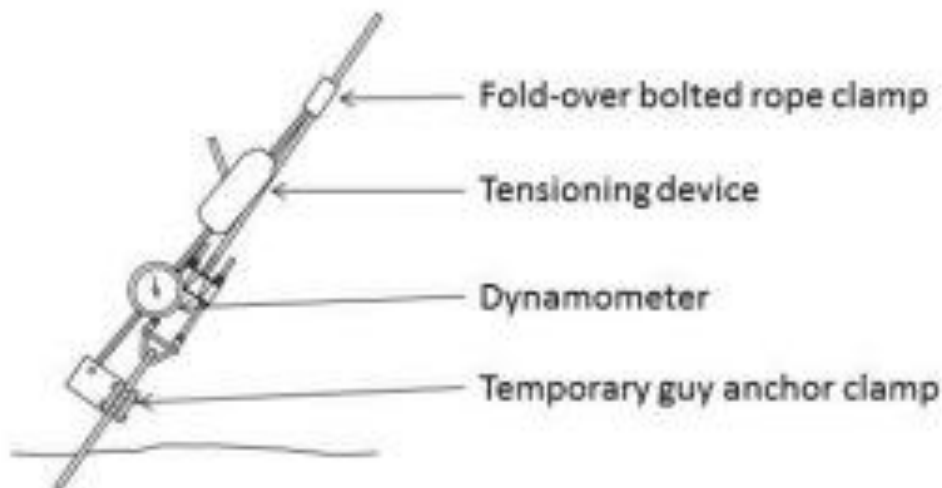
Figure 14: Checking correct tension in the guy wire

- During tensioning care must be taken to ensure its done safely and correctly (Latest version - TRMSCAAC6, 5.4.3 Erection of guyed towers).
- A comprehensive safe working procedure will need to be developed by the contractor detailing exactly how the work will be carried out. A detailed risk matrix including the mitigation measures must be included in the safe working procedure.
