Title: **Scope of Works Document for Beta - Delphi 400kV Tower 74 Guy Anchor Foundations Replacement**

Unique Identifier: **LES1331**

Documentation Type: **Scope of Work**

Replacement of all anchor foundations for the Beta - Delphi 400kV Tower 74

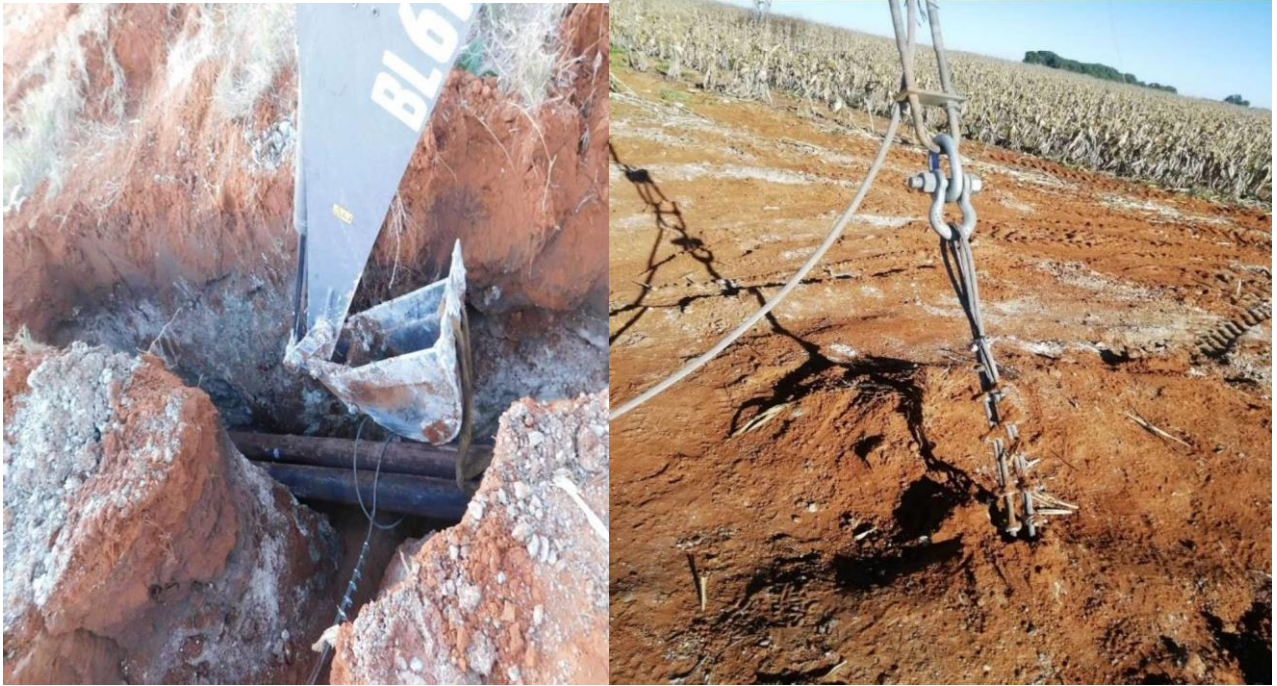
The guy anchor foundation (Leg A) of the Beta-Delphi 400kV Line Tower 74 pulled out on the 13th May 2021 which caused the line to trip however the tower did not collapse. The tower was stabilized on the 15th May 2021 by installing temporary woodpole stay anchor 3m in front of the failed anchor as shown on Figure 2. The tower is located on a maize farm in the Free State, see Table 1 for the TXIS details of the tower and Figure 1 for geographical position of the tower. Figure 3 shows the section of the deadman foundation that pulled out, it is also evident from the picture that the cause of the failure is the corrosion on the link plate. The concrete was also encased in a steel pipe which had also corroded.

Figure 2: Temporary Wooden Poles

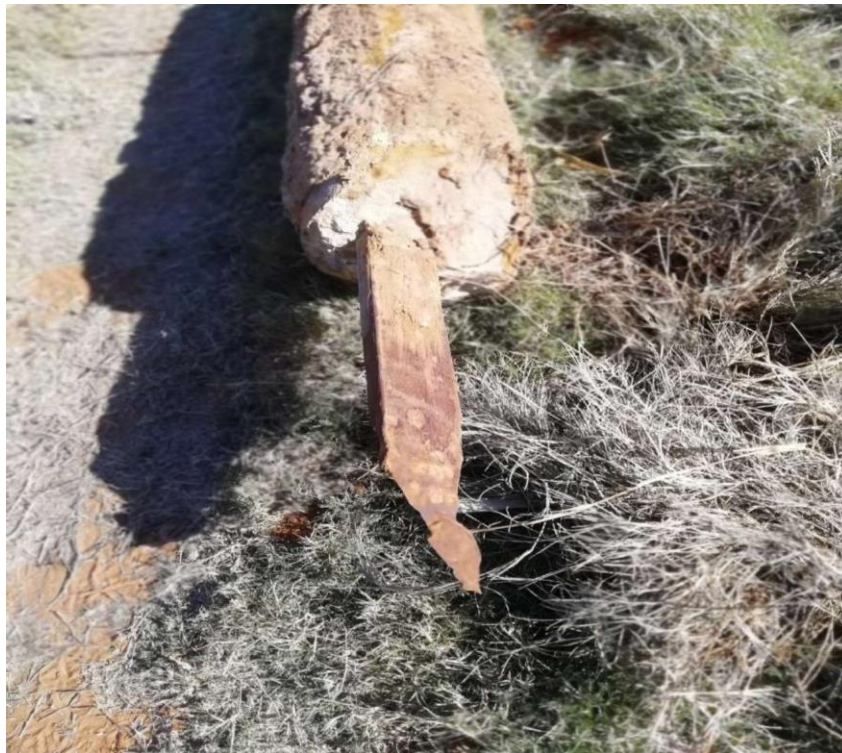
Figure 3: Section of the guy anchor that pulled out

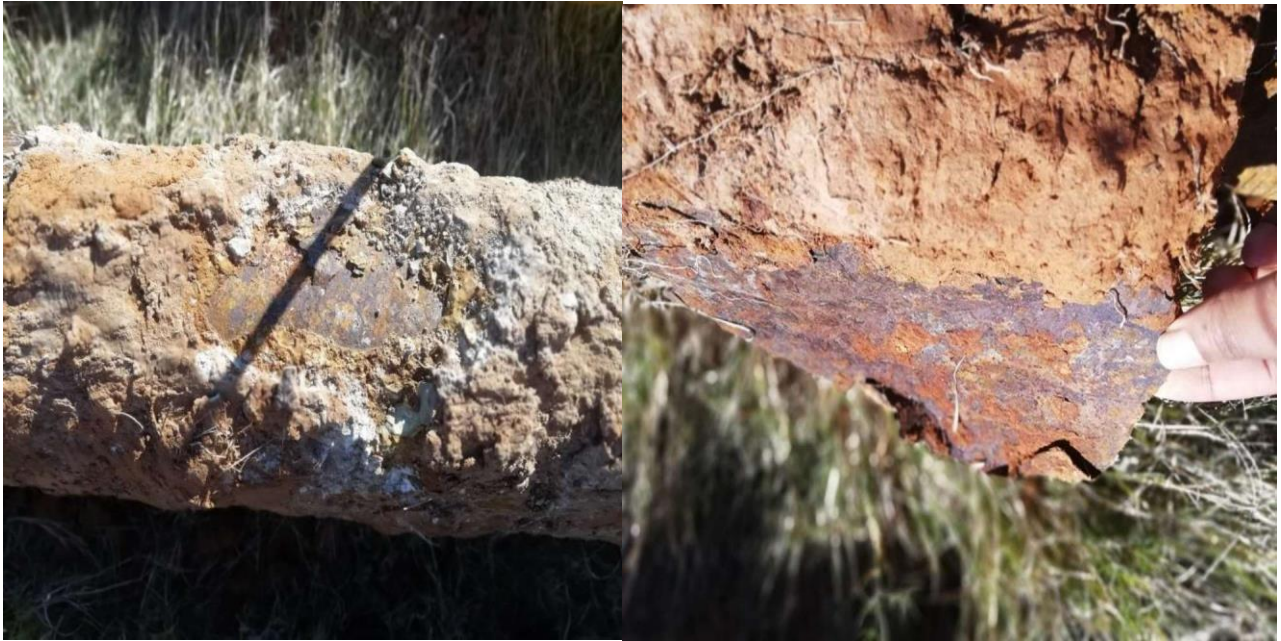
The Beta- Delphi Line 400kV was commissioned in 2007, which is new to have the severe corrosion that will lead to the failure of a foundation anchor. According to the corrosion Table 2 which explains the different categories of corrosion, the link is categorized level 7 because the member had completely disintegrated , broke off and pulled out, the recommendation for this project is to replace all deadman foundations of Tower 74. From the site visit conducted by LES, there was various observations made that could contribute to the corrosion found on the pulled out stay. The steel encasement around the concrete from the deadman section that pulled out, shows severe corrosion as shown on Figure 4. The corrosion on the steel encasement sleeve/pipe is of no surprise since the steel was in direct contact with the soil.

Figure 4: Corrosion on the encasement

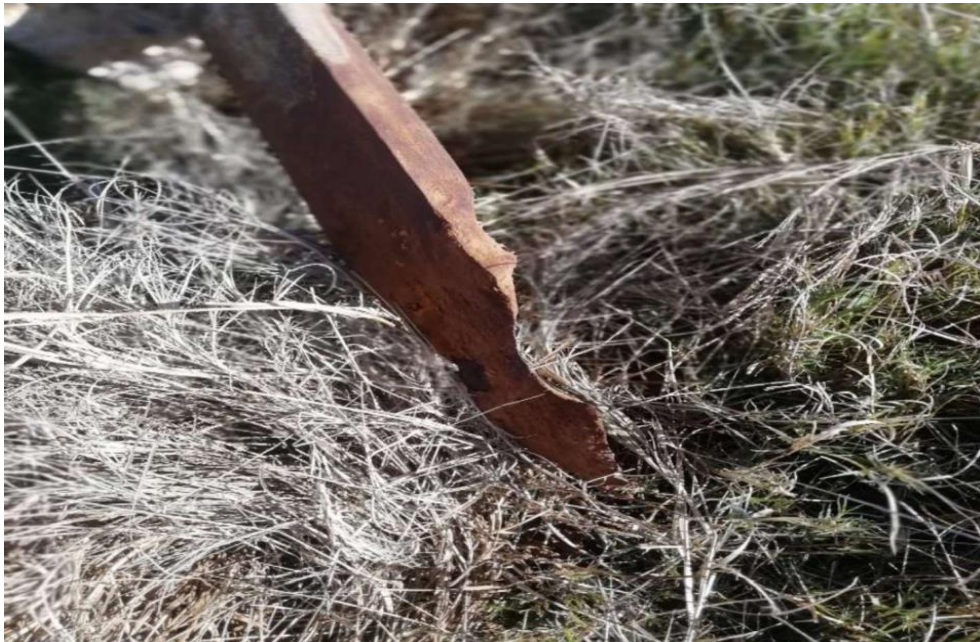
The link plate on the other hand was encased in concrete but not the entire link was encased, the bottom of the link was also in direct contact with the soil. This facilitated the corrosion to the point that there was material loss leading to the failure of the foundation as shown on Figure 5.

Figure 5: Corrosion of link plate

5. All the links must be painted with bitumastic paint 500mm above and 500mm below NGL, the concrete can also be painted with a corrosion protection coat.

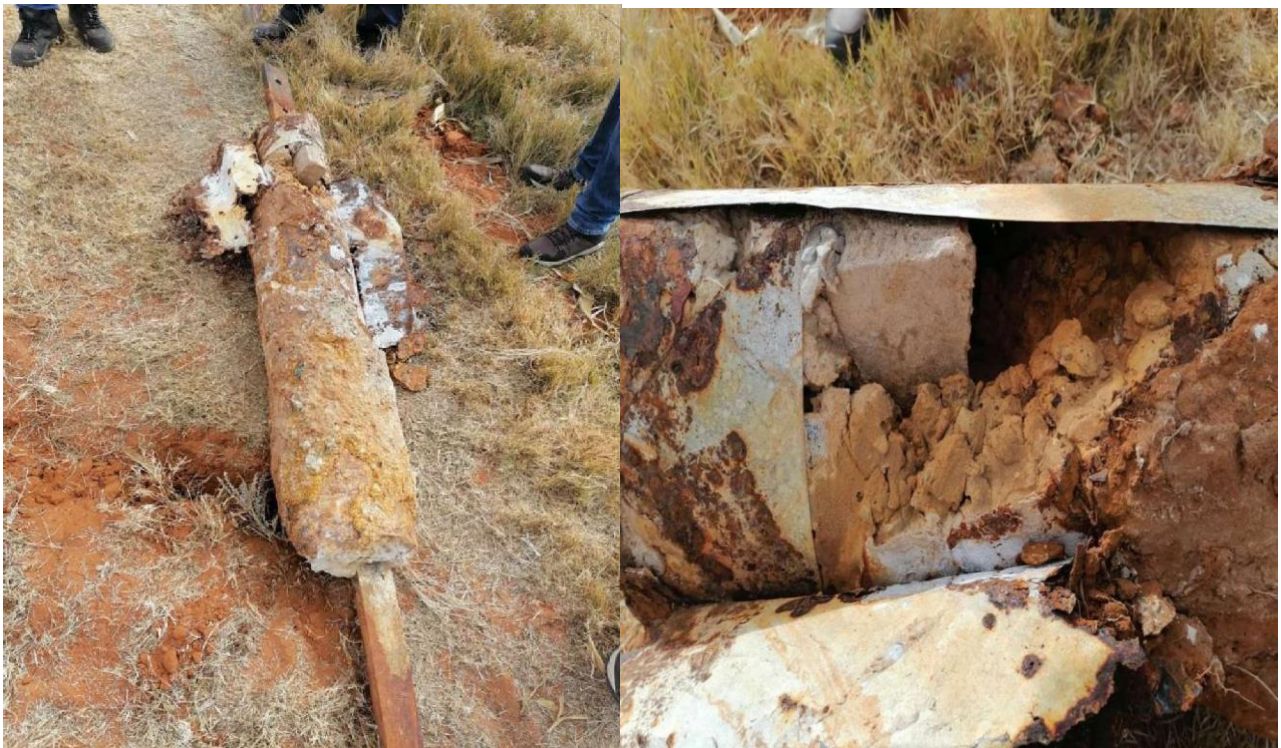
Many were picked up when it comes to the concrete from the section that pulled out. First being that the concrete looked like it was not mixed well or vibrated correctly. The sand from the concrete had separated from the stones which means that the concrete strength had been compromised and might have cracked as well. From the top of the section it was found that there was no concrete but what seemed like a brick and debris as shown on Figure 6. The incorrect material inside the encasement allowed for water to penetrate to the link and cause corrosion. From the images it is also evident that there were air gaps between the bricks and debris allowing water to pond in the section. For the concrete encasement to be effective in protecting the link it has to be socketed into the foundation plinth, but in this instance the link was not encased all the way to bottom. Figure 7 shows the breaking point of the corroded stay, there was no concrete found at the bottom of the excavation during the failed anchor investigation.

Figure 6 : Debris and bricks inside the encasement

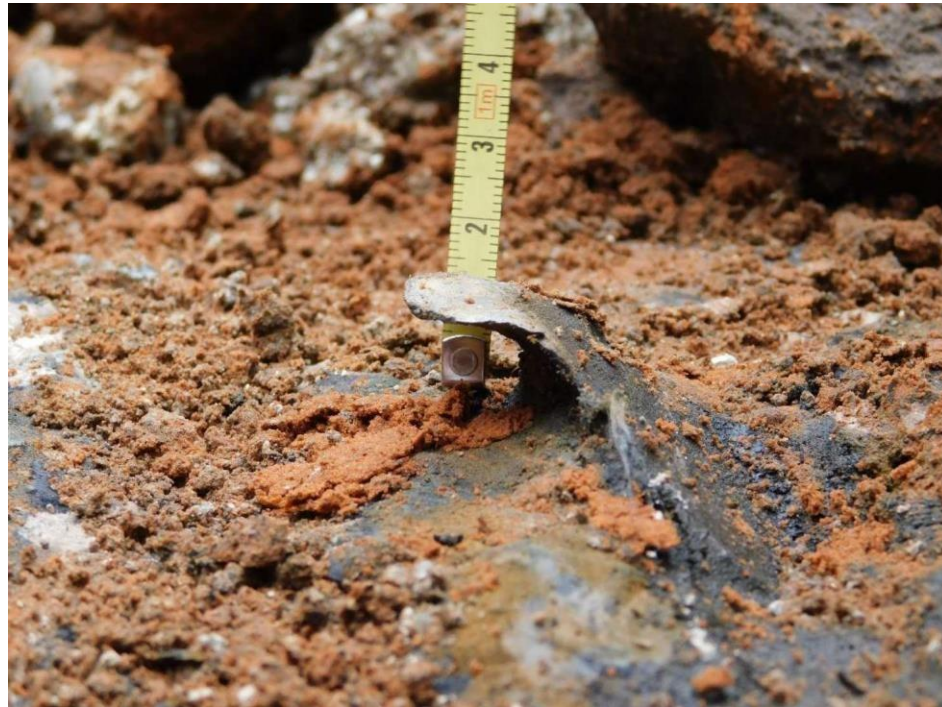
Figure 7: Breaking point of the corroded link

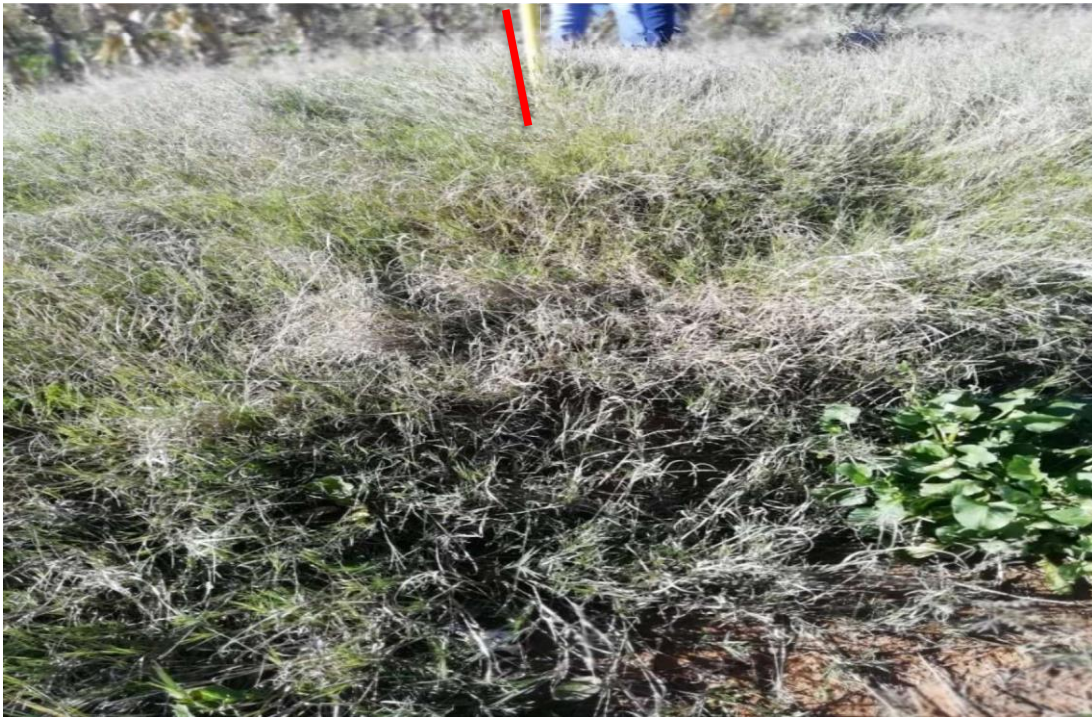
The tower is on a maize farm and the contaminants can influence the rate of corrosion on the foundations. Soil sampling to be done in order to determine what type of contaminants are in the soil. The farming activities have also lead to the foundations (masts and anchors) being buried as shown on Figure 8 meaning that the link plate is in direct contact with the soil promoting corrosion. The guy anchor foundation should protrude above ground a minimum of 250mm as per specification. Figure 9 shows the white clayish material which is an indication of the water path for the water encountered in the excavation. The soil type for tower 74 is type 4 defined as submerged cohesionless and cohesive soils. This includes all soils below the permanent water table, including soils below a re-occurring perched water table, or permeable soils in low-lying areas subjected to confirmed seasonal flooding.

Figure 8: Buried guy anchor foundations

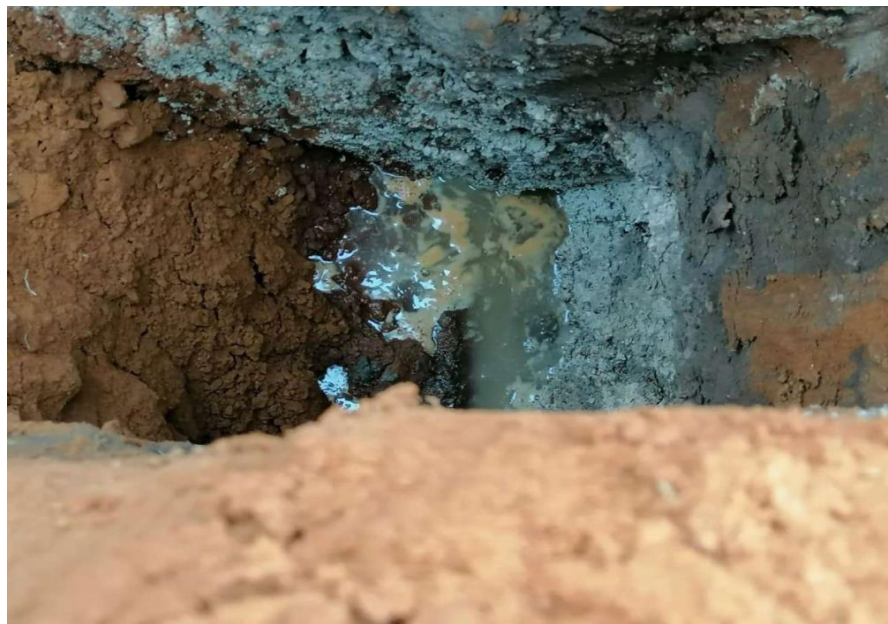
Figure 9: Water encountered in the excavation
