## 2. Background

## 2.1 Problem description

This document aims to clarify the scope of work for the mechanical refurbishment of the cross over plant at Kendal Power Station

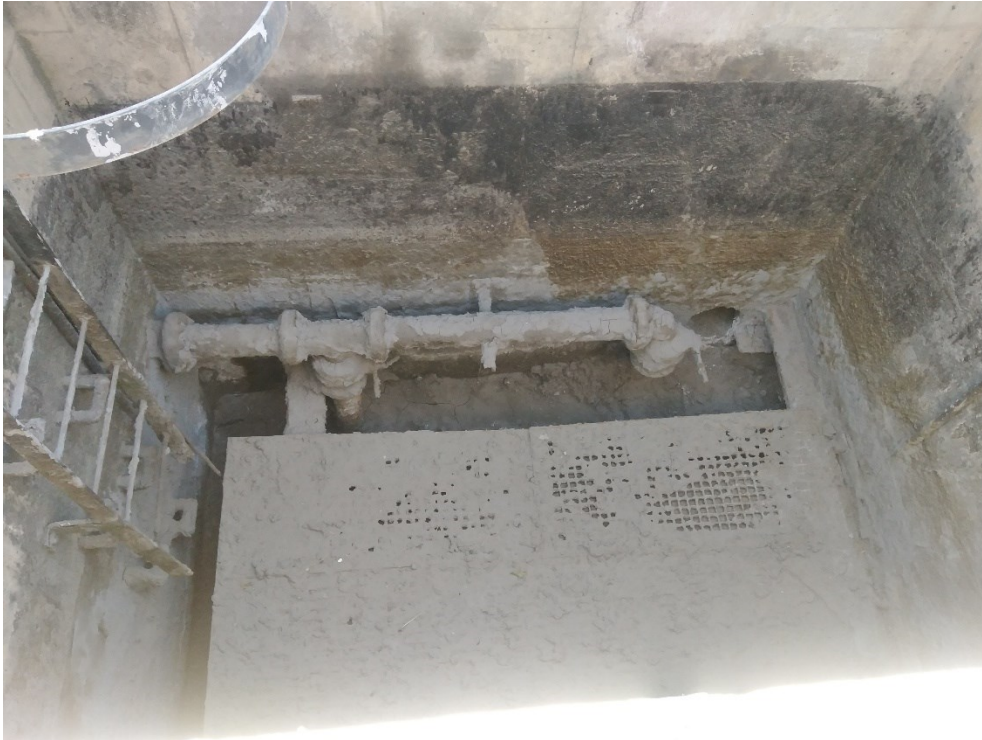
**Figure 1: Sludge sump**

- Sludge sump is fill of hardened ash
- Sludge pump 1 was removed and not available
- Sludge pump 2 is buried under hardened as

- Complete removal of ash inside the sludge sump – Sludge sump dimensions (5m X 7m X 12m)
- Removal, strip, assess and service of sludge pump 2 (if the pump can't be repaired or serviced then a new pump must be purchased)
  - Hazleton submissible sludge pump
  - Model : 50L SSB
  - Serial No.: KDP 004
  - Head: 12 m
  - Flowrate : 5 l/s
- Purchase of new sludge pump 1
  - Hazleton submissible sludge pump
  - Model : 50L SSB
  - Serial No.: KDP 004
  - Head: 12 m
  - Flowrate : 5 l/s
- Installation of new pipe work and valves
  - 6m 100mm galvanized carbon steel pipe
  - 1 X 90° bend
  - 100mm butterfly valve with a lever
- Installation of sludge pump 1 and 2
- Restore electrical power and C&I controls
- Installation of electrical panel roof for rain cover

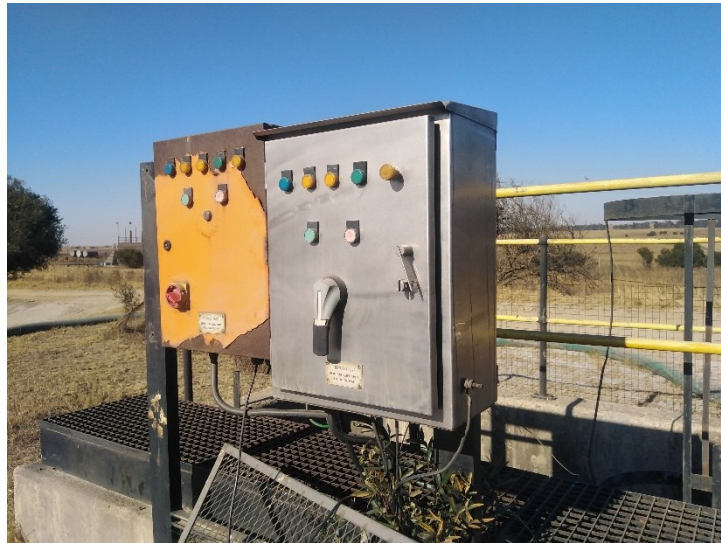
**Figure 2: sludge sump local control panel**

The local control panels of both sludge pump 1 and 2 are exposed to the rain and water ingress will affect operation of the system.

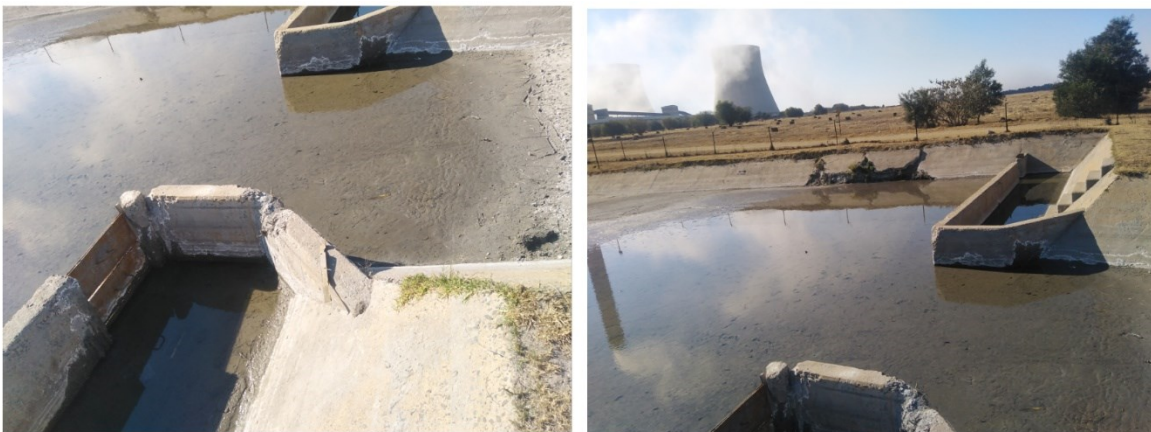
**Figure 3: Sludge drying bed**

Sludge drying bed walls are damaged and sludge gate missing. All damaged walls around the sludge drying bed needs to be repaired

- Cleaning and removal of ash on both sludge drying bed 1 and 2 – 50m X 30m X 1m (sludge bed dimensions)
- Repair damaged concrete wall of both sludge drying bed 1 and 2

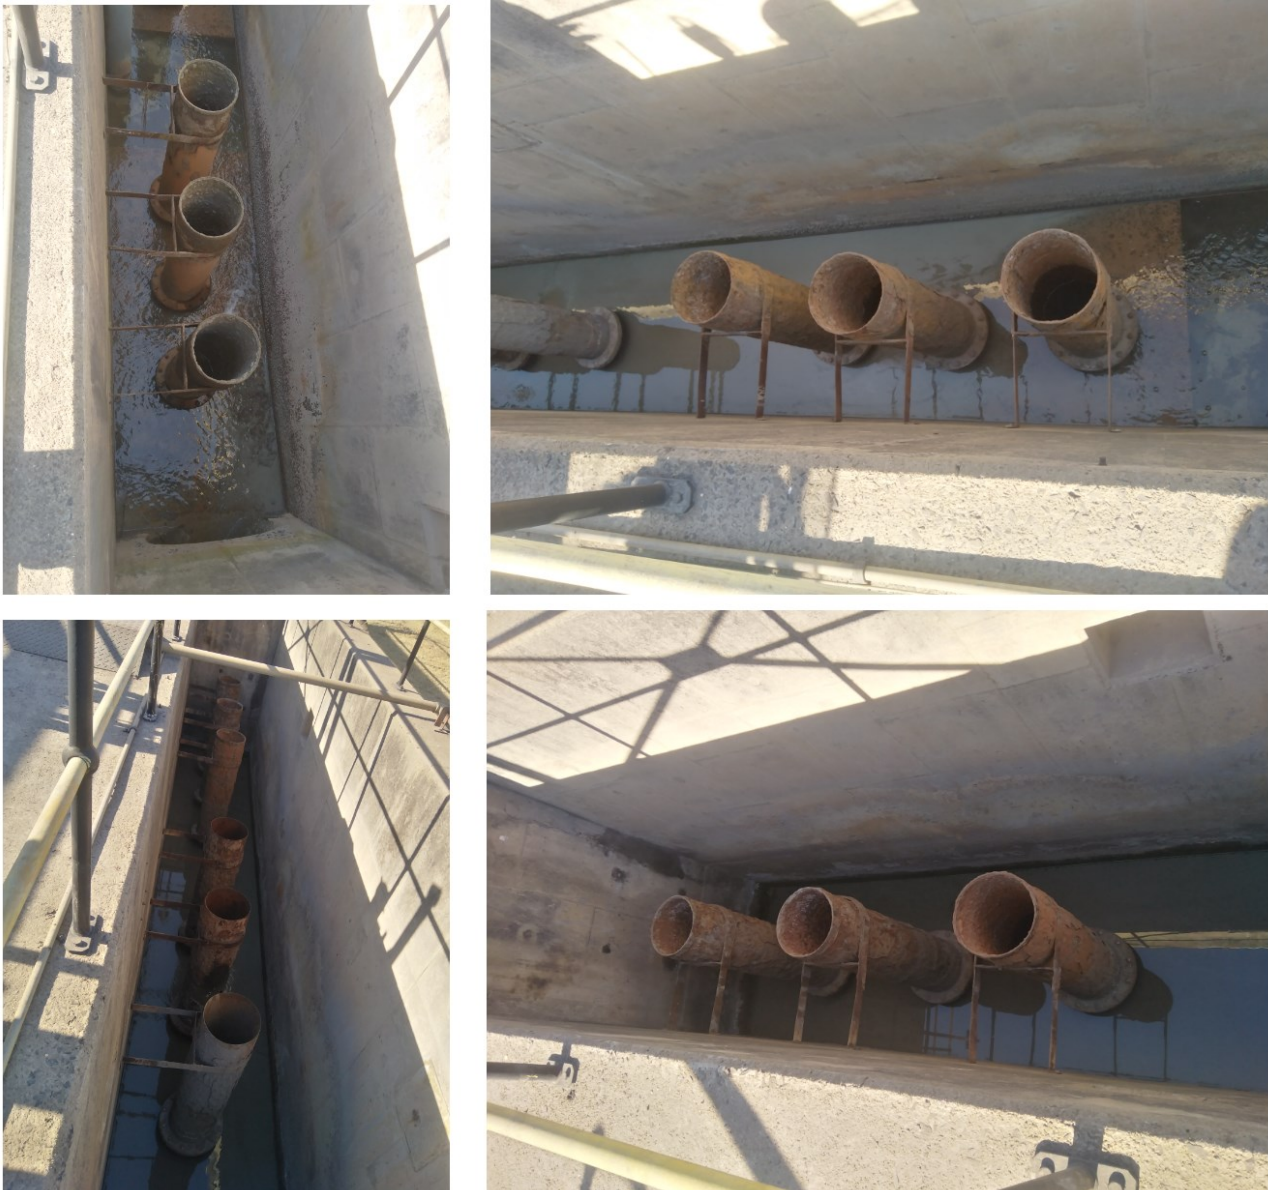
**Figure 4: Clarifier separator tubes**

All 12 clarifier separator tubes are rusted and needs to be replaced and 2 of the 12 are leaking at the bottom

- Replacement of all 12 clarifier separator vertical pipes/tubes with stainless steel tubes – 12 of 3m 350mm Schedule 40 stainless steel pipes

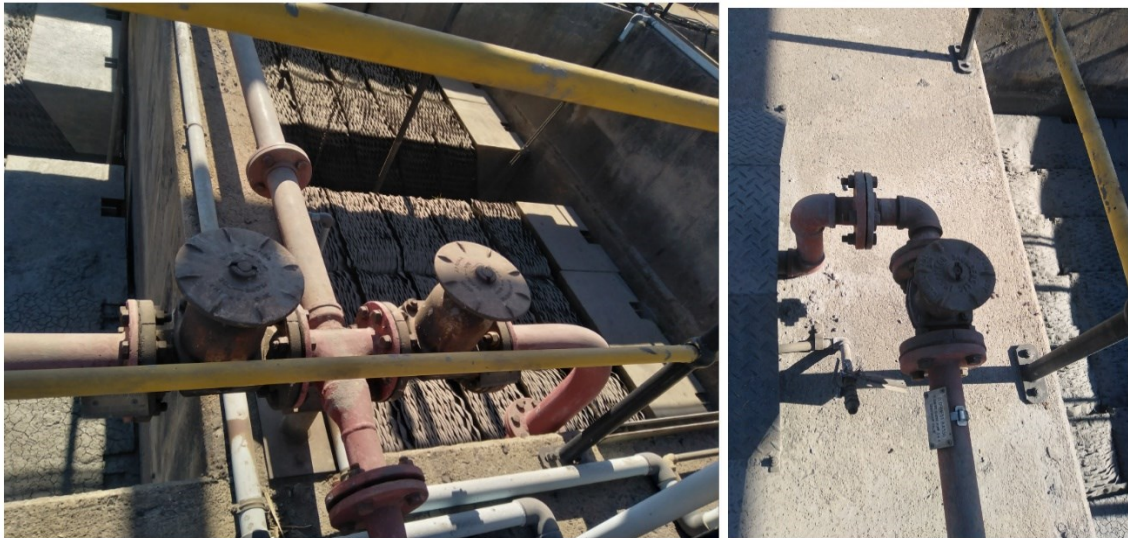
Figure 5: Clarifier discharge valve 1 and 2

All 8 clarifier discharge valves are rusted and needs to be replaced

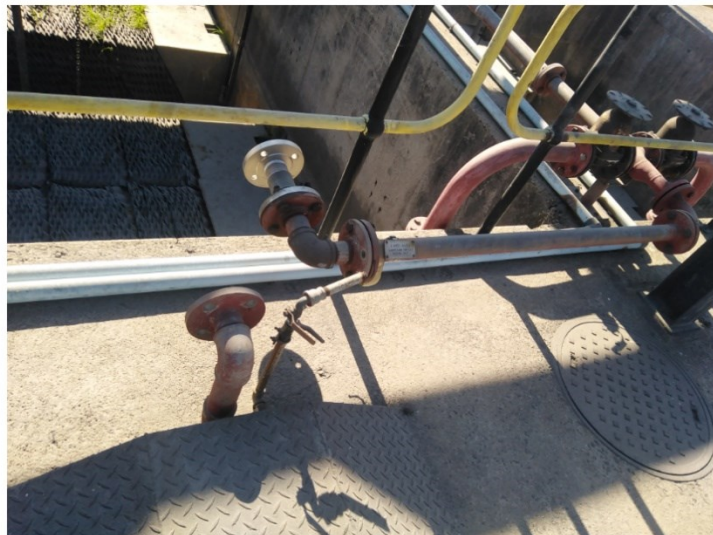
Figure 6: Clarifier discharge valve 1 and 2

Output or discharge leg of clarifier discharge valve incorrectly installed and the valve is missing

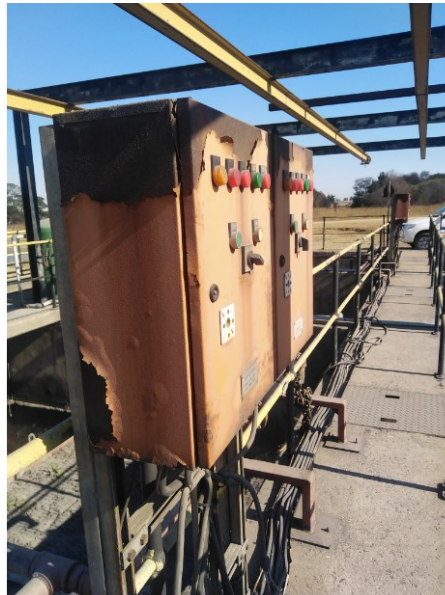
**Figure 7: Clarifier local control panel**

Clarifier local control panel exposed to rain and as a result, they negatively affect operation of the clarifier system. Shelter to be installed to prevent rainwater

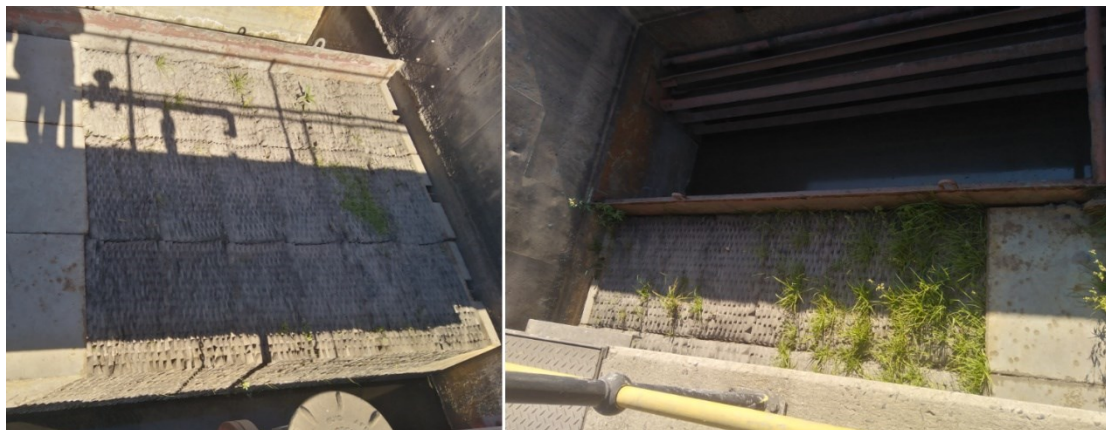
**Figure 8: Flow coalesces packs**

Flow coalesces packs is full of weeds and hard ash which needs to be removed

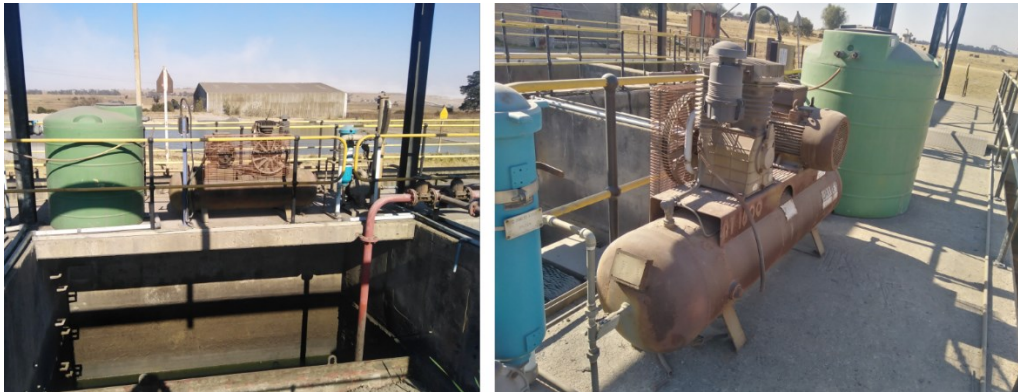
**Figure 9: Oil separation compressor plant**

Oil separation compressor plant has been out of service for a very long time. The compressor itself is rusty due to exposure to unfavourable weather conditions. The system needs to be replaced completely.

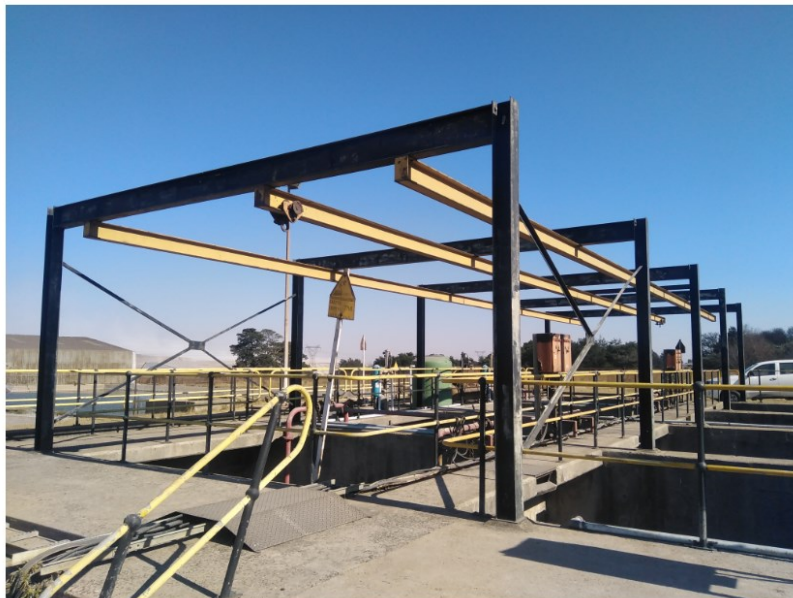
**Figure 10: Clarifier plant**

Roof needs to be installed on the clarifier plant to prevent rainwater from entering electrical panels.

- 22m 50mm galvanized carbon steel pipe
  - 10 X 90°
- Replace all defective isolation gates
  - 4 off 600mm X 250mm stainless steel plates
- Installation of roof across the clarifier plant to prevent rain water from entering electrical panels – 40 X 40 m
- Restoration of electrical power and C&I controls and protections
- Assure all electrical systems and lighting are restored to good working condition

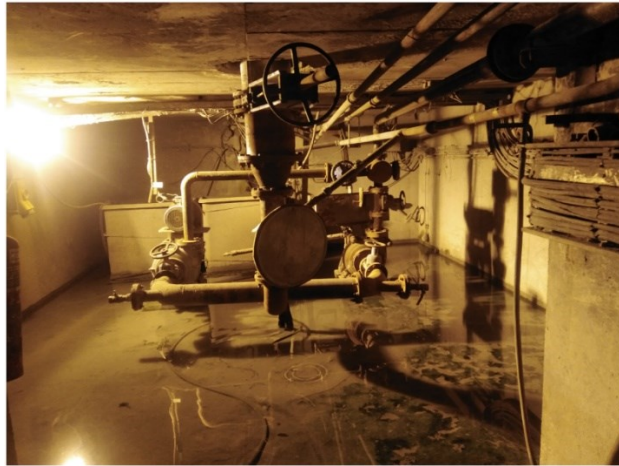
**Figure 11: Underground centrifugal pumps**

Both underground centrifugal pumps not working, the area was previously flooded by water and also affected electrical equipment

- Cleaning and removal of underground water and debris
- Removal of both underground centrifugal pumps since the casings are rusted
  - 2 X Warman 4/3 C slurry pumps
- Removal of all rusted and defective piping
  - 6m 150mm galvanized carbon steel pipe
  - 3 X 150 mm 90° bends
  - 2 X 150mm to 80mm reducer
  - 1 X 150mm T-piece
  - 1 x 250mm to 150mm reducer
  - 8m 80mm galvanized carbon steel pipe
  - 2 X 80 mm 90° bends
  - 1 X 80mm T-piece
  - 90m 50mm galvanized carbon steel pipe
  - 14 X 50 mm 90° bends
  - 3 X 50mm T-piece
- Purchase of new centrifugal pumps and piping
  - 2 X Warman 4/3 C slurry pumps
- Installation of pipe work
  - 6m 150mm galvanized carbon steel pipe

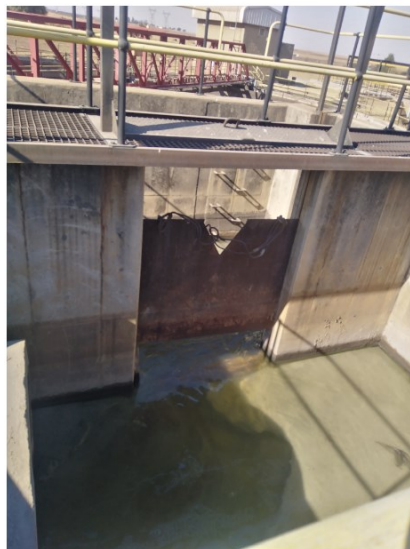
**Figure 12: sluice gate**

Sluice gates are worn-out and some are stuck in open position preventing the control and flow of water to desired channel

- Replacement of all defective sluice gates
  - 3 X 2 m stainless steel plate
  - 0.5 X 3 m stainless steel plate
  - 3 X 3 m stainless steel plate
  - 0.5 X 2 m stainless steel plate

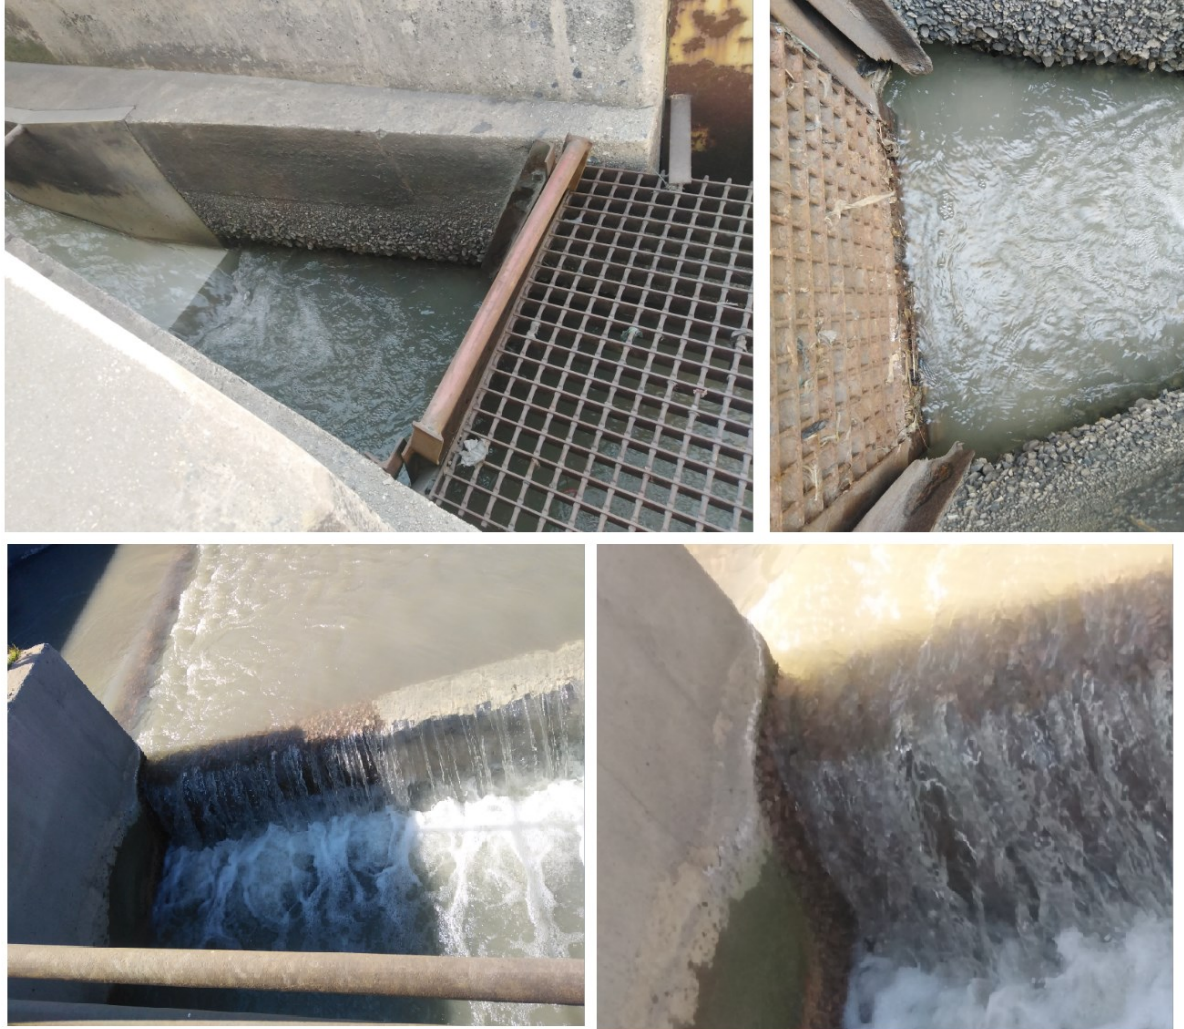
**Figure 13: Damaged walls**

There is several area of visible damage to the walls and as a result debris and foreign object passes and result in blockage of the pumps

- Repair all damaged concrete walls
