Report	National Transmission Company South Africa
---	---------------	---

Title: Failure Investigation Report into Garona STATCOM No1 11kV Breaker Opened on 15 Nov 2024 TIPPS 87140

Document Identifier: 240-185000355

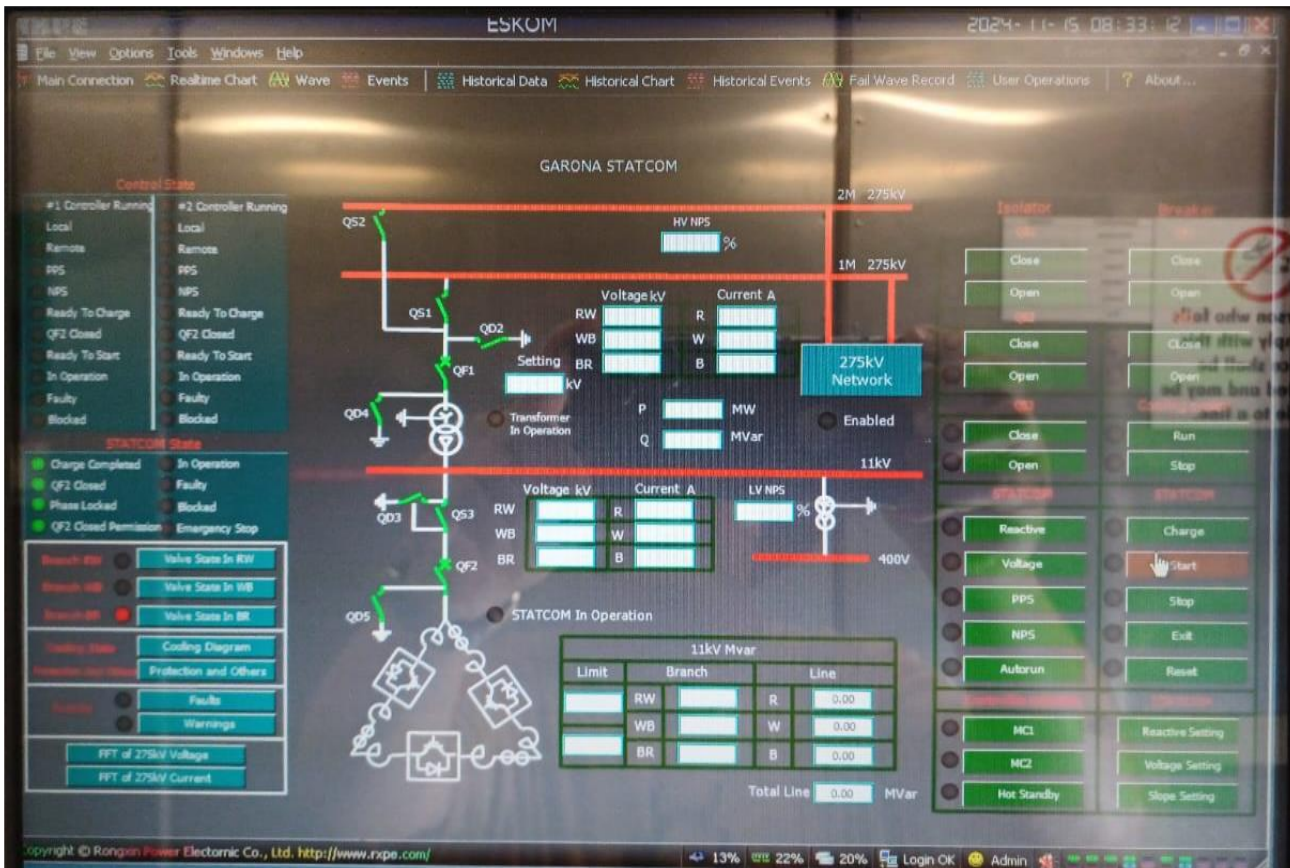
Figure 2: Garona STATCOM Single line diagram – Controllers offline and no analogues

On the day of the incident, the two Controllers on the STATCOM went offline and Control informed the Snr EA to attend to the fault and to investigate. On further inspections, the SEA found that the Control System was not showing any analogues or indications of the STATCOM's HMI. Figure 2 below shows the HMI STATCOM Single line diagram with no analogue readings. The STATCOM (11 kV breakers) was then opened, isolated, and earthed (OIE) and the investigations were conducted on the STATCOM and the alarm logs in Figure 3 showed the flags found.

The fault was reported to the OEM, who suggested that the STATCOM Controllers at Garona should be replaced as they have reached their life span for the Control systems electronic components estimated between 12 and 15 years in service.

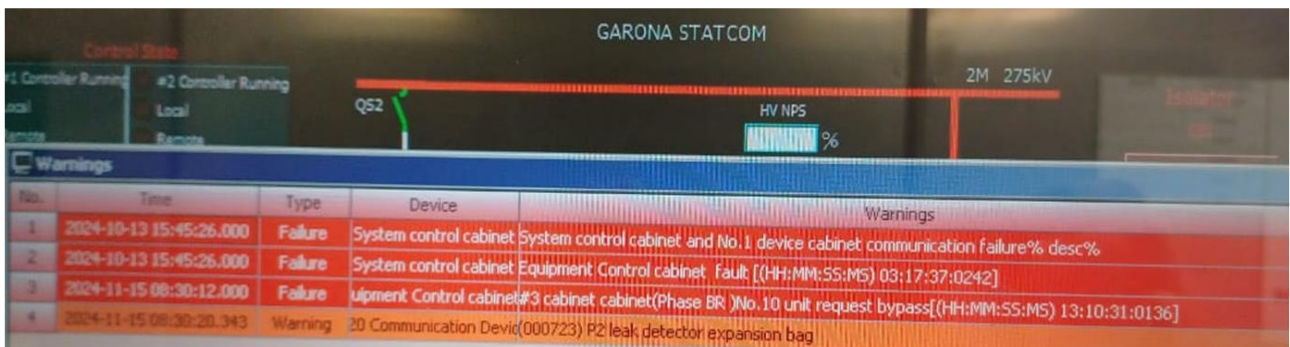
Figure 3: STATCOM Event logs, Communication alarm event logs

- The root cause of the 11 kV STATCOM breaker opening was the STATCOM Controller 1 and Controller 2 that failed and went offline.
- The contributory cause to the Controller going offline is the aging electronic cards on the Control systems.
- The direct cause for opening the STATCOM's 11 kV breakers was Control after identifying that the STATCOM's Controllers were all offline.

Finding	Recommendation (Action)	Responsible	Due Date
The STATCOM's Control system has reached end of life and required urgent upgrade to avoid obsolescence.	AIP to raise a refurbishment project for the STACTCOM's Control systems in consultation with Western Grid.	Nicolaas De Klerk	30 Sept 2025
	Western Grid to replace both the STATCOM Controller 1 and STATCOM Controller 2 (Hardware and software) at Garona substation.	Regi George	31 Mar 2026
