**Report Name** : CTCT Substations Conditional Assessment

Transnet Port Terminals Engineering team has been tasked to undertake a conditional assessment of substations in the Port of Cape Town. The idea is to ensure a safe and reliable electrical infrastructure. The current infrastructure is now old with limited available spares which poses a risk of power supply to operations. It is a requirement by law to entirely make a substation compliant to at least the minimum enforced regulations once you attempt to undertake upgrades of plant such as switchgear. It is for this reason that a thorough conditional assessment was conducted. This document is a resultant assessment report to recommend the required upgrades especially for compliance to regulations.

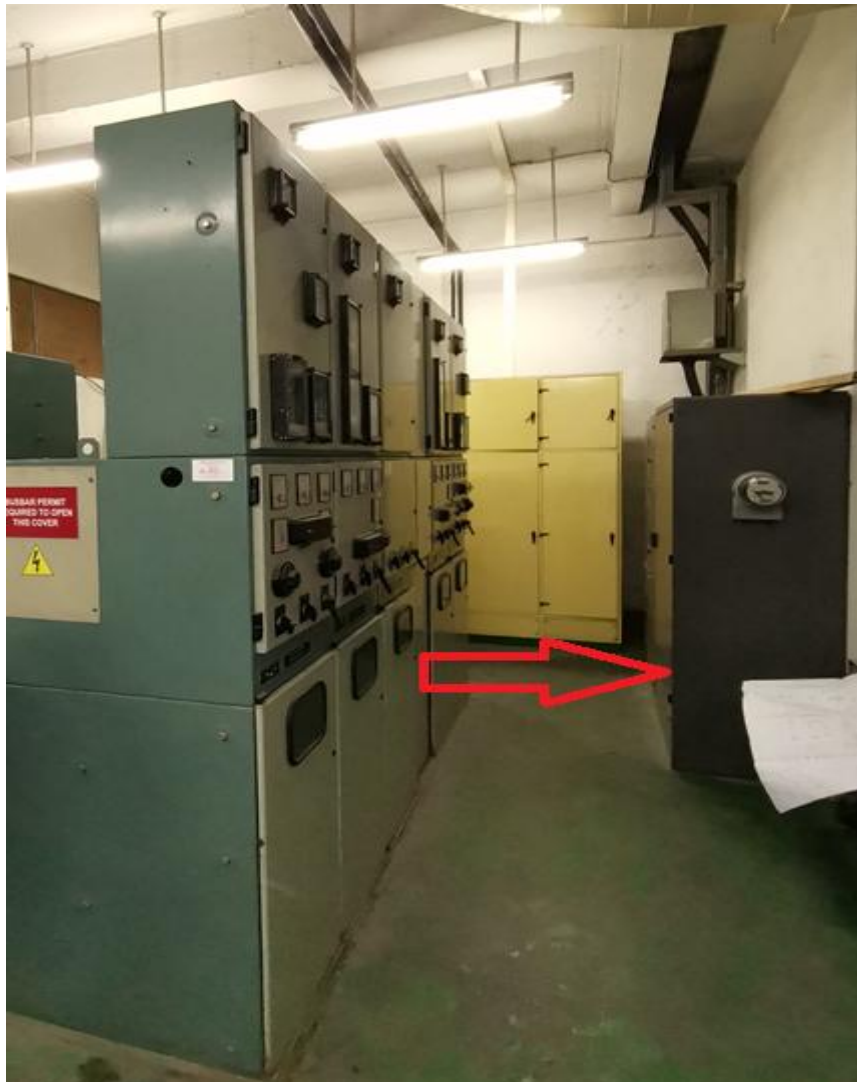
- 1.1.2.1.1 There is not enough working space as informed by the NEC recommendations discussed in section 4.1. See figure 3. It can also be seen from figure 3 that there is no barrier between the MV and LV switch gear. This is in violation of the buildings and enclosures clause of SANS 10142-2.

*Figure 2: Racking space in front of the MV panel is less than 1200mm. MV switch gear is not separated by any form of barrier from the LV switchgear.*

1.1.3.1.4 The room shall be re-arranged to only house the MV and LV plant. A barrier shall be fitted to separate the MV and LV plant. See section 4.1.2. The rearrangement shall be such that a minimal disruption to the reticulation system is achieved to help avoid cable joints. New tranches might be required because of the rearrangement.

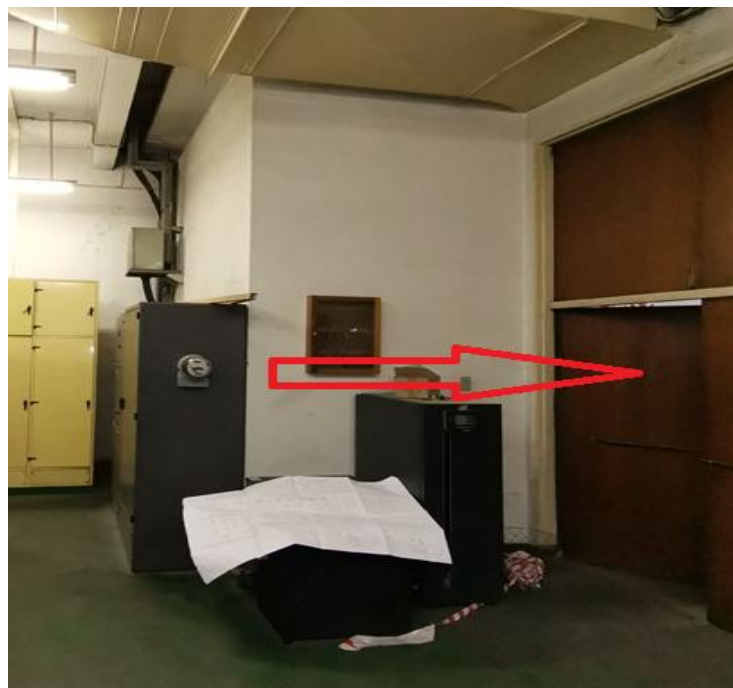
Figure 4: Substation door leading to the admin station.

- 1.1.2.1.2 The substation has two doors which is acceptable but the positioning of the door leading to the admin is not suitable as a fire escape route. See figure 4. If an operator was to be next to the existing LV panel and the fire happened along the existing MV panel position, the operator would be trapped without an accessible escape route.
- 1.1.2.1.3 The substation door leading to the admin station is a safety finding because of the posed risk to unauthorised entry. There is also a risk to personnel occupying the admin area may a fault occur in the MV panel. A typical short circuit fault in MV switchgear on this type may generate enough energy to blast through the door and cause serious injury and possible death.

1.1.3.1.5 The door leading to the admin area shall be sealed with brickwork or replaced with a sufficiently fire rated door (*to be informed by the mechanical engineering conditional assessment report*). The risk to personnel from a possible blast will be reduce further because of the proposed MV switchgear technology with arc flash protection.

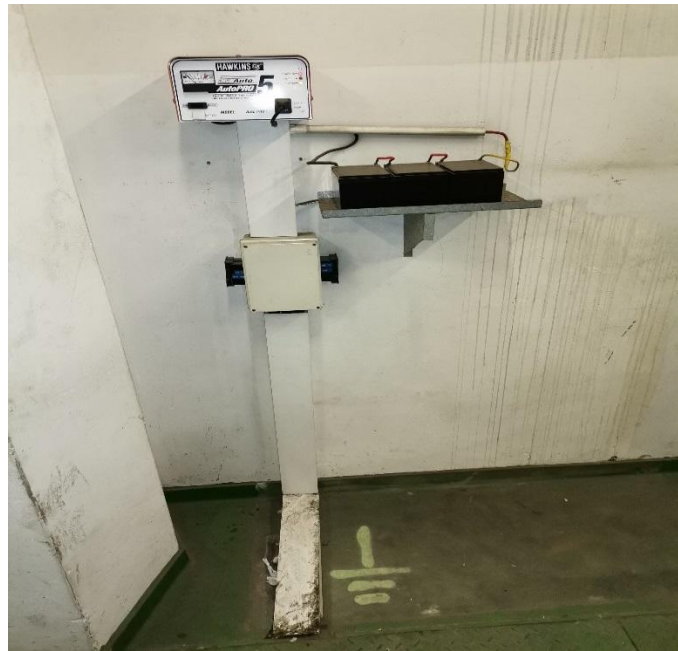
- 1.1.2.2.1 The battery terminal unit is not sufficient for the intended uses. The breaker closing and opening function is supplemented by the voltage transformers. See figure 6.

*Figure 5: BTU with only three batteries.*

- 1.1.3.2.3 Design, supply and install a new DC power supply for the MV switchgear.
- 1.1.3.2.4 Design, supply and install new LV switchgear with automation functionality.

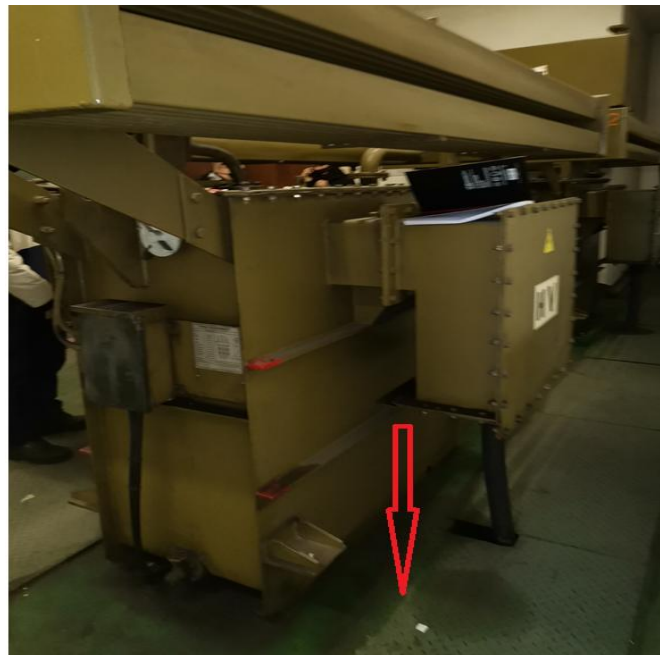
- 1.1.2.2.2 For installations with oil Filled transformers, SANS 10142-2 requires that adequate provision shall be made for containing oil in case of leakages or spillages. Figure 7 shows an installation without an oil containment with some evidence of experienced leakages. The spill oil can also gain access to cable trenches which is in addition not acceptable.

*Figure 6: Distribution transformer with no oil containment provision.*

1.1.3.1.2 The proposed transformer room shall be designed and constructed with ventilation and oil containment requirements in accordance with SANS 10142-1&2 and the fire design requirements.

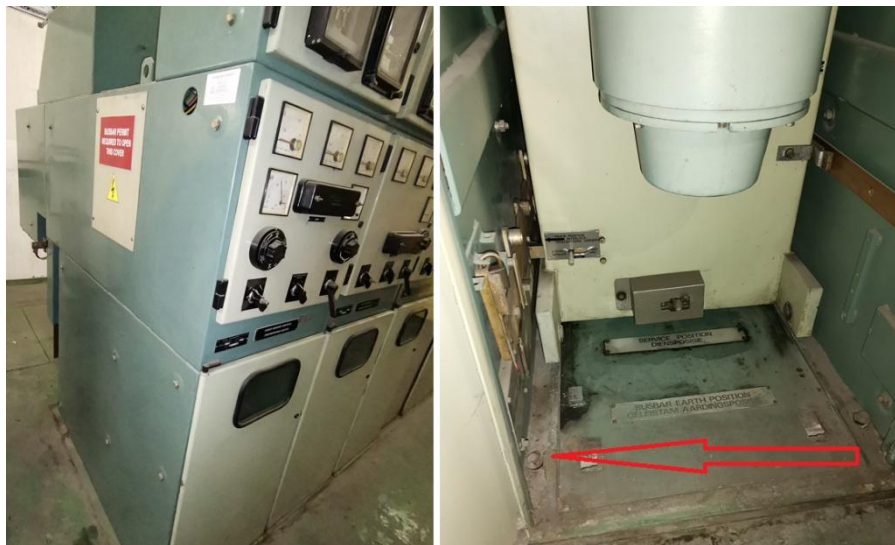
- 1.1.2.3.1 The Container admin substation is fitted with old oil MV circuit breaker technology. See figure 6. The detail of the racking system shows that the breaker is racked at the bottom compartment and with bent old rails. A smooth rail is required to make a firm contact with the bus bars to avoid hotspots. The bottom compartment is not favourable for service conditions. This technology is with findings discussed in section 4.3.1 of this report.
- 1.1.2.3.2 The switchgear is fitted with old relay technology that is of the disc type.

Figure 7: Old oil circuit breaker MV switchgear

- 1.1.3.2.1 Design, supply and install a new substation reticulation system to complement the rearrangement of the substation plant.
- 1.1.3.2.2 Design, supply and install new MV switchgear complete instrument transformers and modern electronic relays compatible with SANS 61850. The switchgear shall meet the requirements of section 4.3.3 of this report.

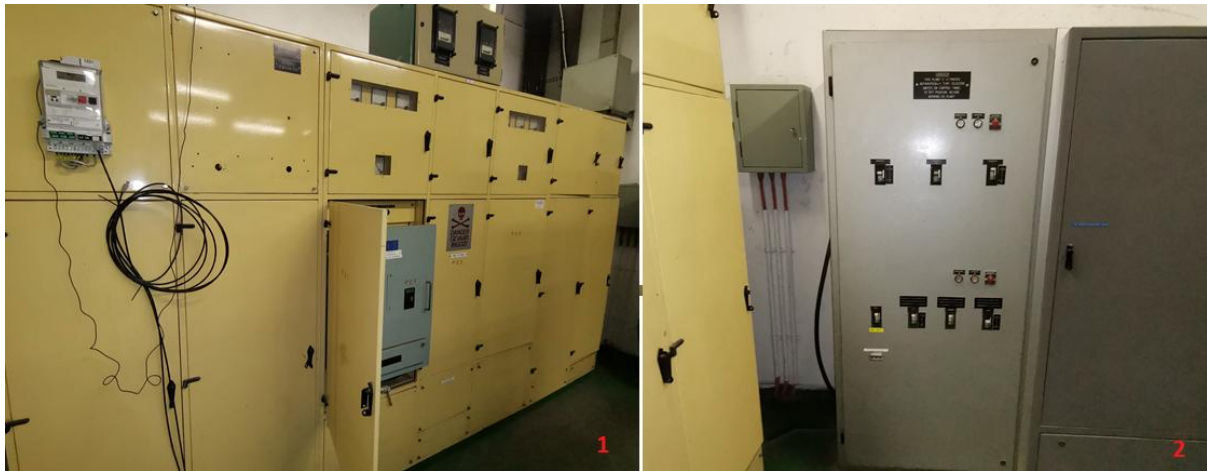
- 1.1.2.3.3 The LV switchgear makes use of circuit breakers which is recommended than the fuse technology. The switchgear shown in figure 9 is now old and is an old design that is not compact. See figure 9.
- 1.1.2.3.4 Next to the main LV switchgear that is fed from the transformers, there's a Generator LV panel that is also fitted with circuit breakers. See figure 9,2. This panel is also old strictly dedicated to supply the lifts, UPS (*in the same room for the third floor*) and the third floor which is a control room. The installation is not simple to follow, with some unnamed breakers, but can be made simpler in the proposed upgrades.

Figure 8: Old LV switchgear.

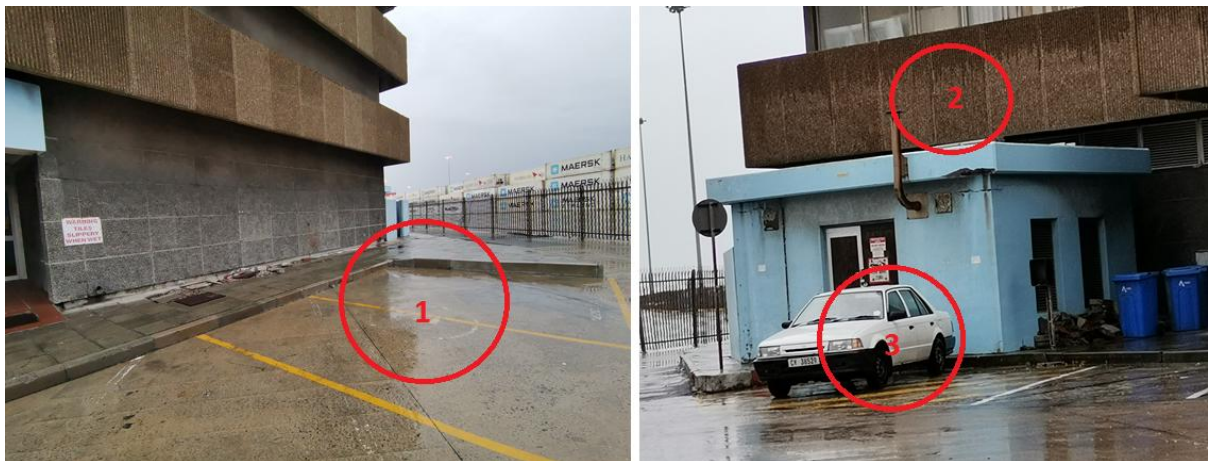
Figure 10: Positions for the proposed transformer room

The room is congested with all plant in one room, the solution making the substation complaint to working space requirements is to relocate the transformers to a proposed new room outside the substation. The proposed positions for the room are highlighted in red as shown in figure 10. Position 1 is a parking space behind the wall that is adjacent to the existing LV switchgear, position 2 is the roof space of the generator room and position three is also a special parking position as show in figure 11.

1.1.3.1.3 A door that is suitable for an escape route is required. The position indicated with a yellow squire in figure 10 is ideal for this proposal.

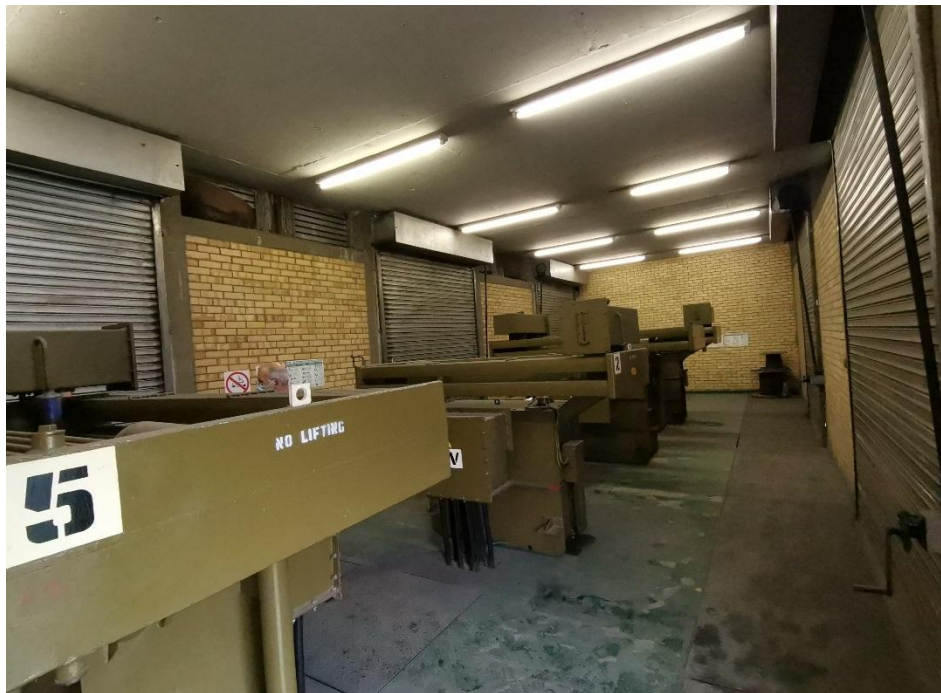
1.2.2.1.2 Figure 13 shows an ample size transformer room with five transformer bays and four transformers without oil containment.

Figure 12: Distribution transformers with no oil containment provision.

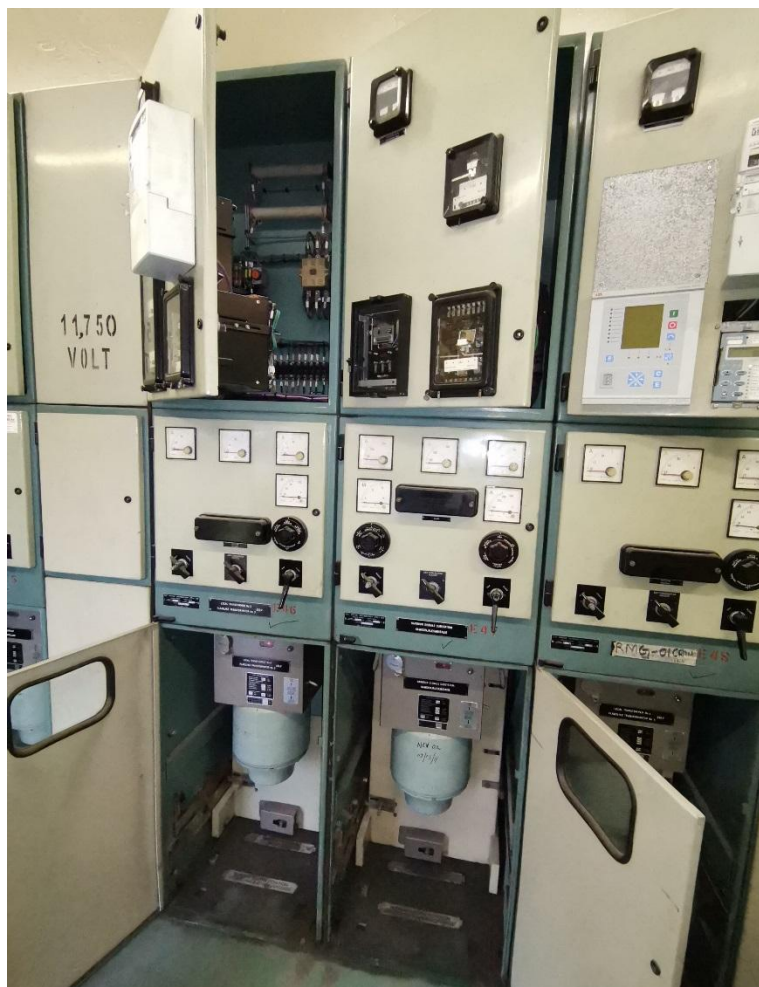
1.2.2.2.3 The switchgear is fitted with old relay technology that is of the disc type. There are few modern electronic relays as seen in figure 14.

Figure 13: Old oil circuit breaker MV switchgear

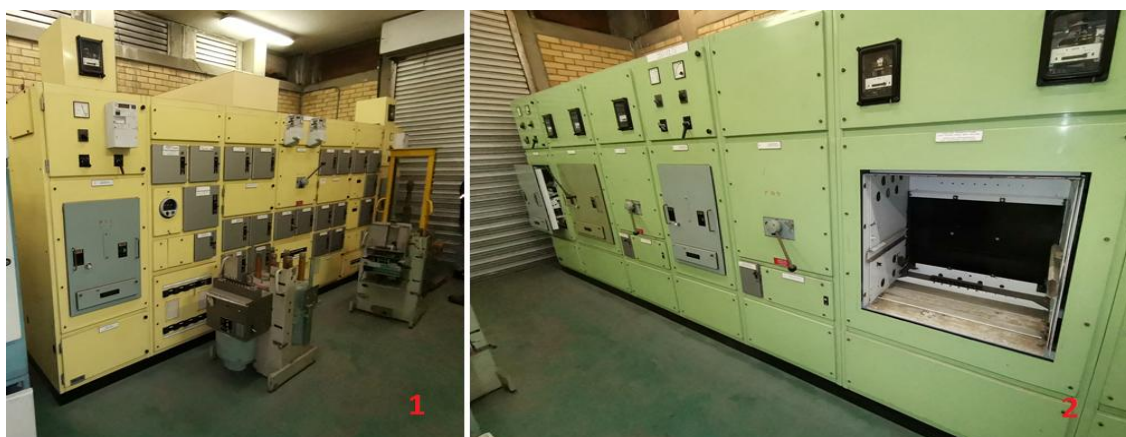
- 1.2.2.2.4 The switchgear shown in figure 15 (Fig.15.1 400V and Fig15.2 550V) is now old and is an old design. The 550V switchboard was used to supply cranes, it is out of service and is no longer required.

Figure 14: 400V and 550V switchgear

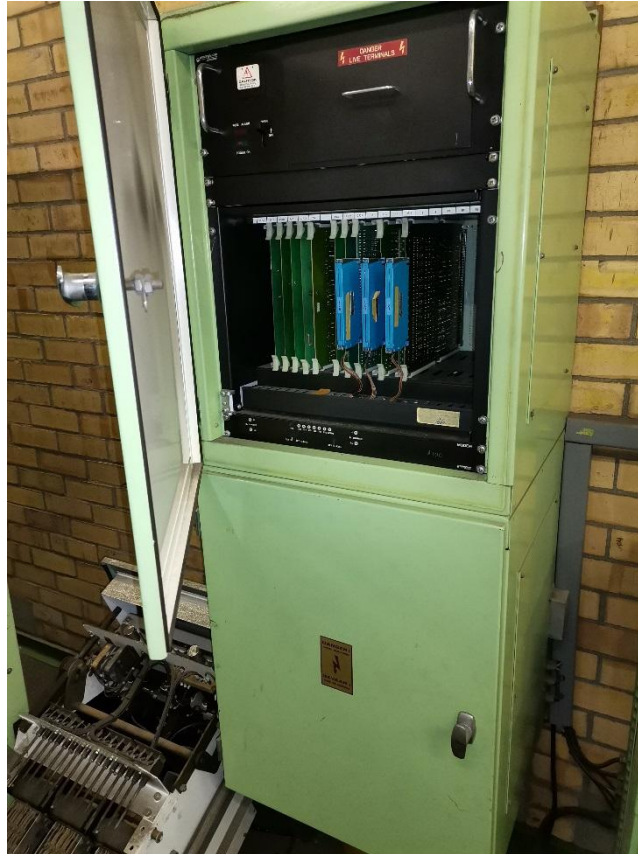
- 1.2.2.2.5 The substation had SCADA which is no longer working. See figure 16 for the instrumentation board.

Figure 15: SCADA instrumentation board

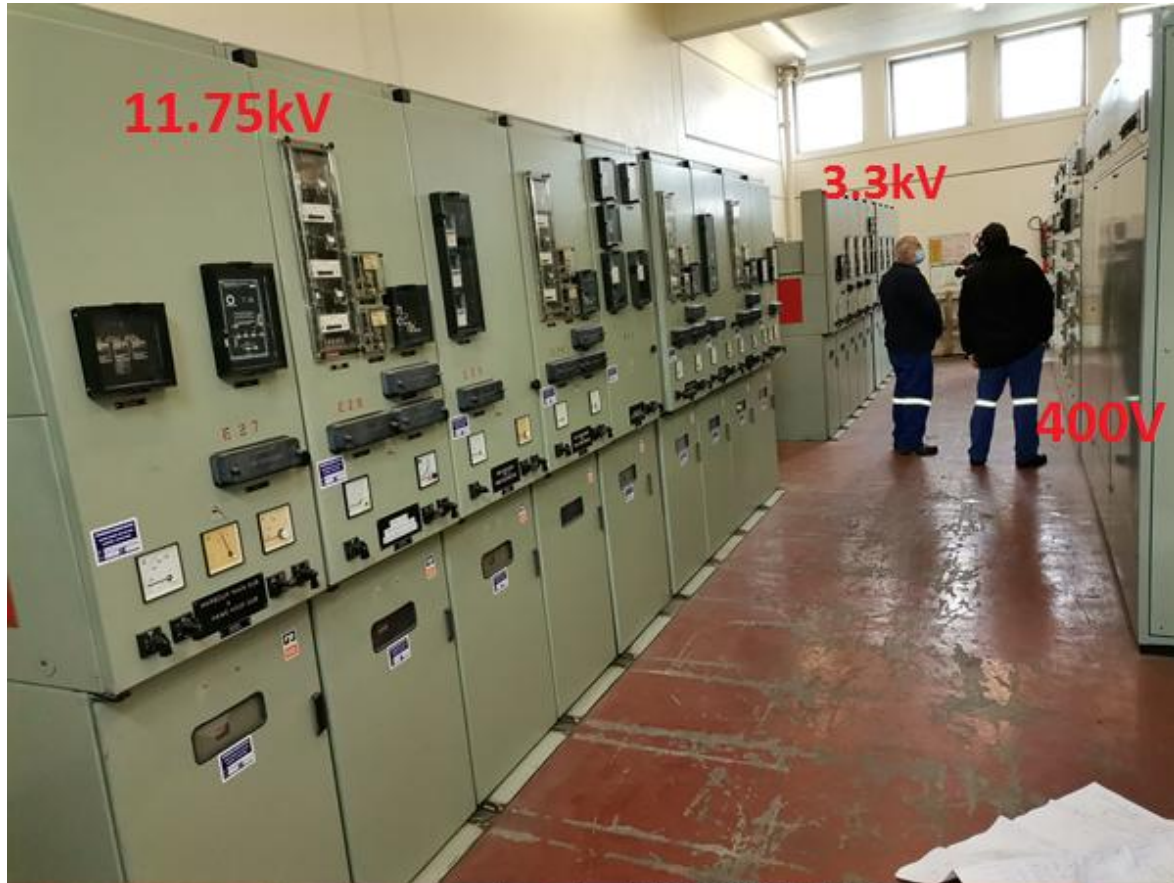
1.3.2.1.1 There is no that there is no barrier between the MV and LV switch gear. See Fig. 18.

Figure 17: MV and LV Switchgear all in one room with no barrier in-between.

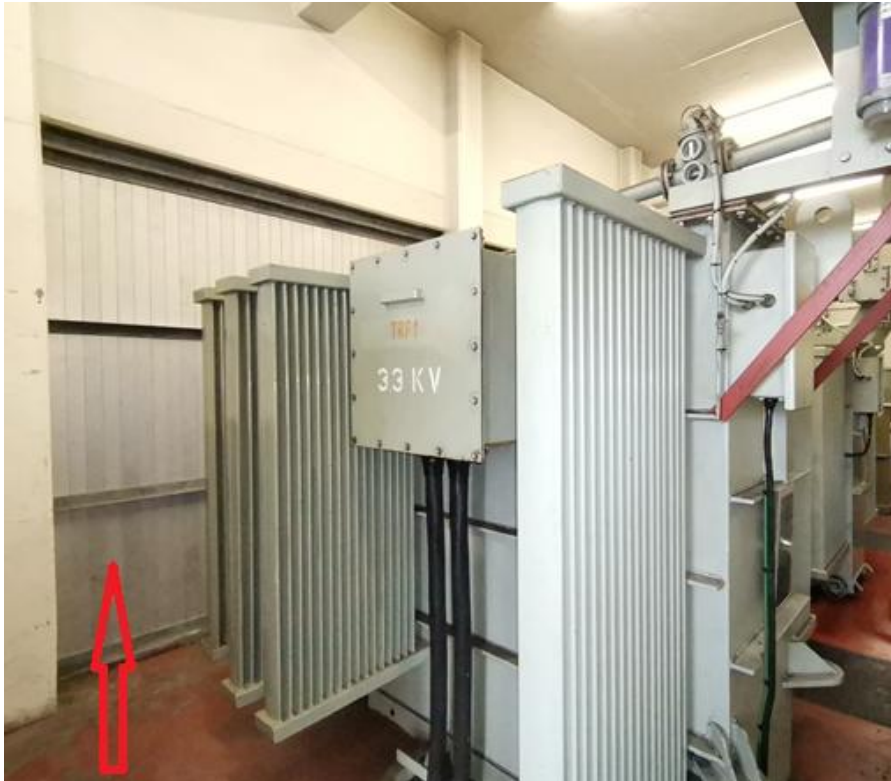
1.3.2.1.2 Figure 19 shows a transformer room with four transformers without any form of oil containment.

1.3.2.1.3 The pointed roller door positions in the same figure are also sealed as shown and cannot be opened. This is a problem for cases of replacing the transformers.

Figure 18: Transformer Room Roller door Openings

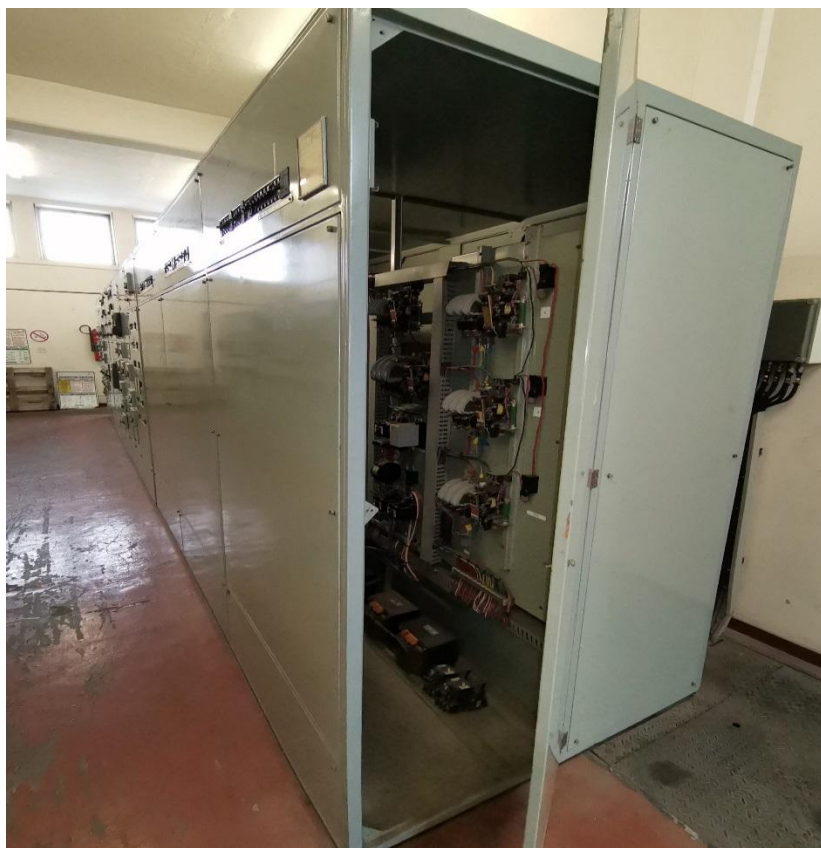
- 1.3.2.2.1 This substation is fitted with old oil MV circuit breaker technology like the preceding discussed substations. The protection relays are also of the old technology.
- 1.3.2.2.2 The low voltage switchgear shown in figure 20 with details of the interior in Figure 21,1&2 was designed such that a person can walk inside through the side door. This switchgear arrangement has no form of segregation between panels, meaning a fault in a specific location can easily affect more sections if not the entire switch gear. The switchgear qualifies as a confined space by definition of the OHS Act. Hence respective measures for such an enclosure are absent requirements.

Figure 19: 400V Switchgear with a door opening on the side.

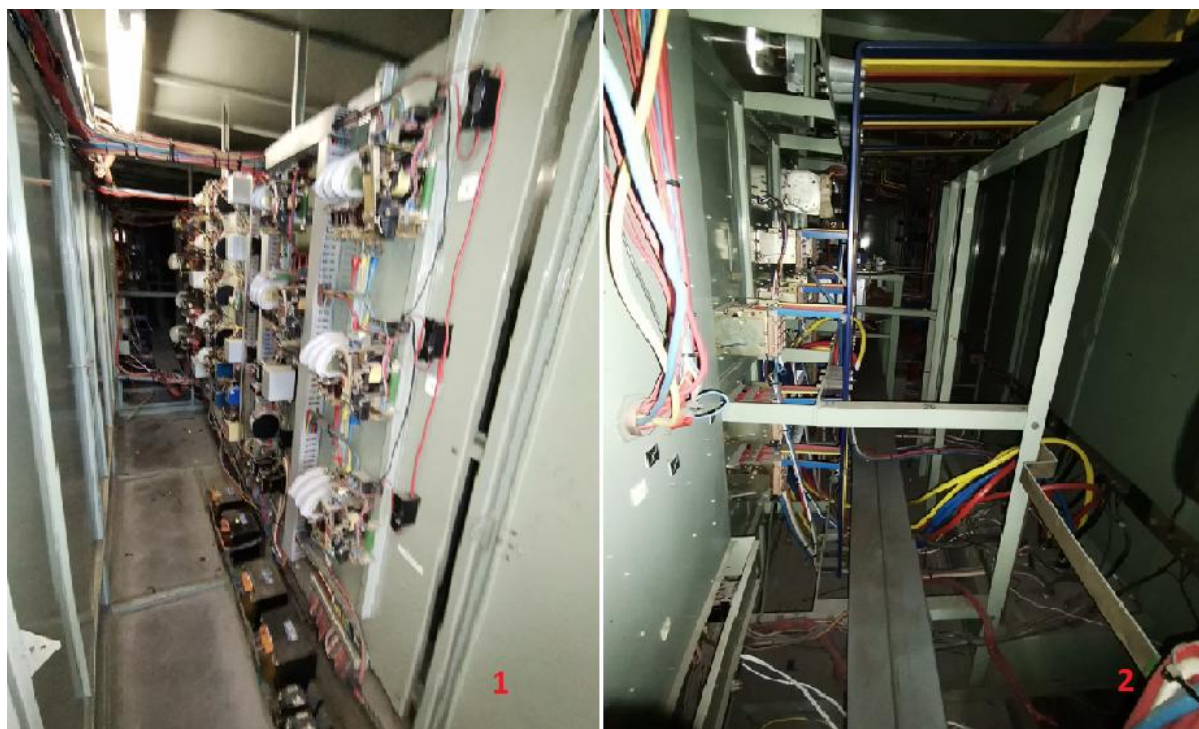
Figure 20: Inside Details of the 400V LV Switchgear.

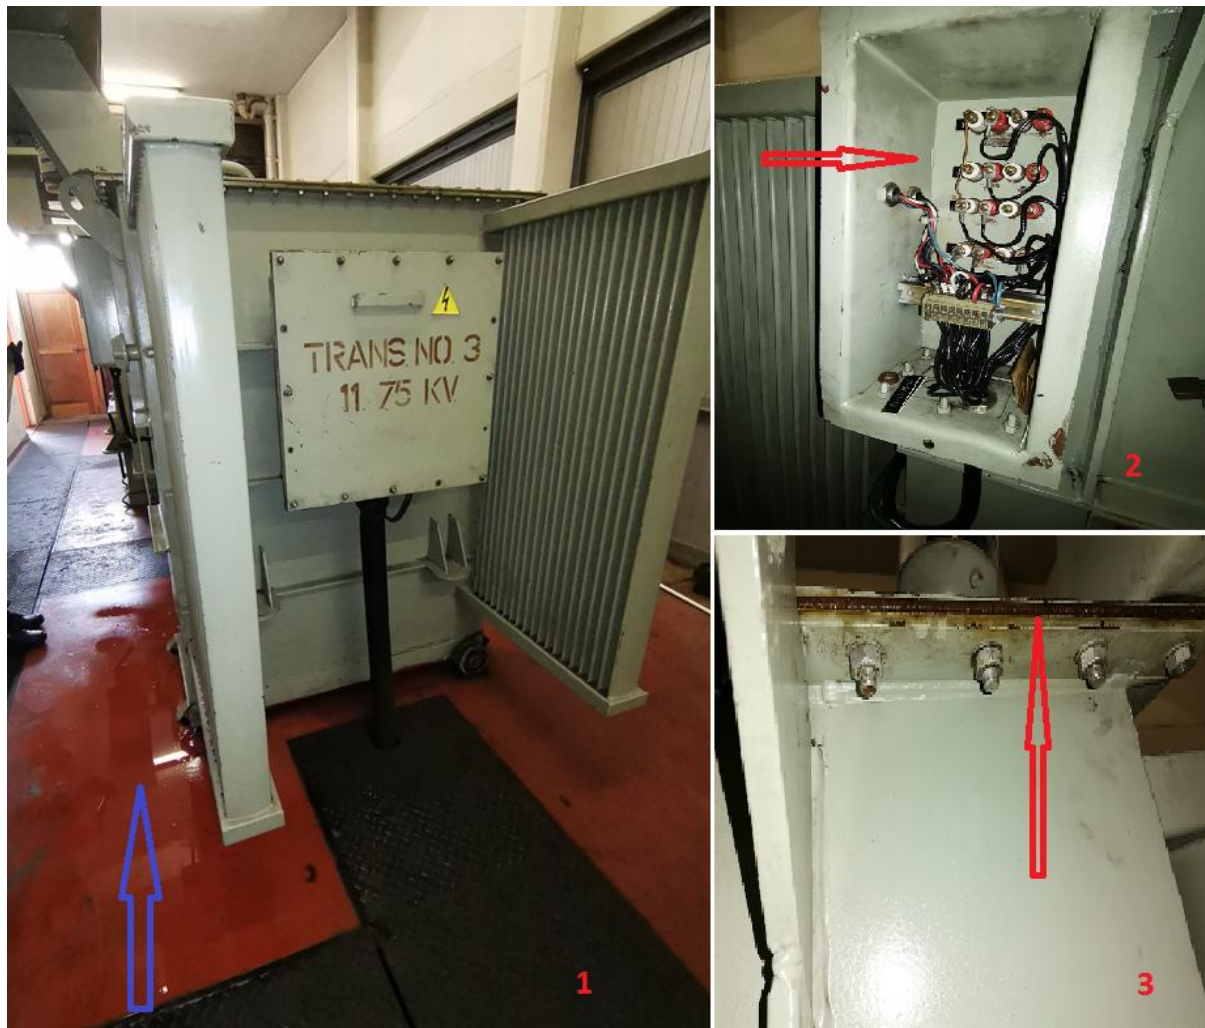
- 1.3.2.2.4 Transformer 3 which is operational is also with apparent problems of oil leakage. Figure 22 shows oil leaks on the floor, the TRF auxiliaries and the seal of the TRF tank. Such problems do not only affect the level of the oil but are indications that impurities can invade in locations where there are leaks and thus affect the properties of the oil. The maintenance team is following this problem closely and have tried to fix the leaks on the auxiliaries without success.

- 1.3.2.2.5 The oil sample test from 2019 reports that the moisture content is high and the dielectric strength is on a borderline.

Figure 21,1 TRF Oil Leakage of the Floor. 2, TRF Auxiliaries with Oil Leaks. 3, Tank Seal with Oil Leaks

- 1.3.3.2.5 Prioritise the problem of the leaking TRF 3 that is operational. Since there is currently no N+1 redundancy because of the faulty TRF 2, any fault on TRF 3 would result in loss of supply to the respective loads.

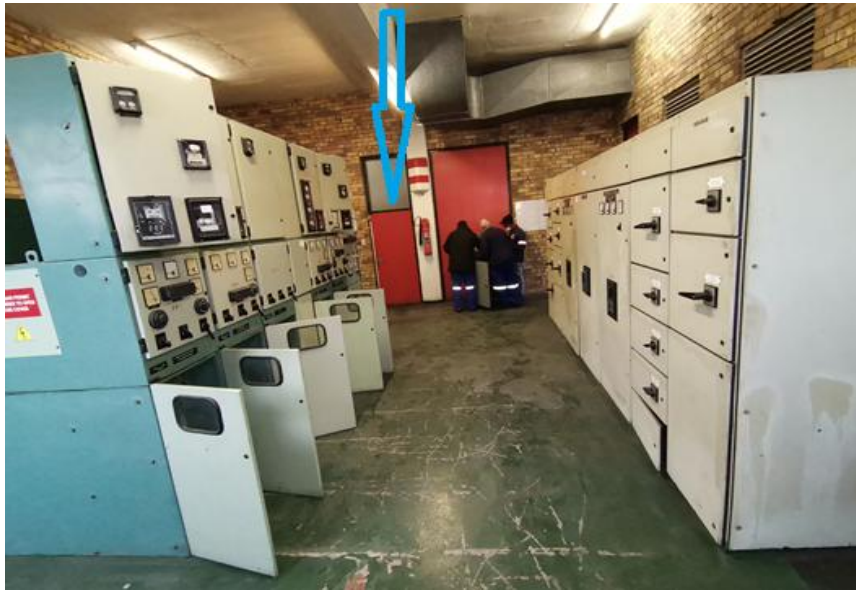
1.4.2.1.1 There is no that there is no barrier between the MV and LV switch gear. See Fig. 24.

1.4.2.1.2 There is also a door pointed with an arrow which leads to an Electrical workshop area. This door opens inwards and presents a risk of unauthorised entry from the personnel occupying the workshop.

Figure 23: MV and LV Switchgear in one room with no barrier in-between.

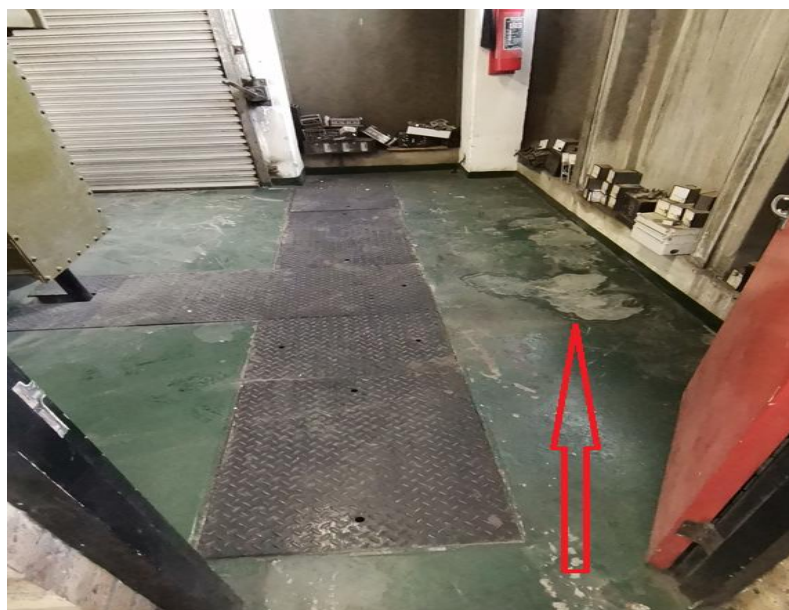
1.4.2.1.3 Figure 25 shows evidence of roof leaks on the floor and on the wall.

Figure 24: Transformer Room Roof Leak Stain

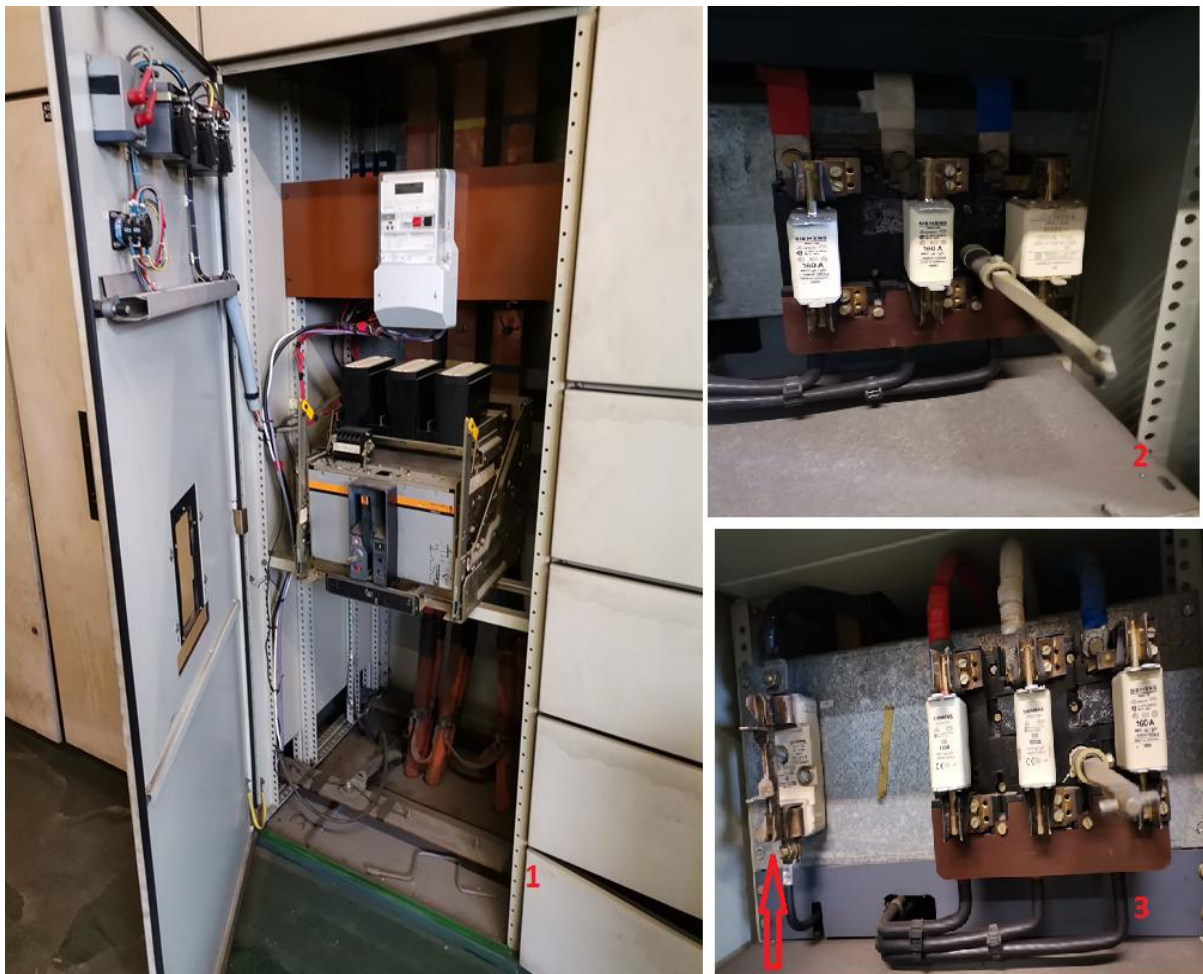
- 1.4.2.2.1 This substation is fitted with old oil MV circuit breaker technology like the preceding discussed substations. The protection relays are also of the old technology.
- 1.4.2.2.2 The low voltage switchgear shown in figure 26 is old and uses a combination of breakers and fuses. Detail 2 shows that the different fuse sizes are used for the same three phase feeder because of the shortage of equal spares. Detail 3 points to a link conducting material used in the absence of a fuse which is a risk because of no protection to potential faults.

Figure 25: 400V Switchgear with (1) breakers and (2&3) details of the fuses

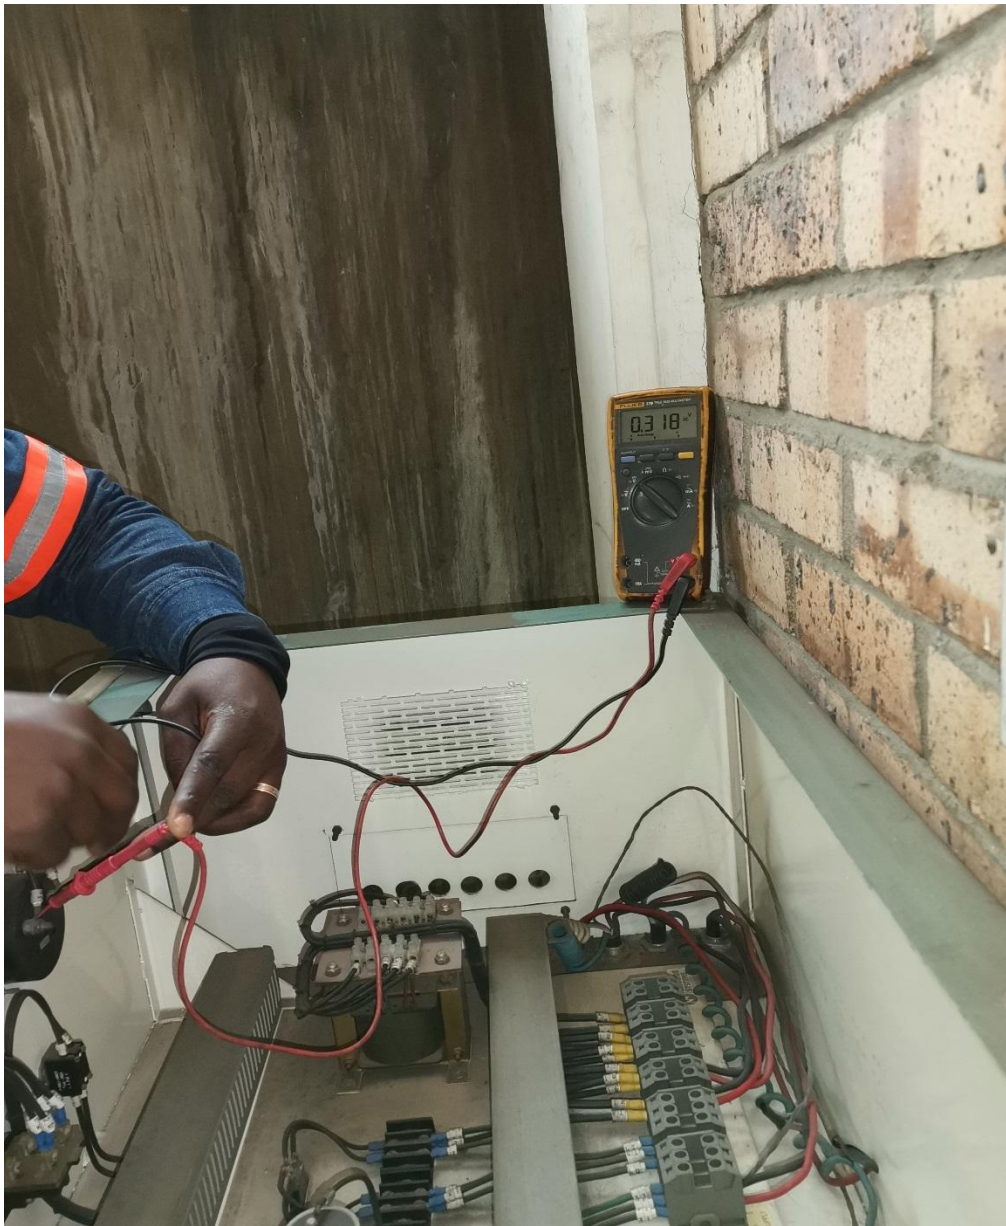
- 1.4.2.2.3 The DC power supply for the MV switchgear was tested and found to be almost dead as shown in figure 27. The dead batteries were replaced with the new batteries that were sourced by the electricians during the assessment. This literally meant the MV protection was entirely compromised at the time before the replacement.

Figure 26: Testing of the DC supply for the MV switchgear.

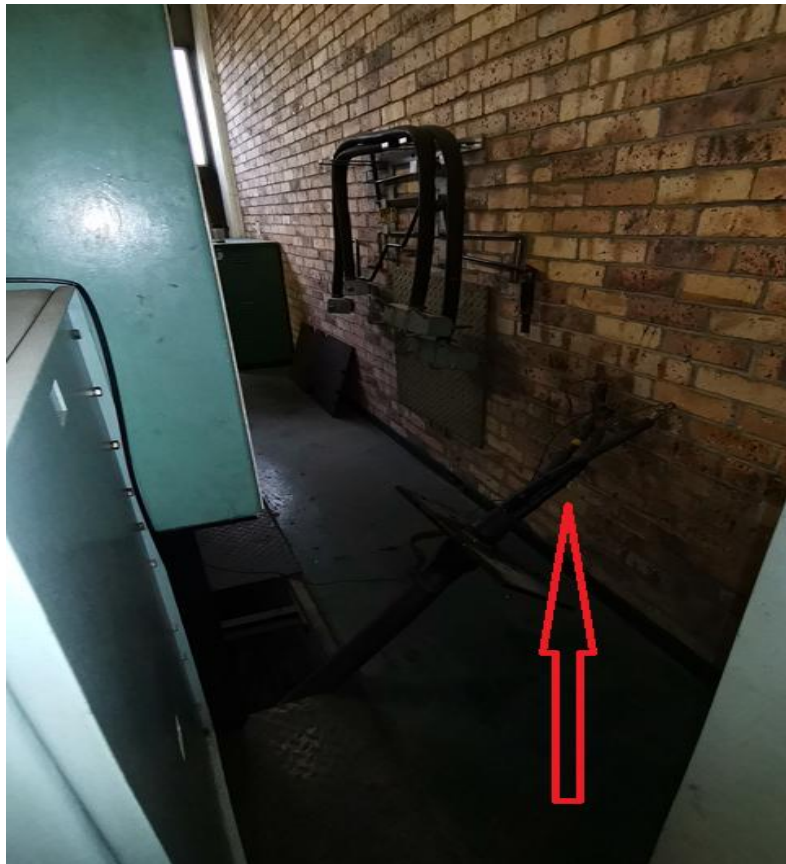
- 1.4.2.2.4 Figure 28 shows a disconnected cable in one of the MV incomers. The cable is supposed to be 2x150mm<sup>2</sup> terminated as a parallel connection but one cable is now used because of the cable fault on the accompanying cable. The Electricians on site advised that the cable has been faulty and disconnected for some time and there are no known plans to fix the fault. This problem violates the design principle of the network such as load capacity and the design fault level. By removing one cable as seen directly increases the design fault level. Such values are imperative in fault level studies and thus informs the protection settings for the plant.

Figure 27: Faulty MV Incomer Cable Disconnected
