OUTAGE SCOPE OF WORK FORM/TEMPLATE

**Matla Power Station
Outage Scope of Work for Cooling Towers (CT) 1 to 6**

Reference No.	MEA-
Revision:	0
Unit No.	4
Genix ID.	24423
Date:	13/08/2026

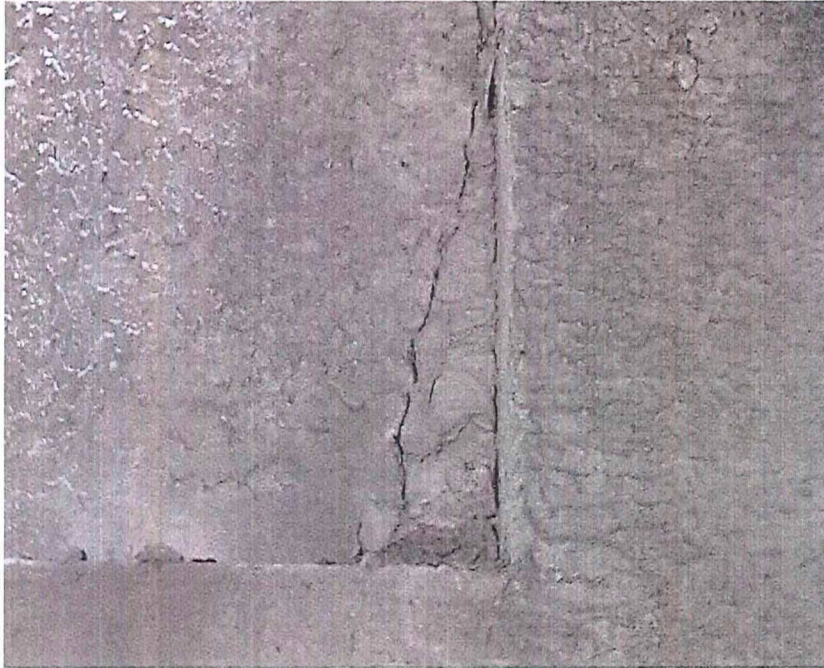
The columns, ring beams and corbels generally have a low degree of damage, but there are a few beam connections that have a medium degree of damage with misalignment and cracking due to thermal movement. These beam connections need to be repaired or sealed per the concrete repair method (Please refer to method stated below. Knee braces (see below) should be installed at all affected column beam connections. The knee brace will tie the columns to the beams and prevent any future movement.

Figure 3: Cracking at beam edge

The knee braces are to be installed at all affected column beam connection. The knee brace will tie the columns to the beams and prevent any future movement. The knee brace consists of 150x150x10 angle 300mm long with 4 M16 grade 8.8 stainless steel chemical anchors and a 10mm stiffener between the bolts.

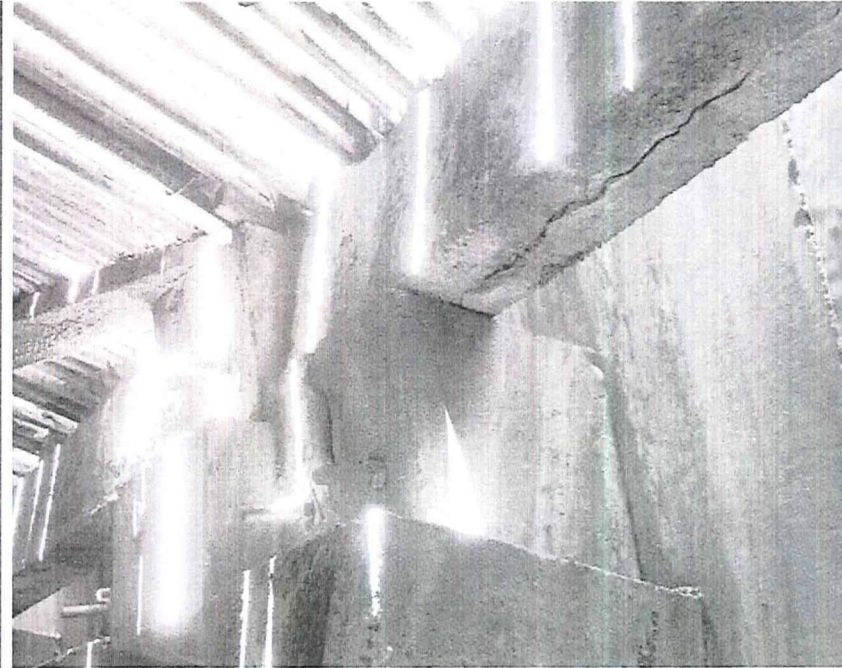
Figure 4: Ring Beam Cracking

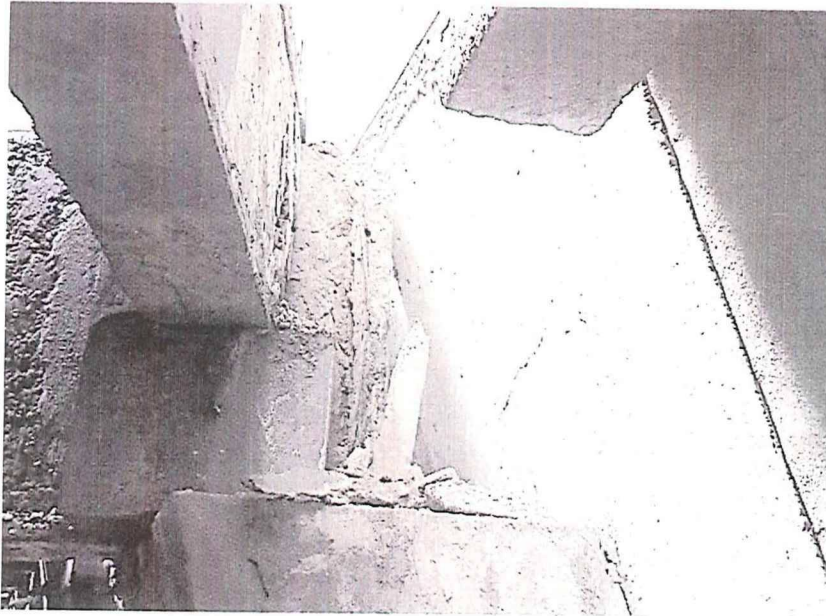
Figure 5: Cracking and spalling at beam corbel connection

- a) Re-instatement of the collapsed supporting beams for the fill on Collapsed section
- b) Repair the broken corbels on all Cooling towers and any collapsed beams during the Outage

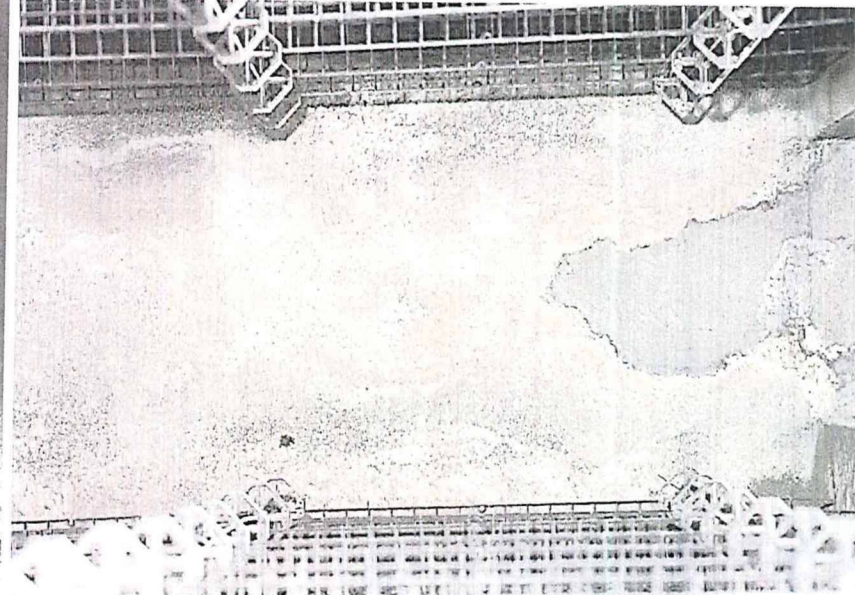
Figure 6: Sulphate Attack
