**MOKOLO AND CROCODILE
WATER AUGMENTATION PROJECT
(MCWAP)**

**PHASE 2: GEOTECHNICAL INVESTIGATIONS
Stage 1: Tarantaalpan – Operational Reservoir**

VOLUME 1: GEOTECHNICAL DATA REPORT

Report No: 2A-R-111E-43 (Rev A)

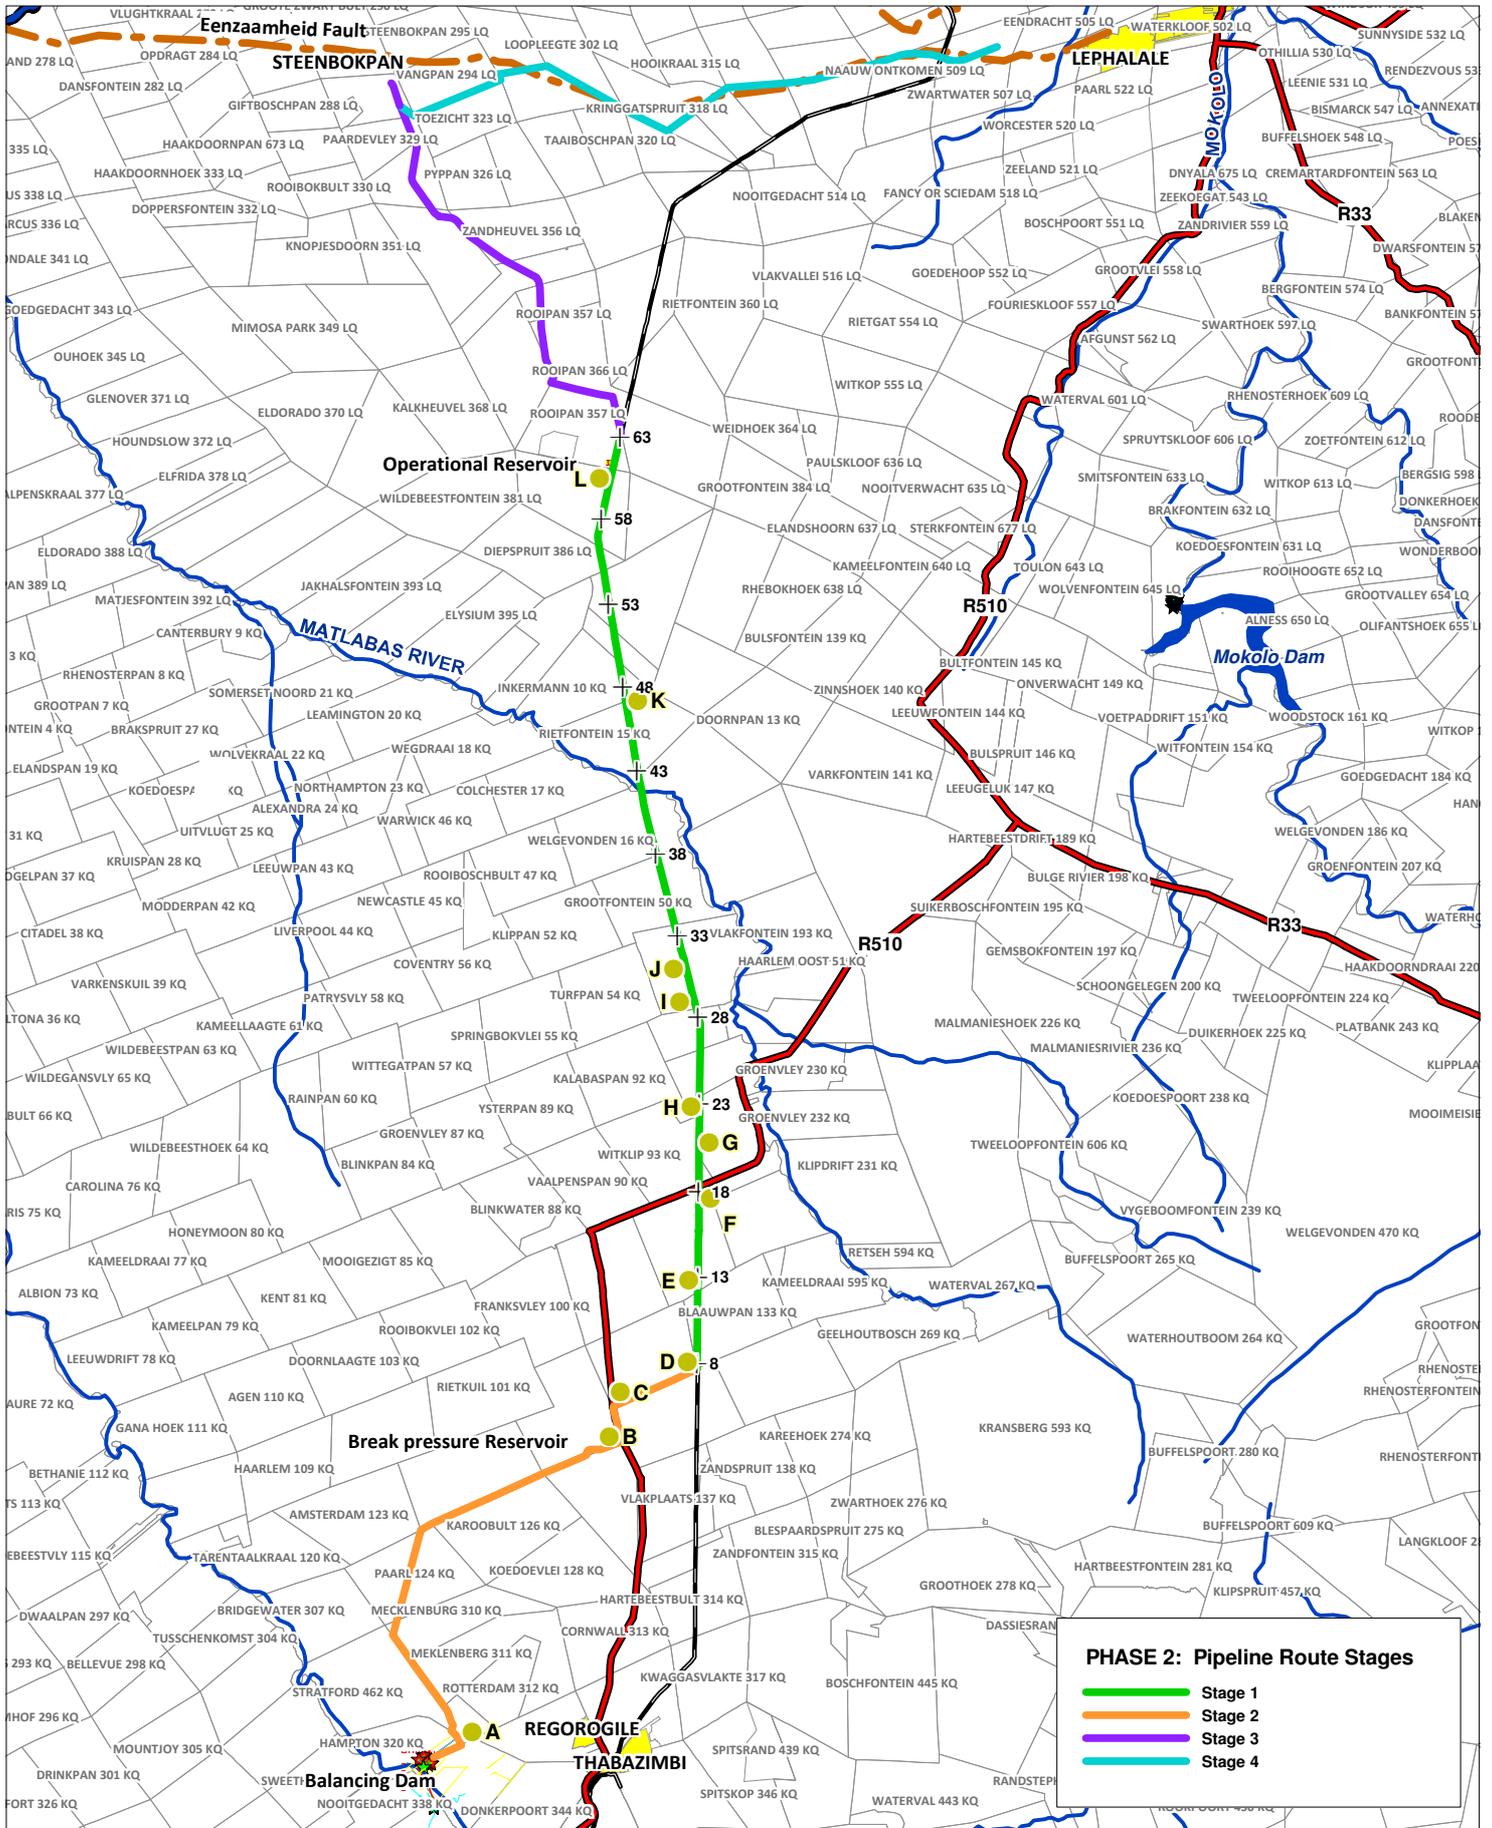
A Locality Map for Phase 2 is included as Figure 1 (Drawing No. 2A-G3-020).

PHASE 2: Pipeline Route Stages

- Stage 1
- Stage 2
- Stage 3
- Stage 4

This Report deals only with Phase 2 Stage 1 of the Project. Similar reports will be compiled for the other three Stages making up Phase 2. The location of the different Stages is shown on the Locality Plan (Figure 1).

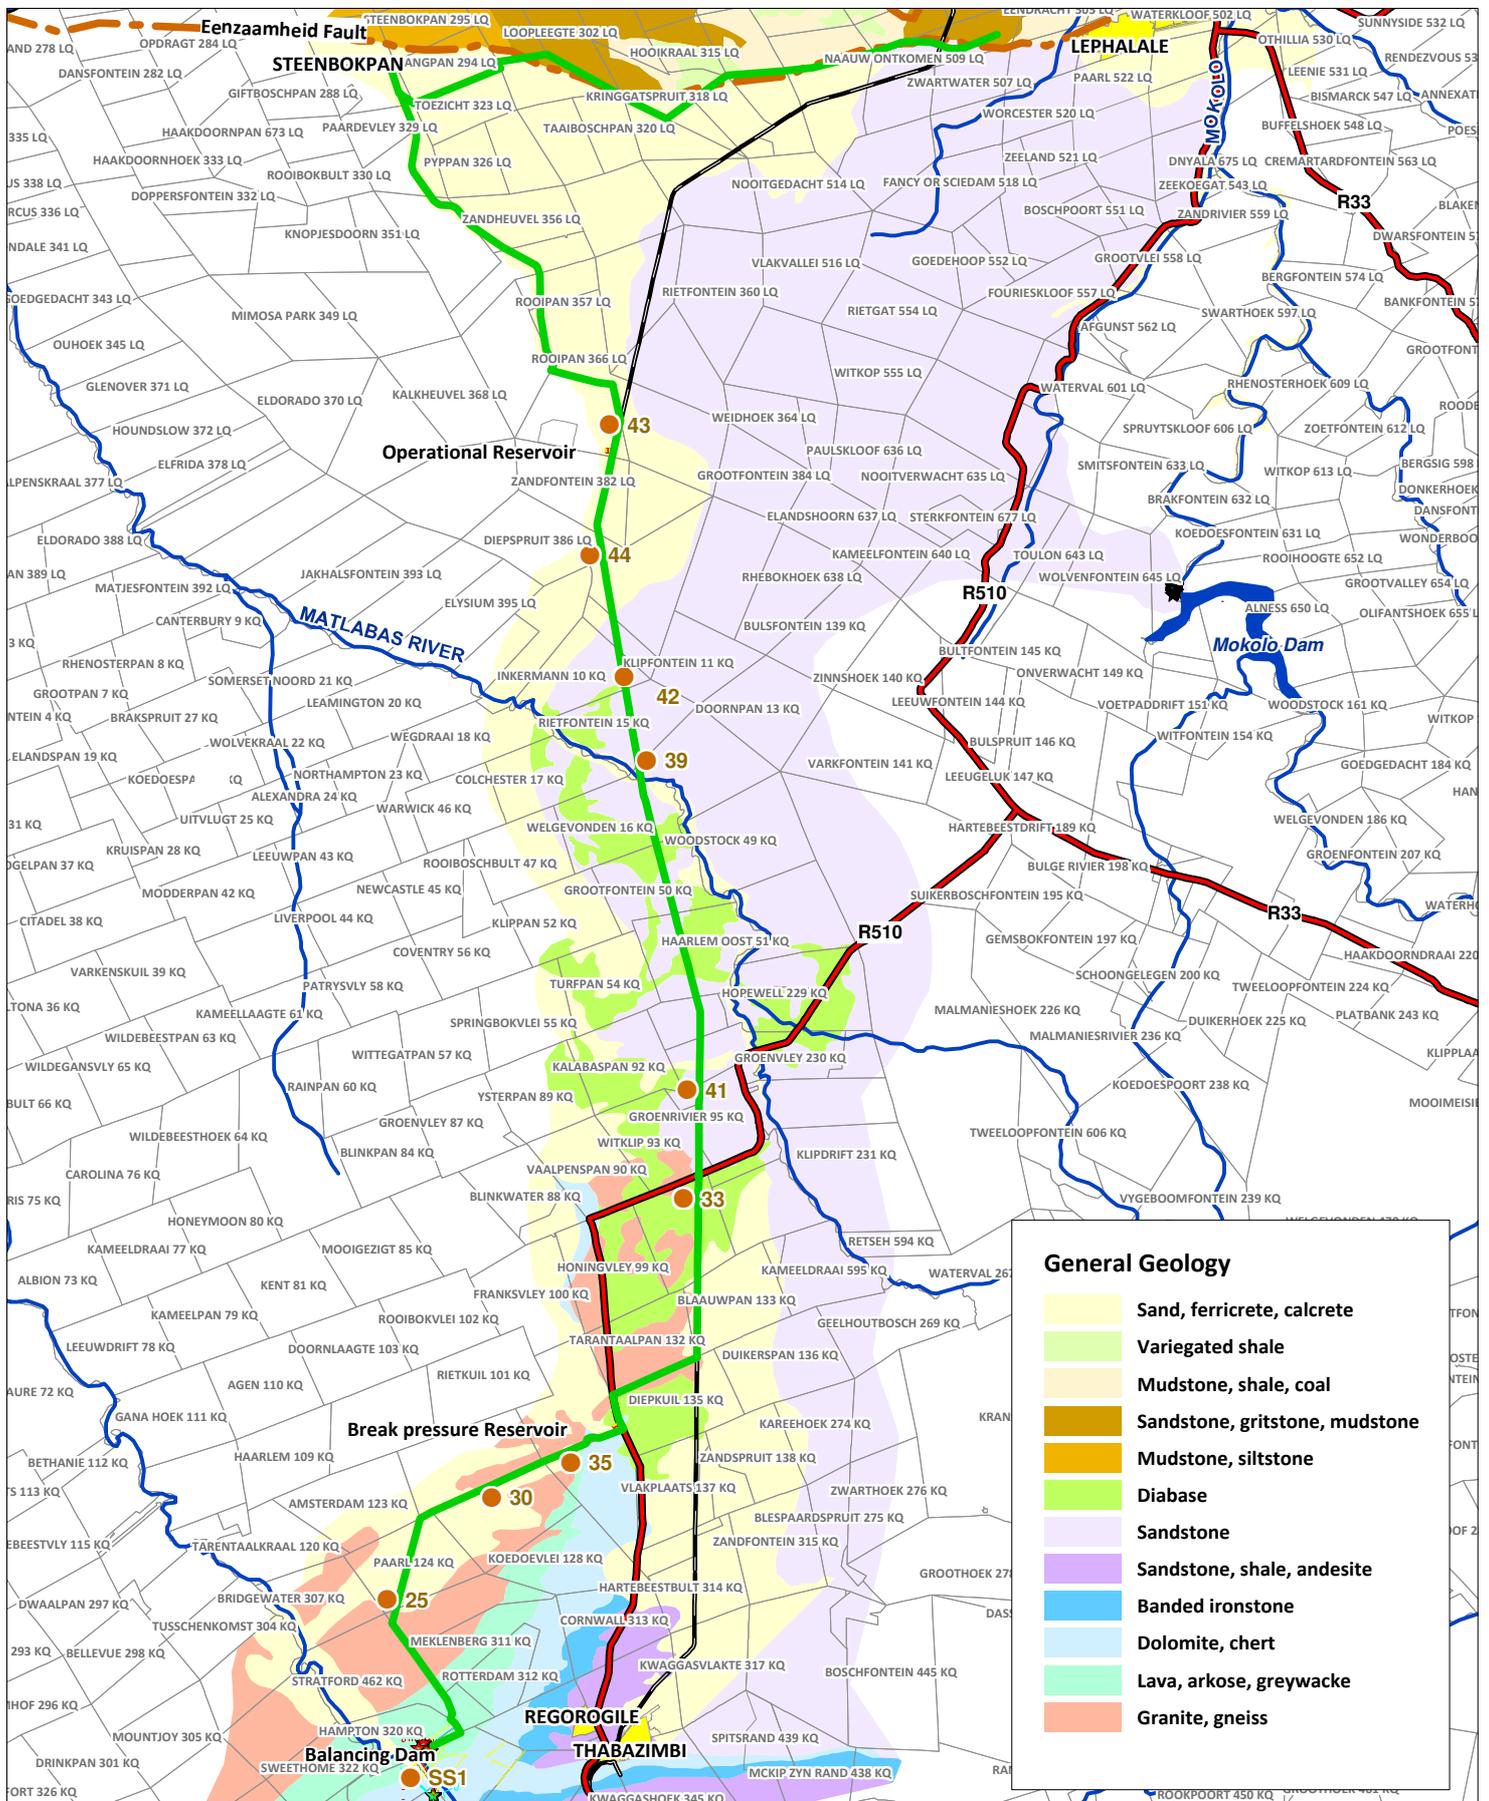
The sandstones of the Waterberg Group are near-horizontally bedded with a very shallow dip towards the north. Prominent NE- and NW-striking lineaments are recognised. The Lebowa Granite forms the Basement Complex in the area. Diabase is intruded in irregular bodies (generally sills or inclined sheets) into both the granite and Waterberg.

General Geology

- Sand, ferricrete, calcrete
- Variegated shale
- Mudstone, shale, coal
- Sandstone, gritstone, mudstone
- Mudstone, siltstone
- Diabase
- Sandstone
- Sandstone, shale, andesite
- Banded ironstone
- Dolomite, chert
- Lava, arkose, greywacke
- Granite, gneiss

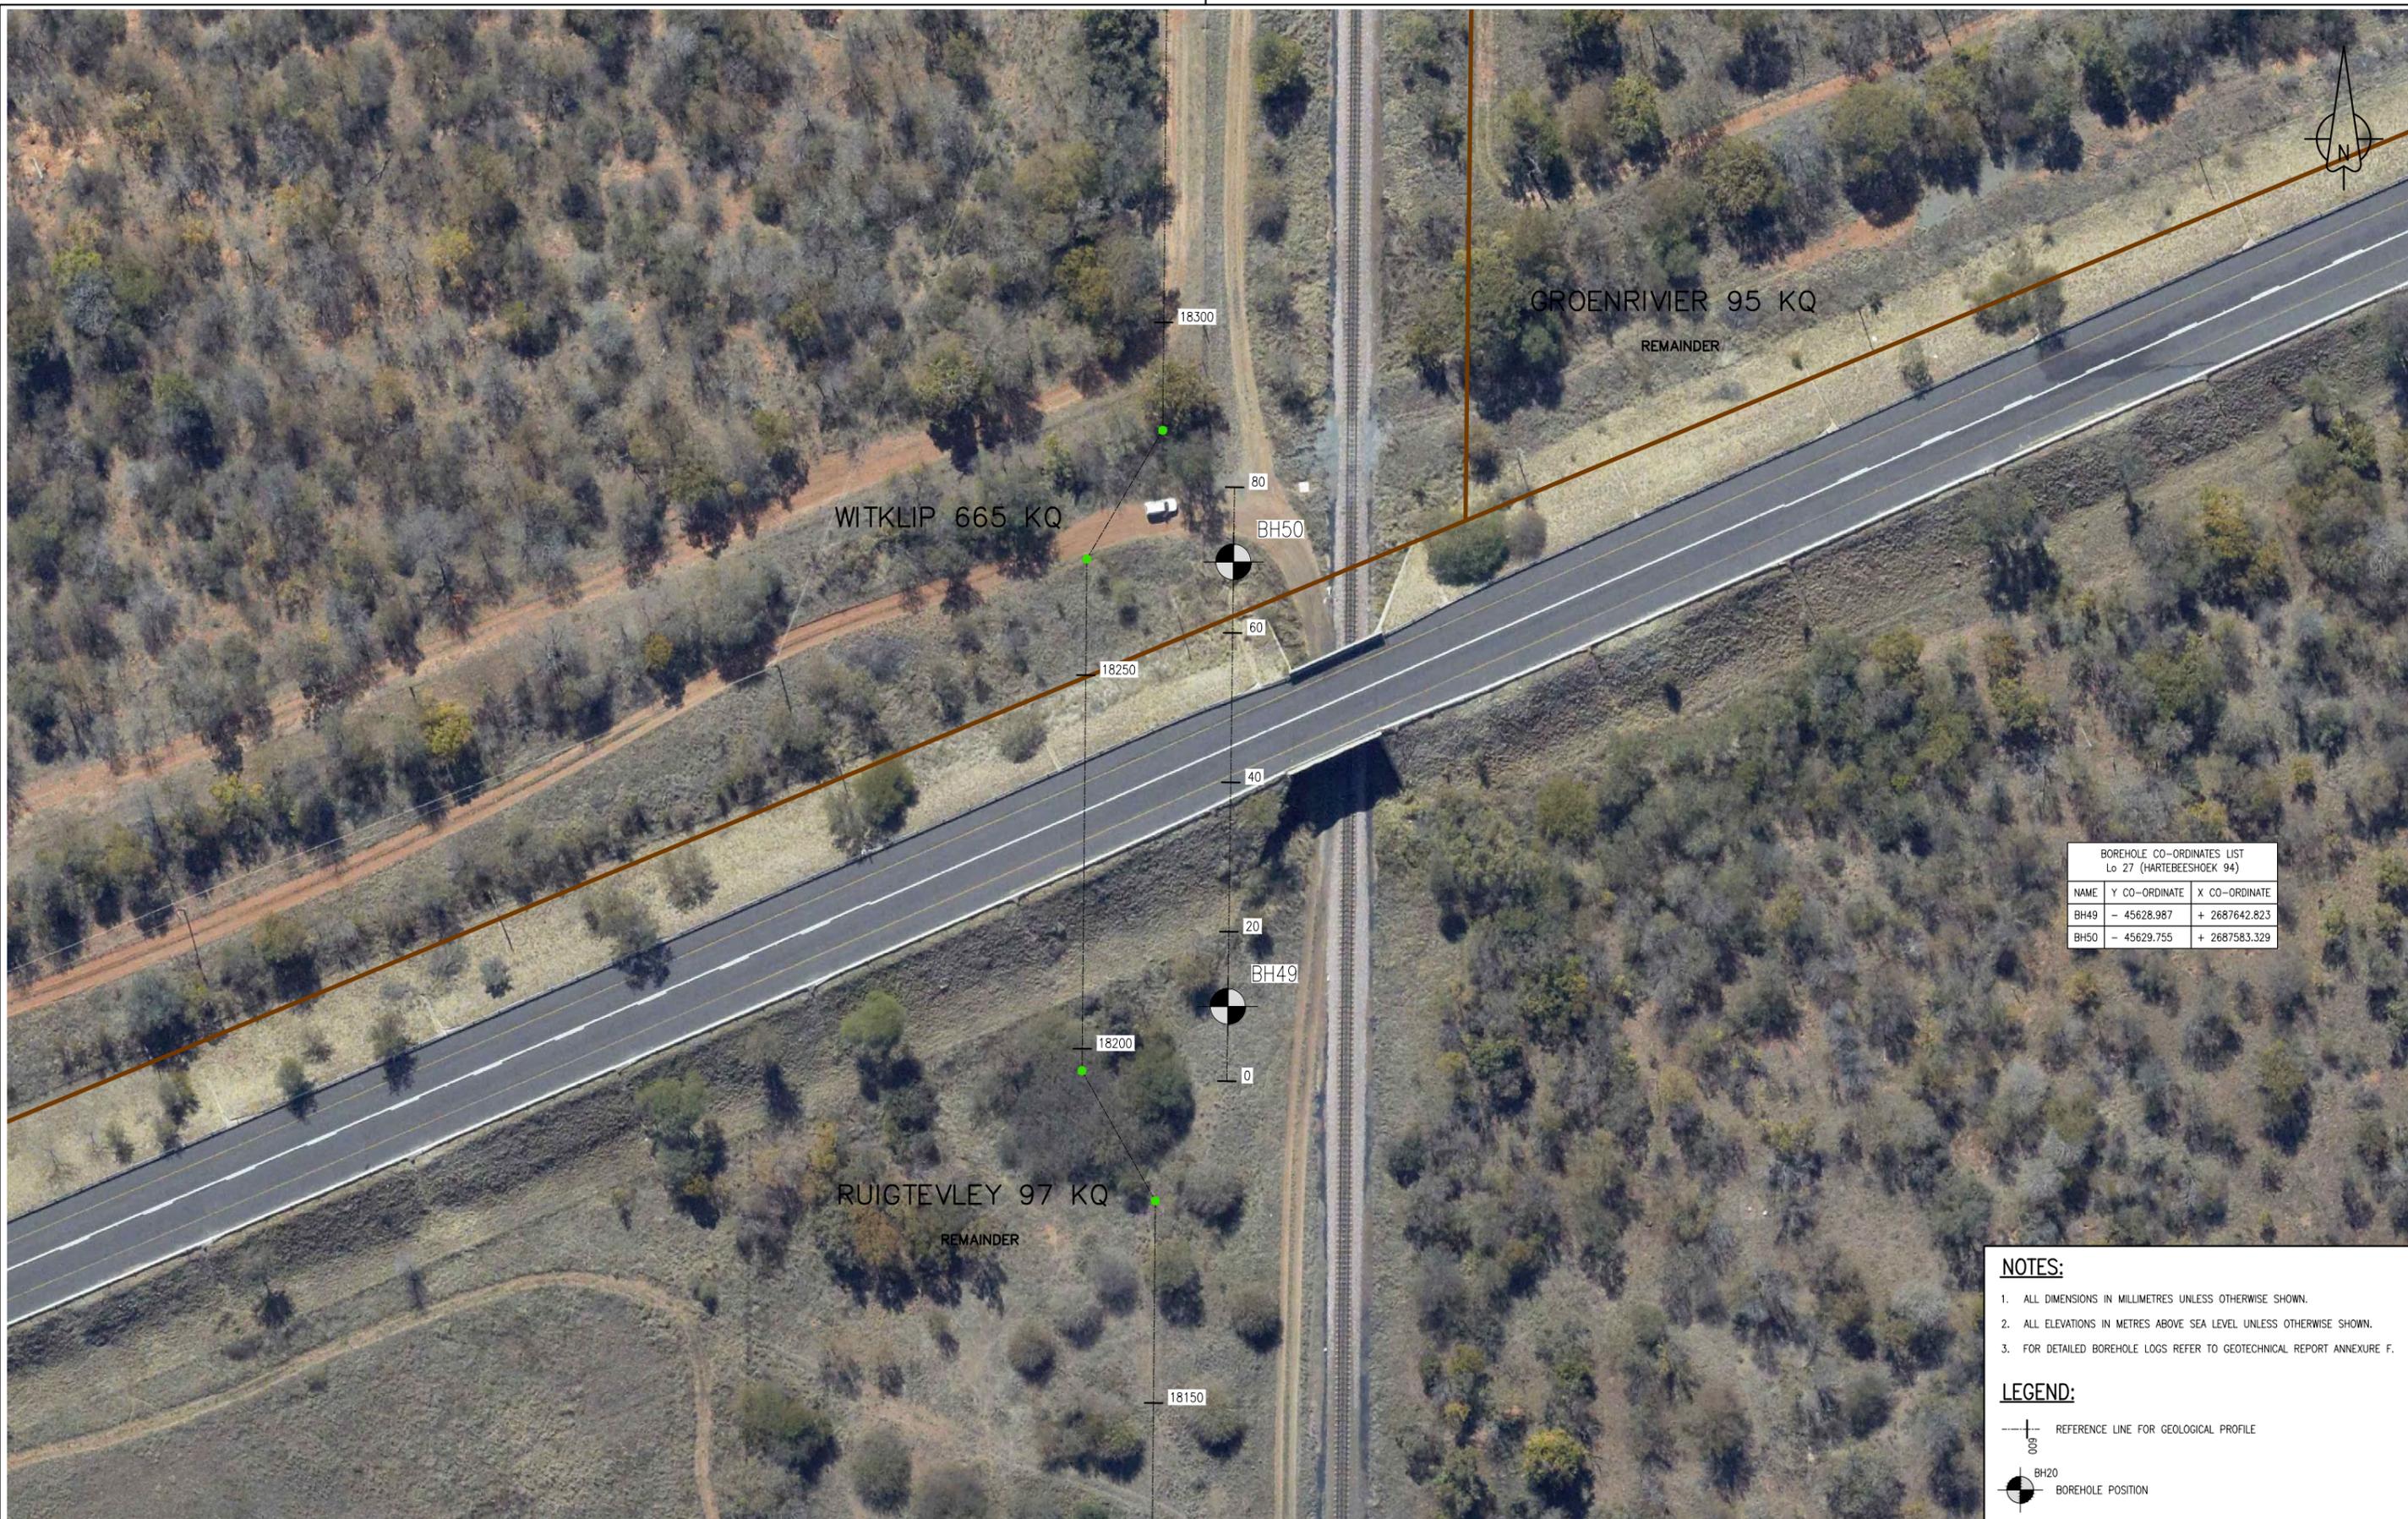
At the R510 Road Crossing (farm Ruigtevley 97KQ), the rockhead was intersected between 3.70 m and 4.20 m and medium hard rock Waterberg sandstone was encountered at a depth of 4.90 m and 5.25 m respectively.

BOREHOLE CO-ORDINATES LIST Lo 27 (HARTEBESHOEK 94)		
NAME	Y CO-ORDINATE	X CO-ORDINATE
BH49	- 45628.987	+ 2687642.823
BH50	- 45629.755	+ 2687583.329

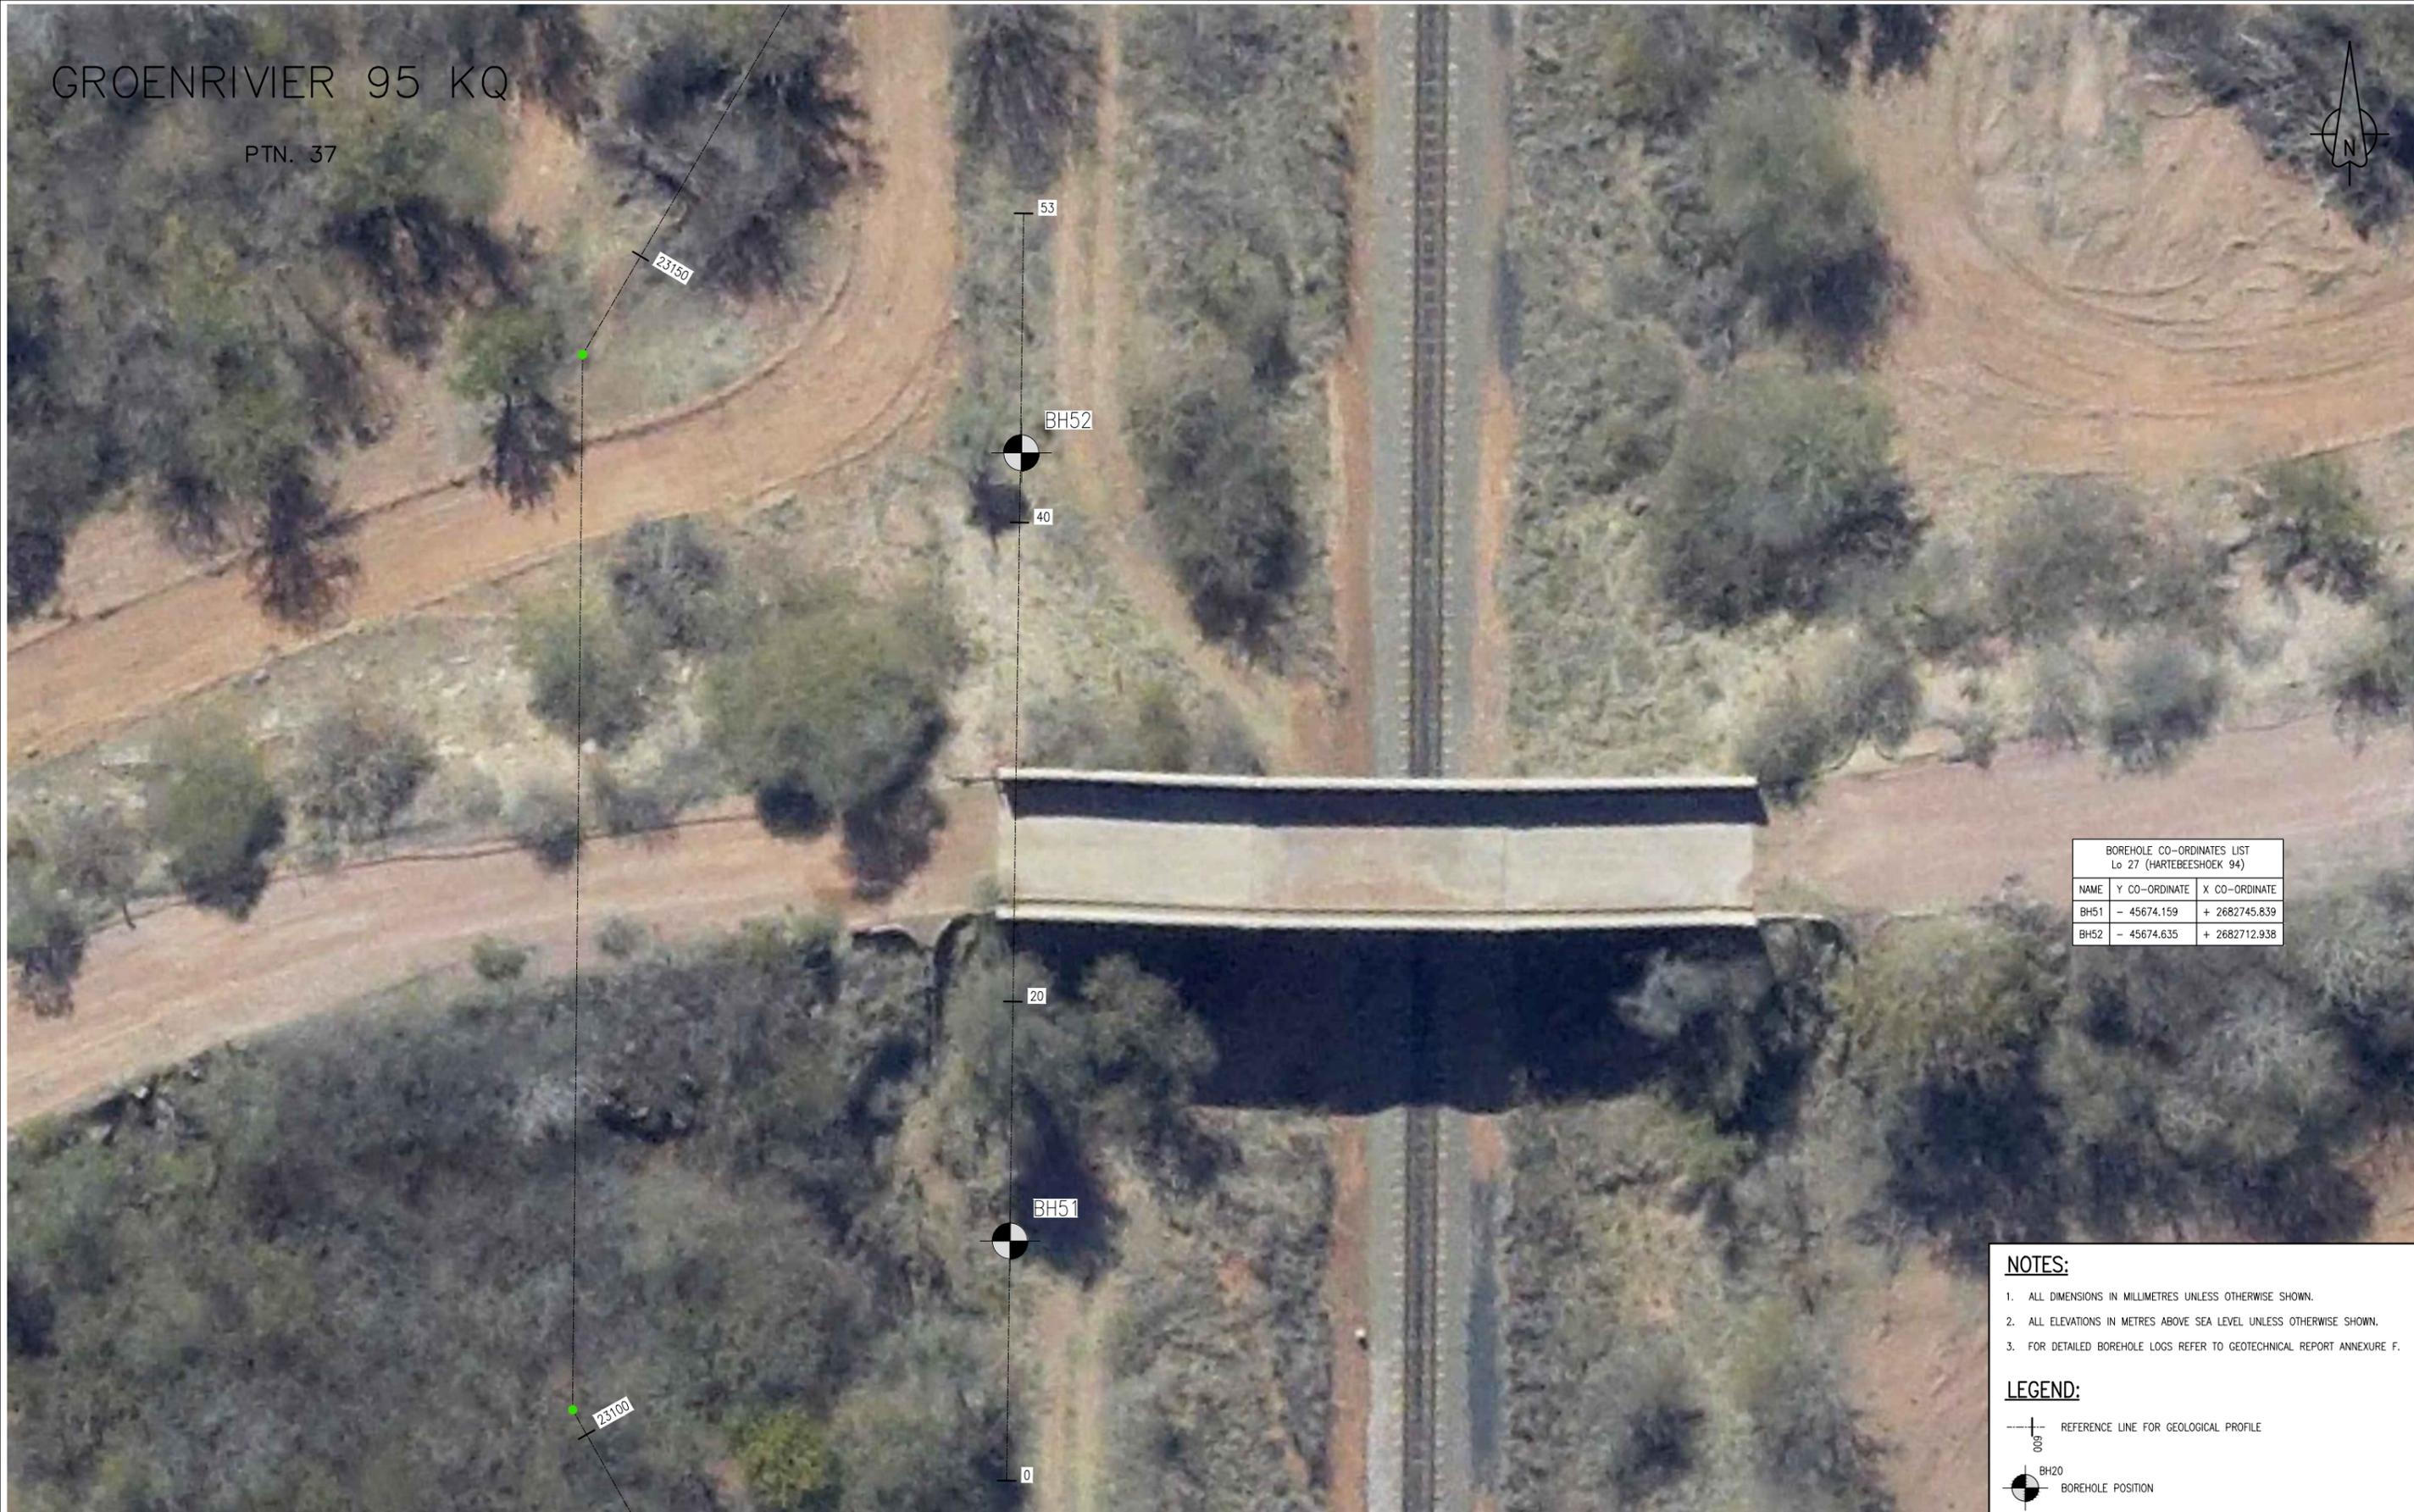
At the Railway Overpass Road Crossing (farm Groenrivier 95KQ, Ptn 37), the rockhead was intersected between 1.70 m and 3.75 m and medium hard to hard rock Waterberg sandstone was encountered at a depth of 2.20 m and 4.50 m, respectively.

BOREHOLE CO-ORDINATES LIST Lo 27 (HARTEBESHOEK 94)		
NAME	Y CO-ORDINATE	X CO-ORDINATE
BH51	- 45674.159	+ 2682745.839
BH52	- 45674.635	+ 2682712.938

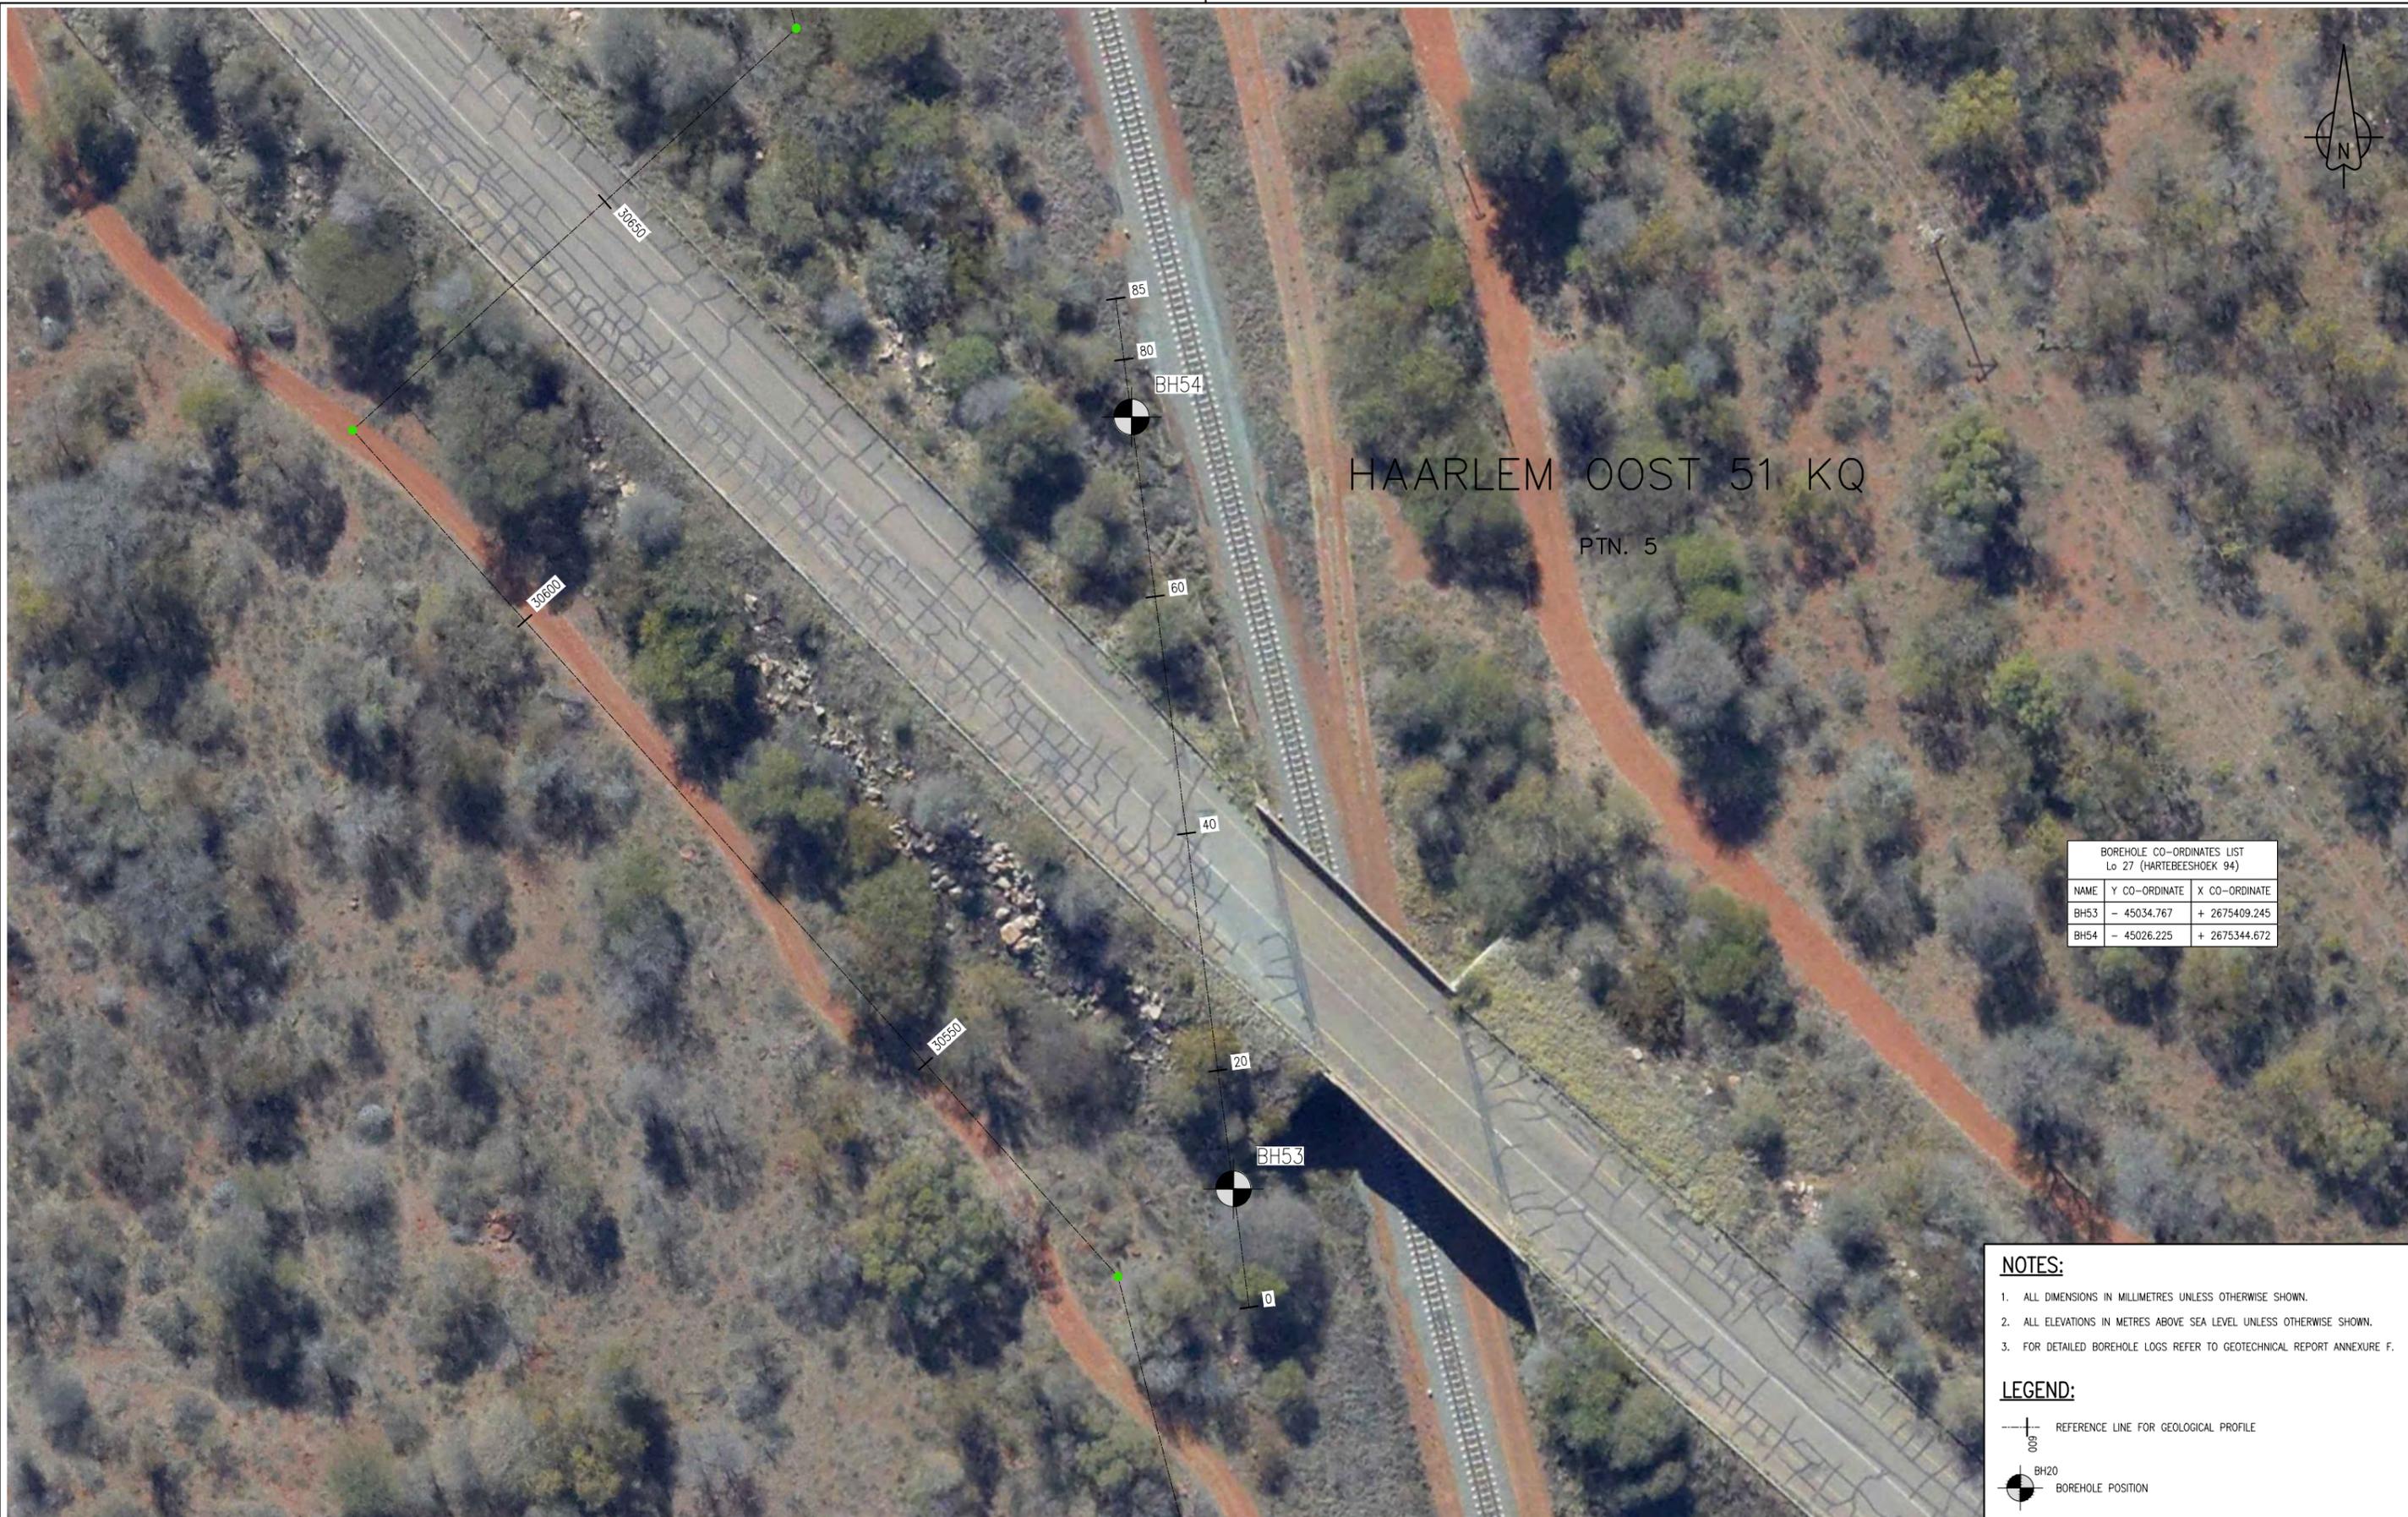
At the Road D2701 Crossing (farm Haarlem Oost 51KQ), the rockhead was intersected between 1.35 m and 1.75 m and hard Lebowa Granite was encountered at a depth of between 2.57 m and 6.75 m.

BOREHOLE CO-ORDINATES LIST Lo 27 (HARTEBESHOEK 94)		
NAME	Y CO-ORDINATE	X CO-ORDINATE
BH53	- 45034.767	+ 2675409.245
BH54	- 45026.225	+ 2675344.672

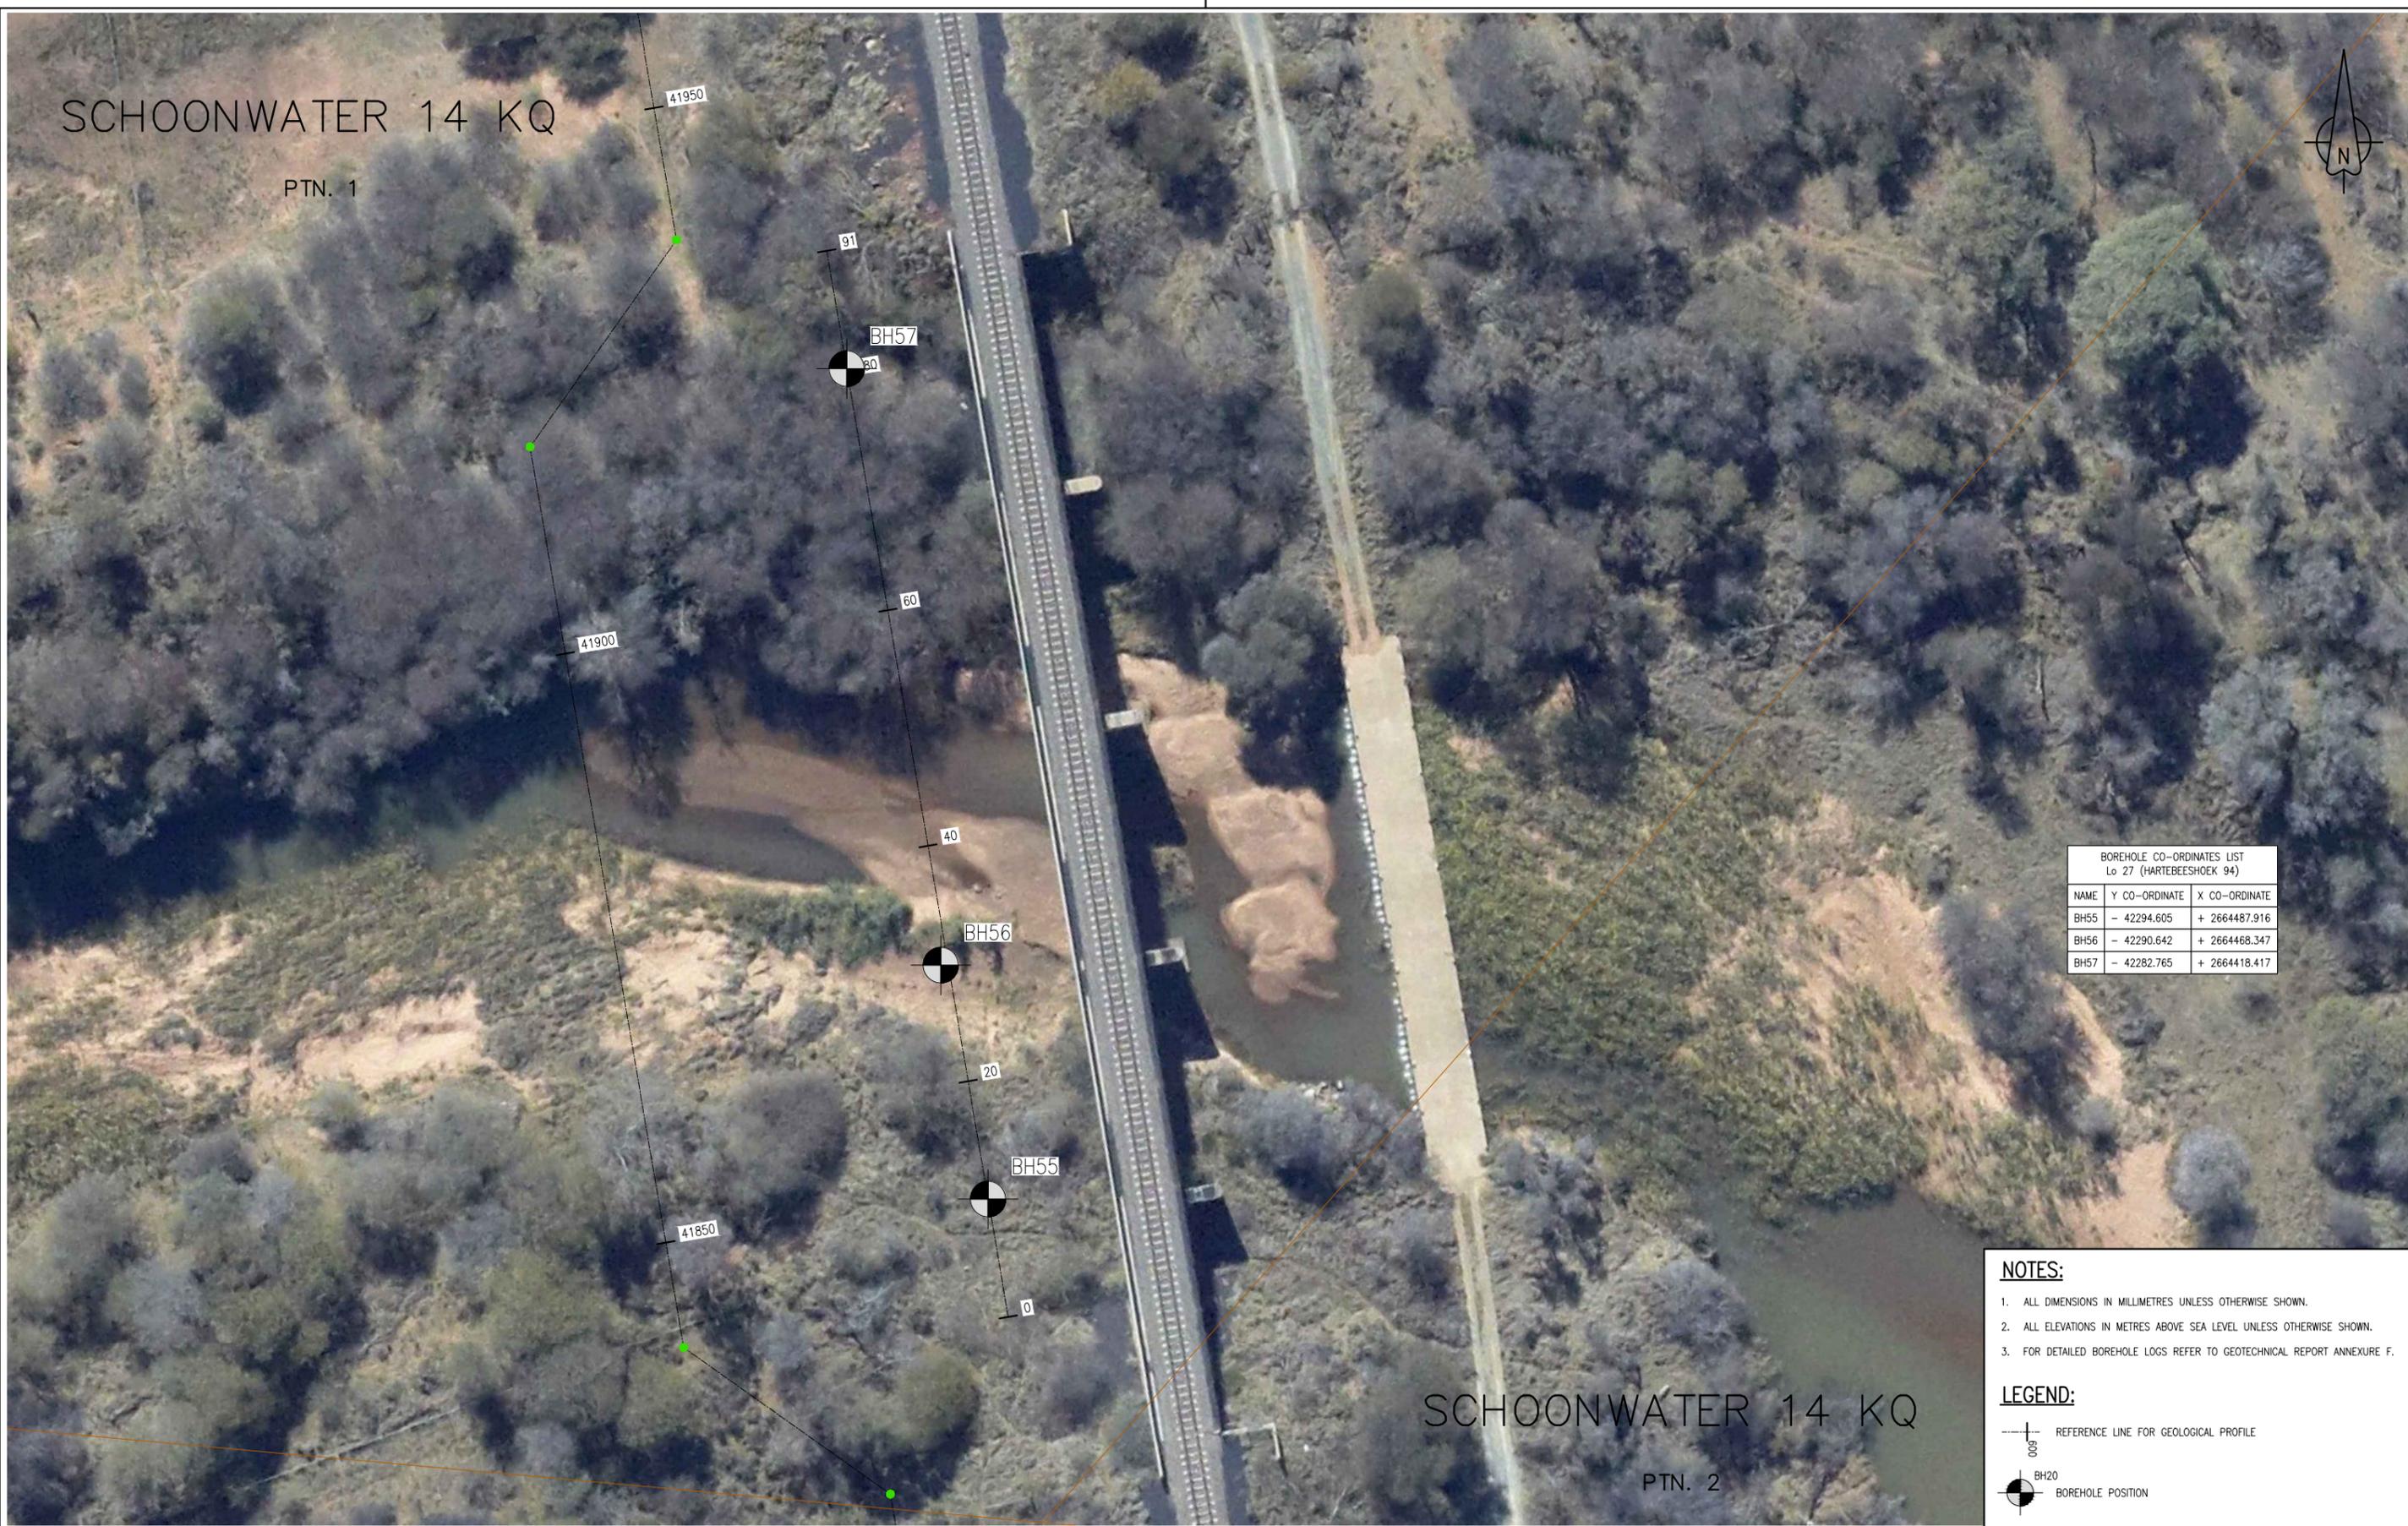
At the Matlabas River Crossing (approximately Chainage 41,820 to 49,000 m), the rockhead was intersected between 2.50 m and 5.48 m. Medium hard rock Waterberg siltstone was encountered from 7.90 m on the left bank, while very soft to hard rock post-Waterberg diabase (dolerite) was encountered from 7.50 m on the right bank.

BOREHOLE CO-ORDINATES LIST Lo 27 (HARTEBEE SHOEK 94)		
NAME	Y CO-ORDINATE	X CO-ORDINATE
BH55	- 42294.605	+ 2664487.916
BH56	- 42290.642	+ 2664468.347
BH57	- 42282.765	+ 2664418.417

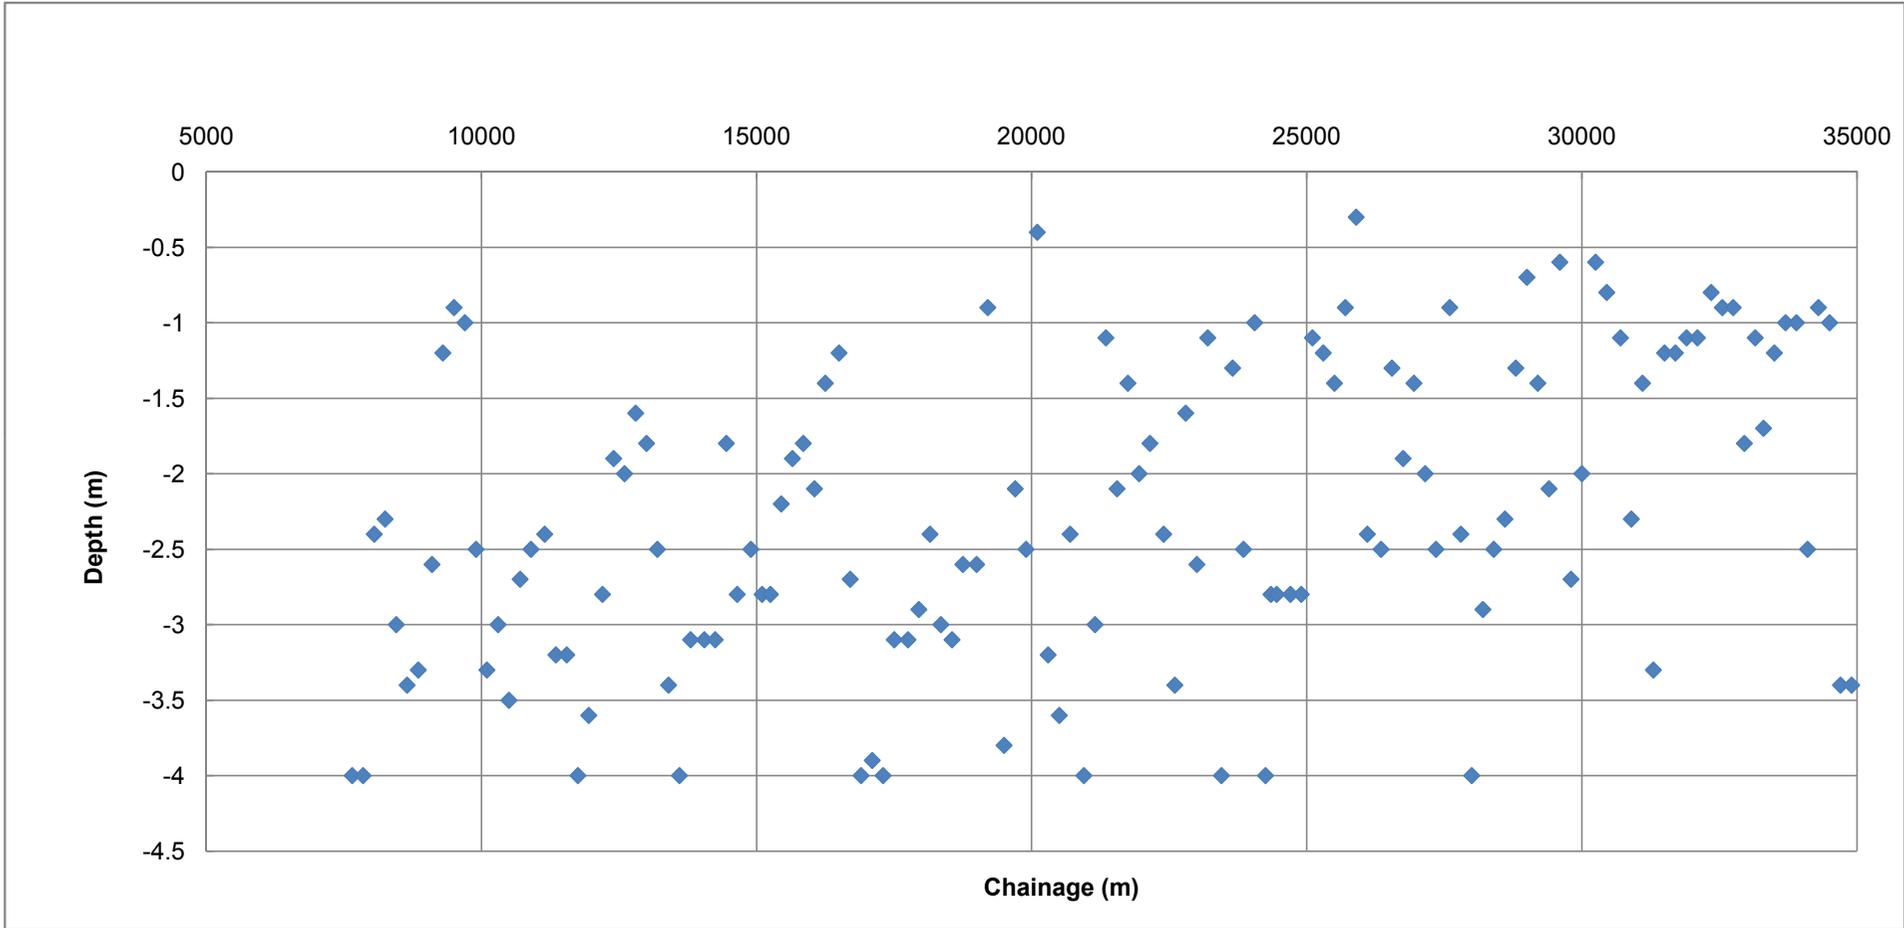
FIGURE 8: PIPELINE: DEPTH TO REFUSAL
Tarantalpan - Operational Reservoir: Chainage 7,700 - 35,000 m

A summary of the ground conditions at each test pit position along the pipeline route is given on spreadsheets in Annexure A1. Graphical representations of the excavation depth for each test pit are included as Figure 8 and Figure 9.

The DPL soundings are shown as equivalent SPT N-values (blows per 300 mm) and are shown graphically as N-value versus depth on the soil profiles. The majority of the pits terminated on sandstone, ferricrete or calcrete. The TLB used was able to excavate into the weathered zone of the sandstone but refused when unweathered rock was encountered. An inspection of cuttings on the adjacent railway line reveals that the sandstone generally broke out in blocks and there is ample evidence that it had to be blasted.
