**MOKOLO AND CROCODILE
WATER AUGMENTATION PROJECT
(MCWAP)**

**PHASE 2: GEOTECHNICAL INVESTIGATIONS
Stage 1: Tarantaalpan – Operational Reservoir**

VOLUME 1: GEOTECHNICAL DATA REPORT

Report No: 2A-R-111E-43 (Rev A)

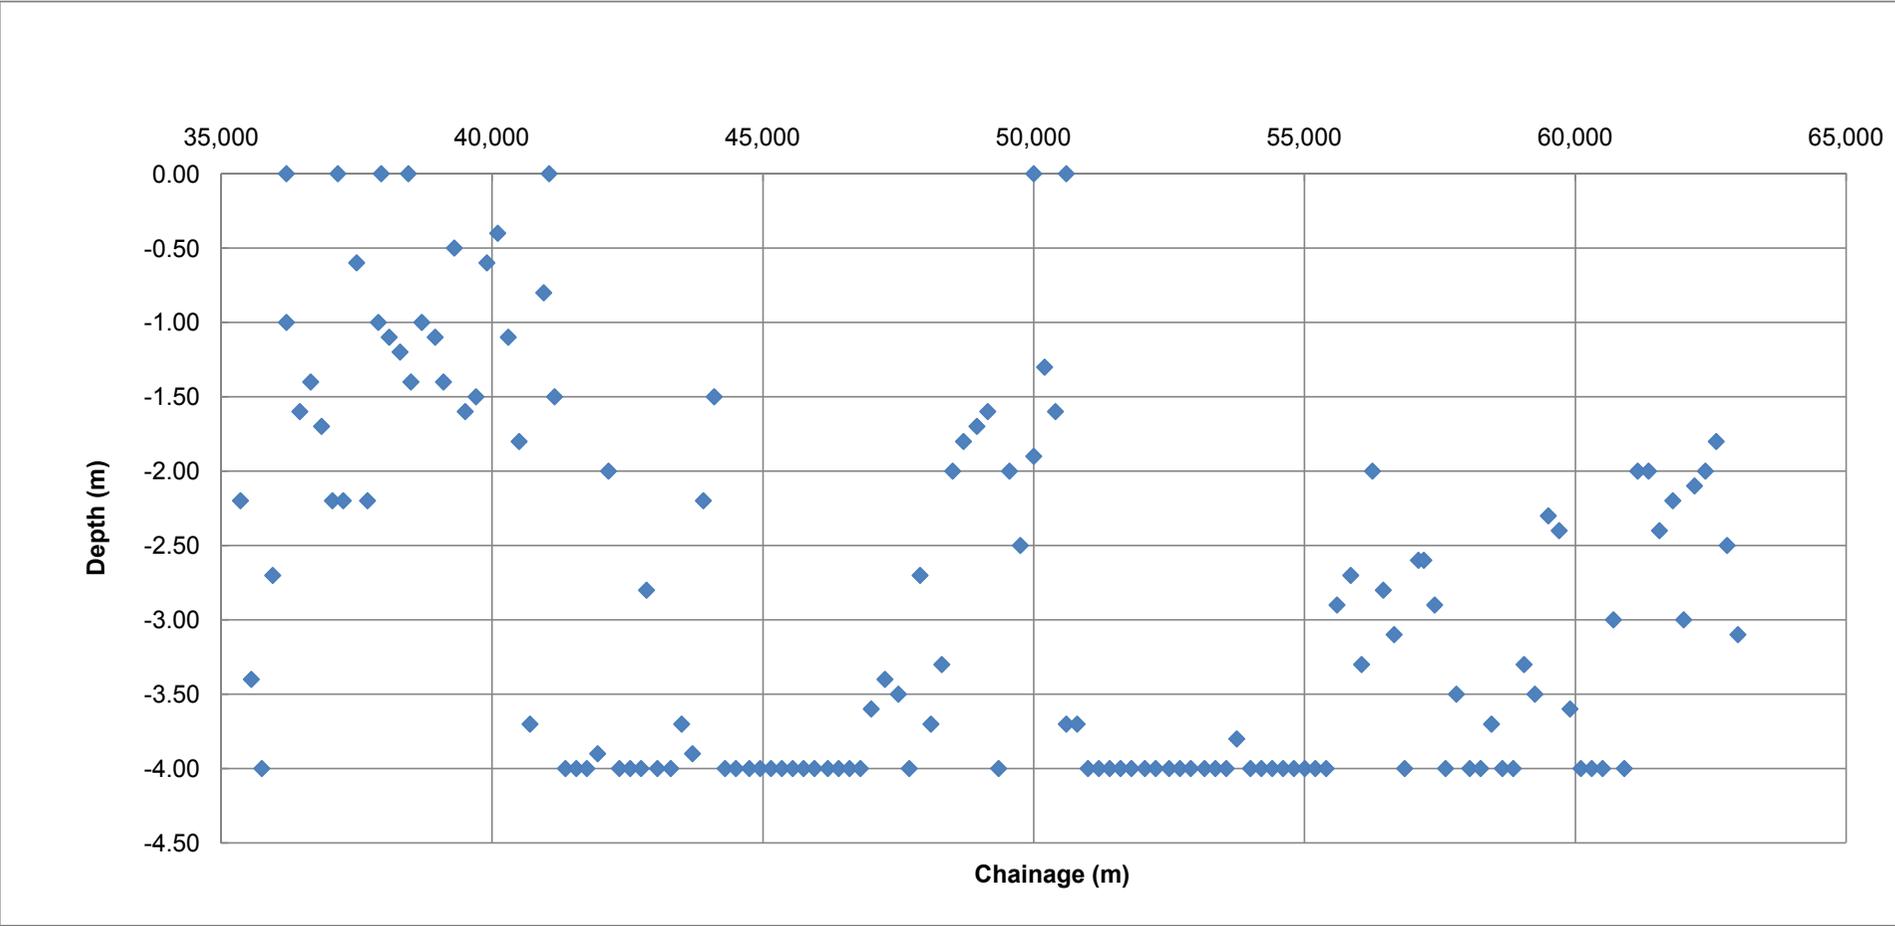
FIGURE 9: PIPELINE: DEPTH TO REFUSAL
Tarantaalpan - Operational Reservoir: Chainage 35,000 - 63,200 m

A summary of the ground conditions at each test pit position along the pipeline route is given on spreadsheets in Annexure A1. Graphical representations of the excavation depth for each test pit are included as Figure 8 and Figure 9.

The DPL soundings are shown as equivalent SPT N-values (blows per 300 mm) and are shown graphically as N-value versus depth on the soil profiles. The majority of the pits terminated on sandstone, ferricrete or calcrete. The TLB used was able to excavate into the weathered zone of the sandstone but refused when unweathered rock was encountered. An inspection of cuttings on the adjacent railway line reveals that the sandstone generally broke out in blocks and there is ample evidence that it had to be blasted.
