**MOKOLO AND CROCODILE
WATER AUGMENTATION PROJECT
(MCWAP)**

**PHASE 2: GEOTECHNICAL INVESTIGATIONS
STAGE 4: Steenbokpan - Matimba**

VOLUME 1: GEOTECHNICAL DATA REPORT

Report No: 2A-R-111E-55 (Rev A)

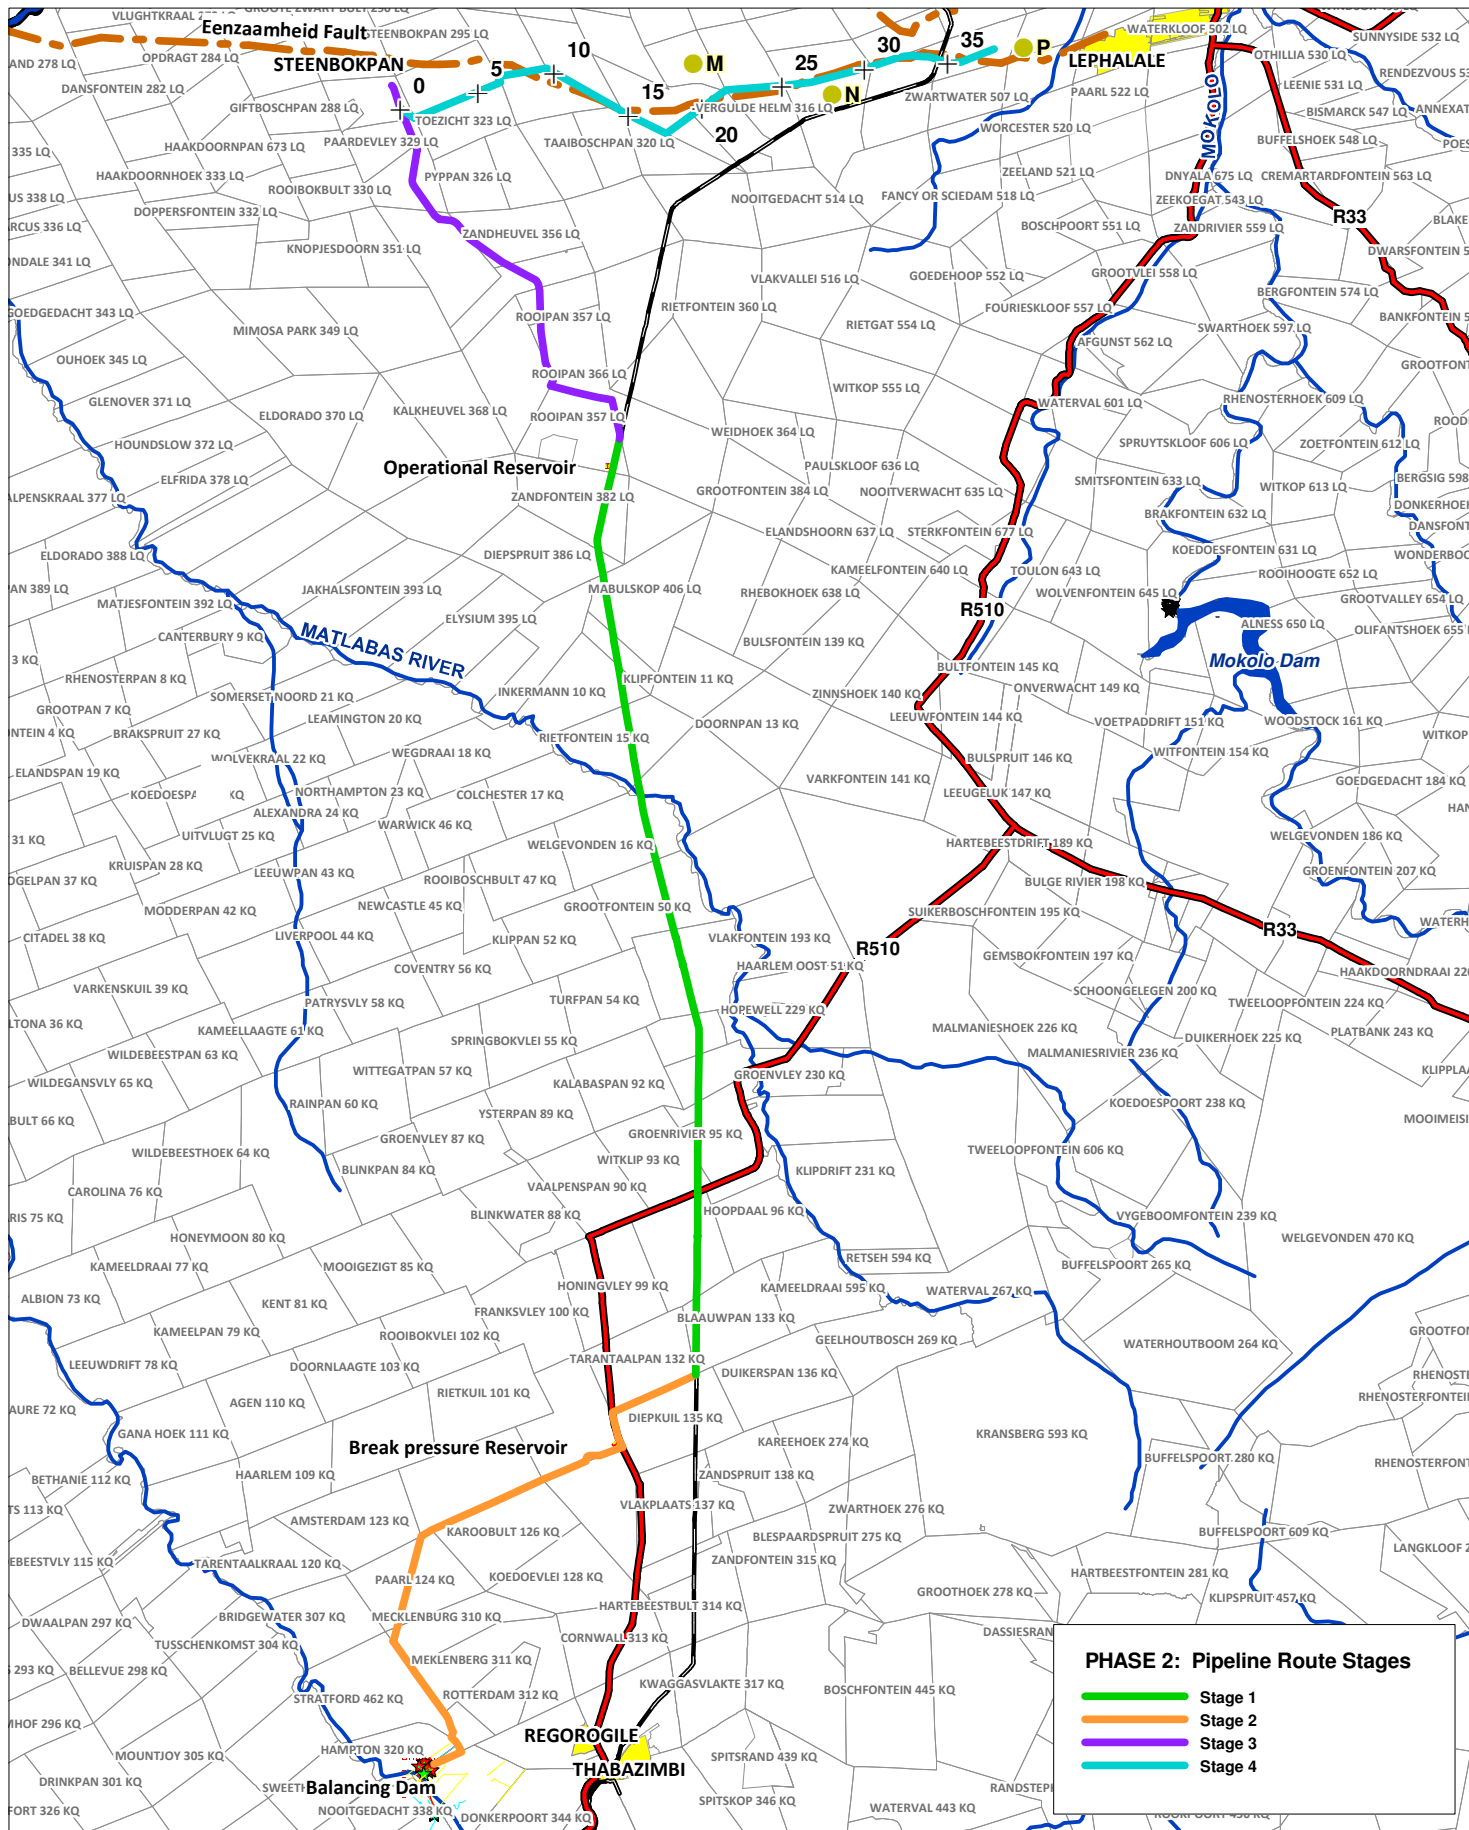
Drawing Number: 2A-G3-028

This Report deals only with Phase 2 Stage 4 of the Project. Similar reports have been compiled for the other three Stages making up Phase 2. The location of the different Stages is shown on the Locality Plan (Figure 1).

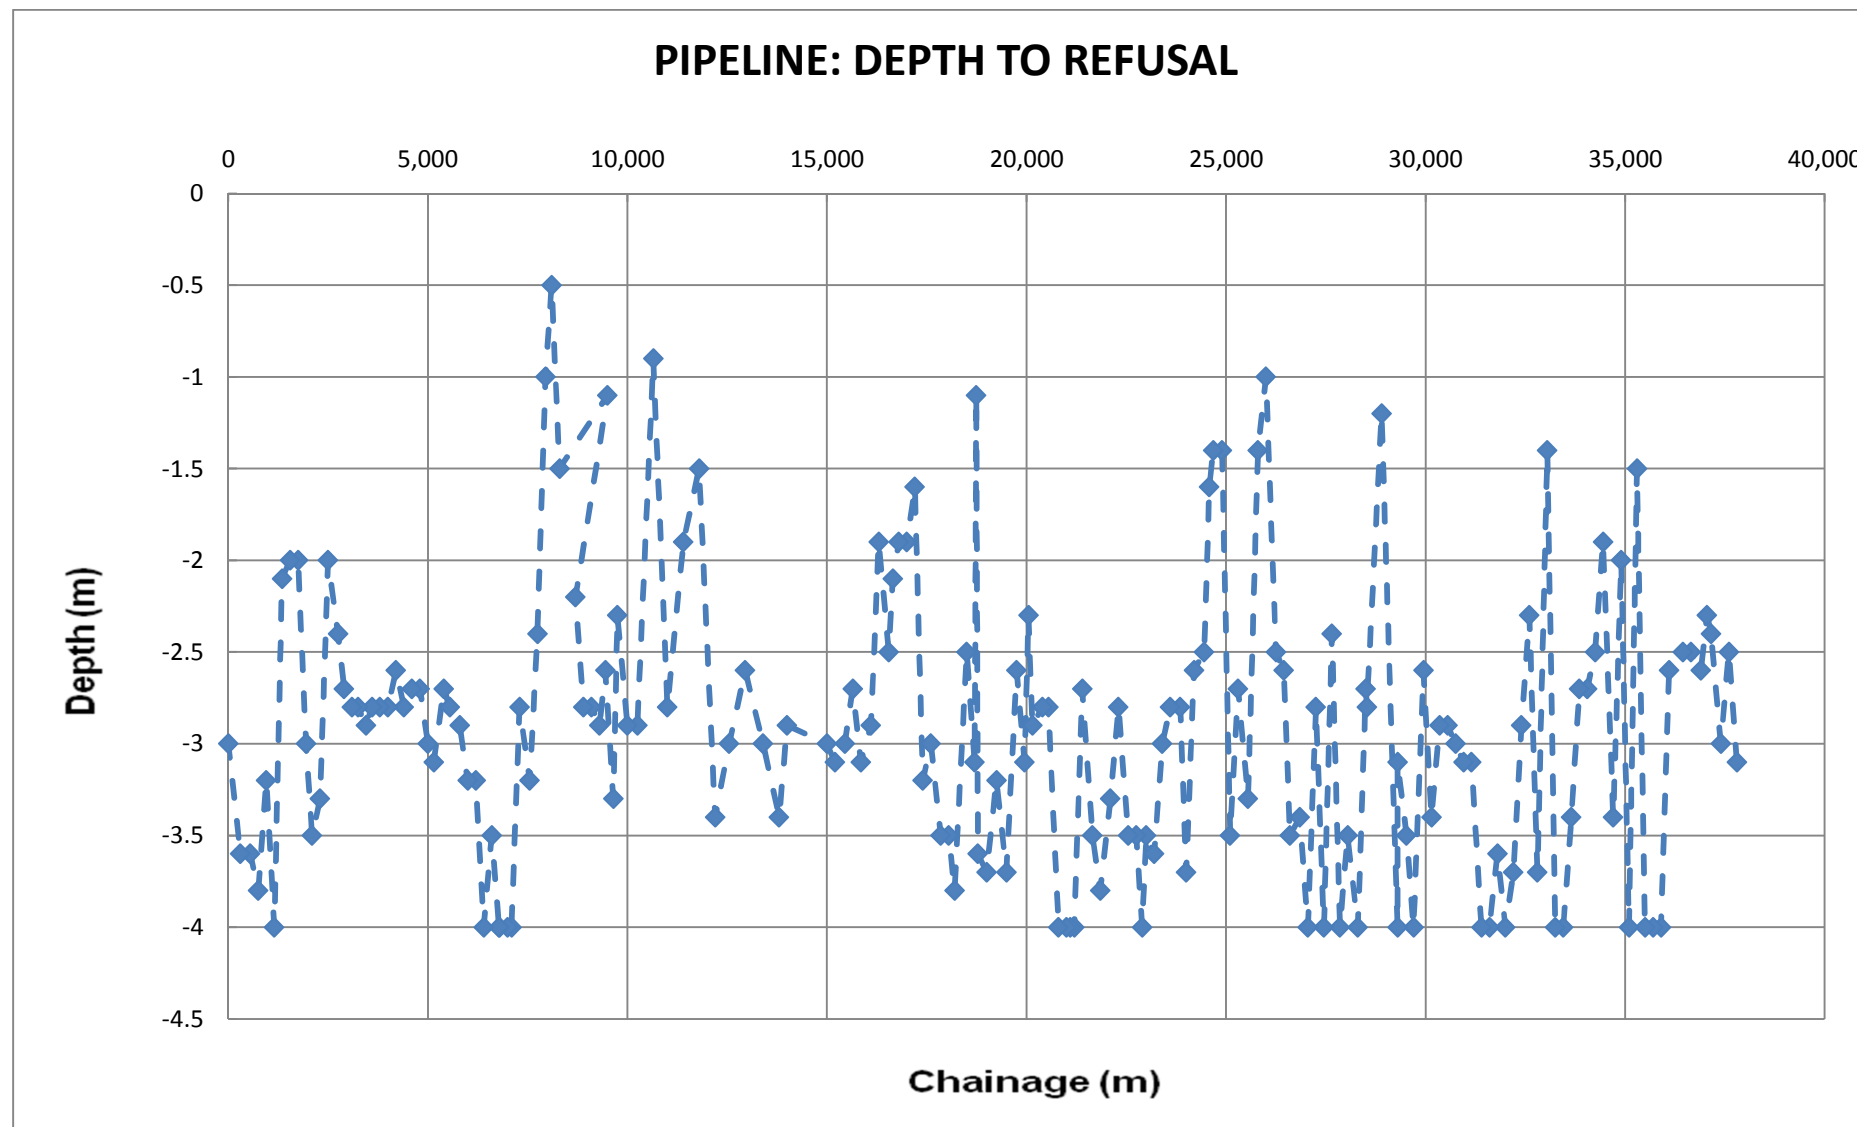
Figure 4: Summary of Refusal Depths – Steenbokpan to Matimba (Chainage 0 – 37,965 m)

A summary of the ground conditions at each test pit position along the pipeline route is given on spreadsheets in Annexure A. A graphical representation of the excavation depth for each test pit is included as Figure 4.

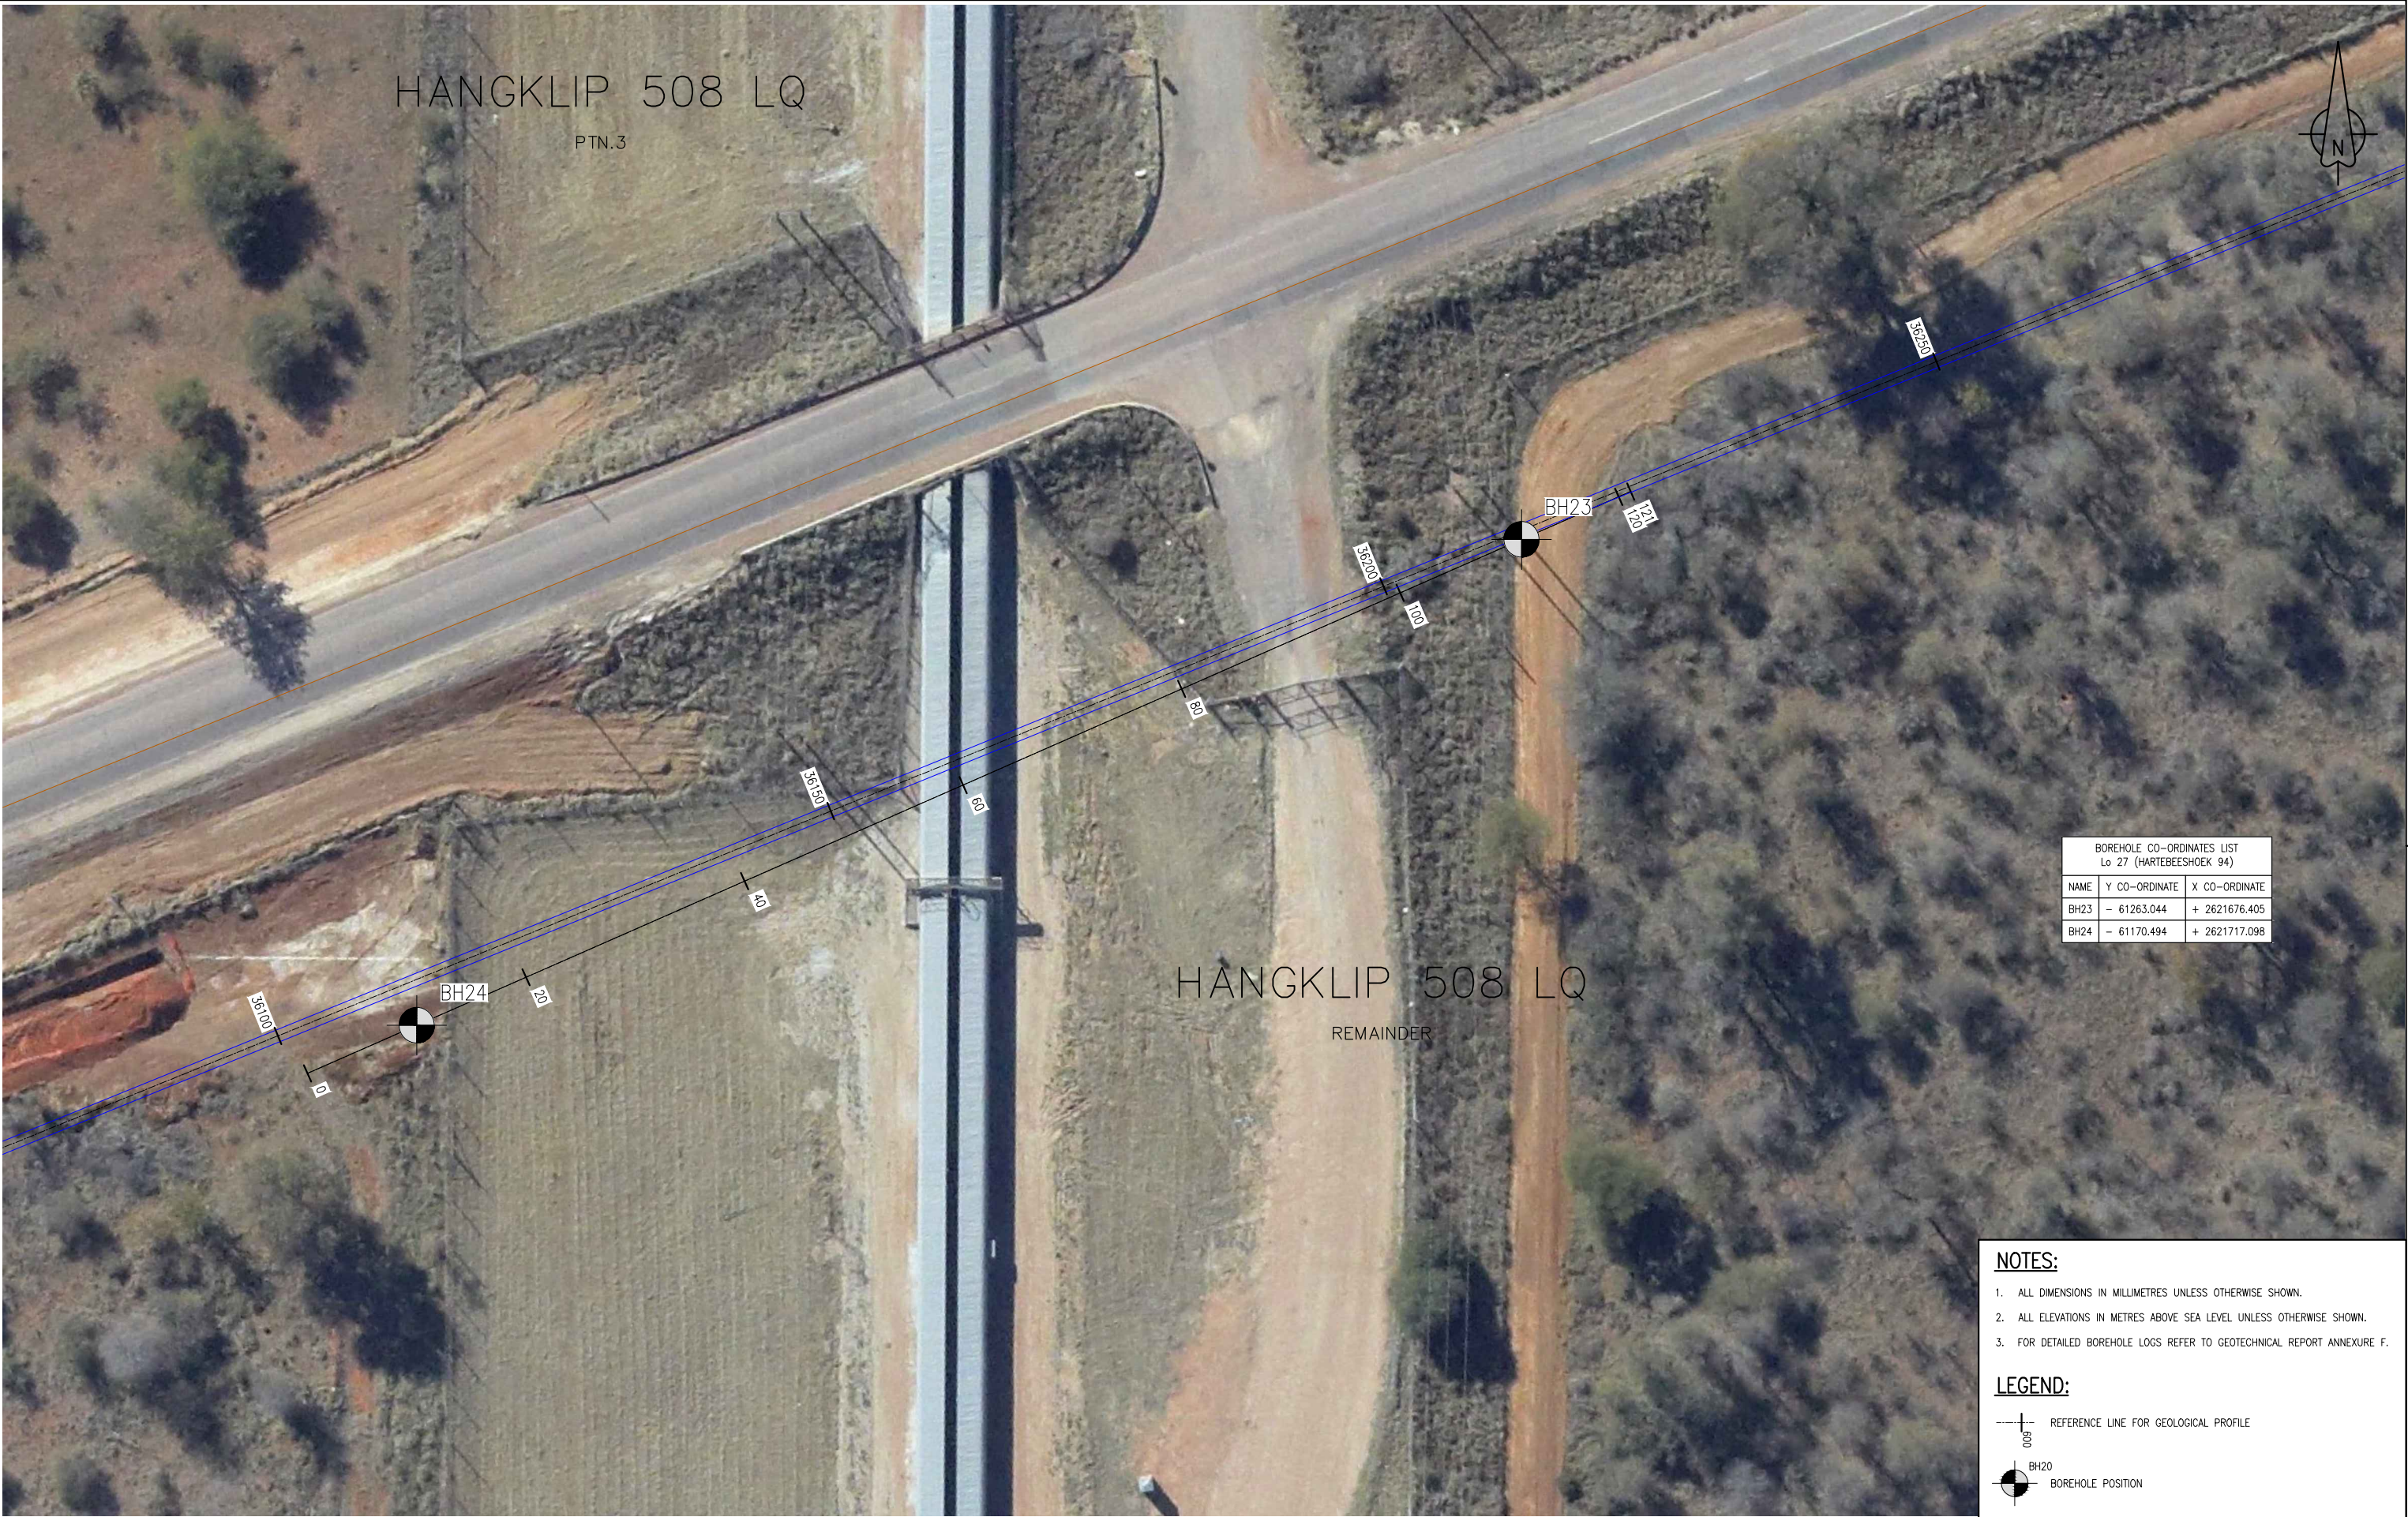
Table 8: Conveyor Crossing (farm Hangklip 508LQ): (Drawing no. 2E-G3-207): Summarised geological profile (depths in metres)

BH no.	Transported material: clayey, silty sand with calcrete or ferricrete nodules	Residual sandstone: silty sand with ferricrete nodules	Bedrock: very soft and soft rock sandstone
BH23	0 – 0.50		0.50 – 10.01+
BH24	0 – 2.15	2.15 – 3.20	3.20 – 10.01+

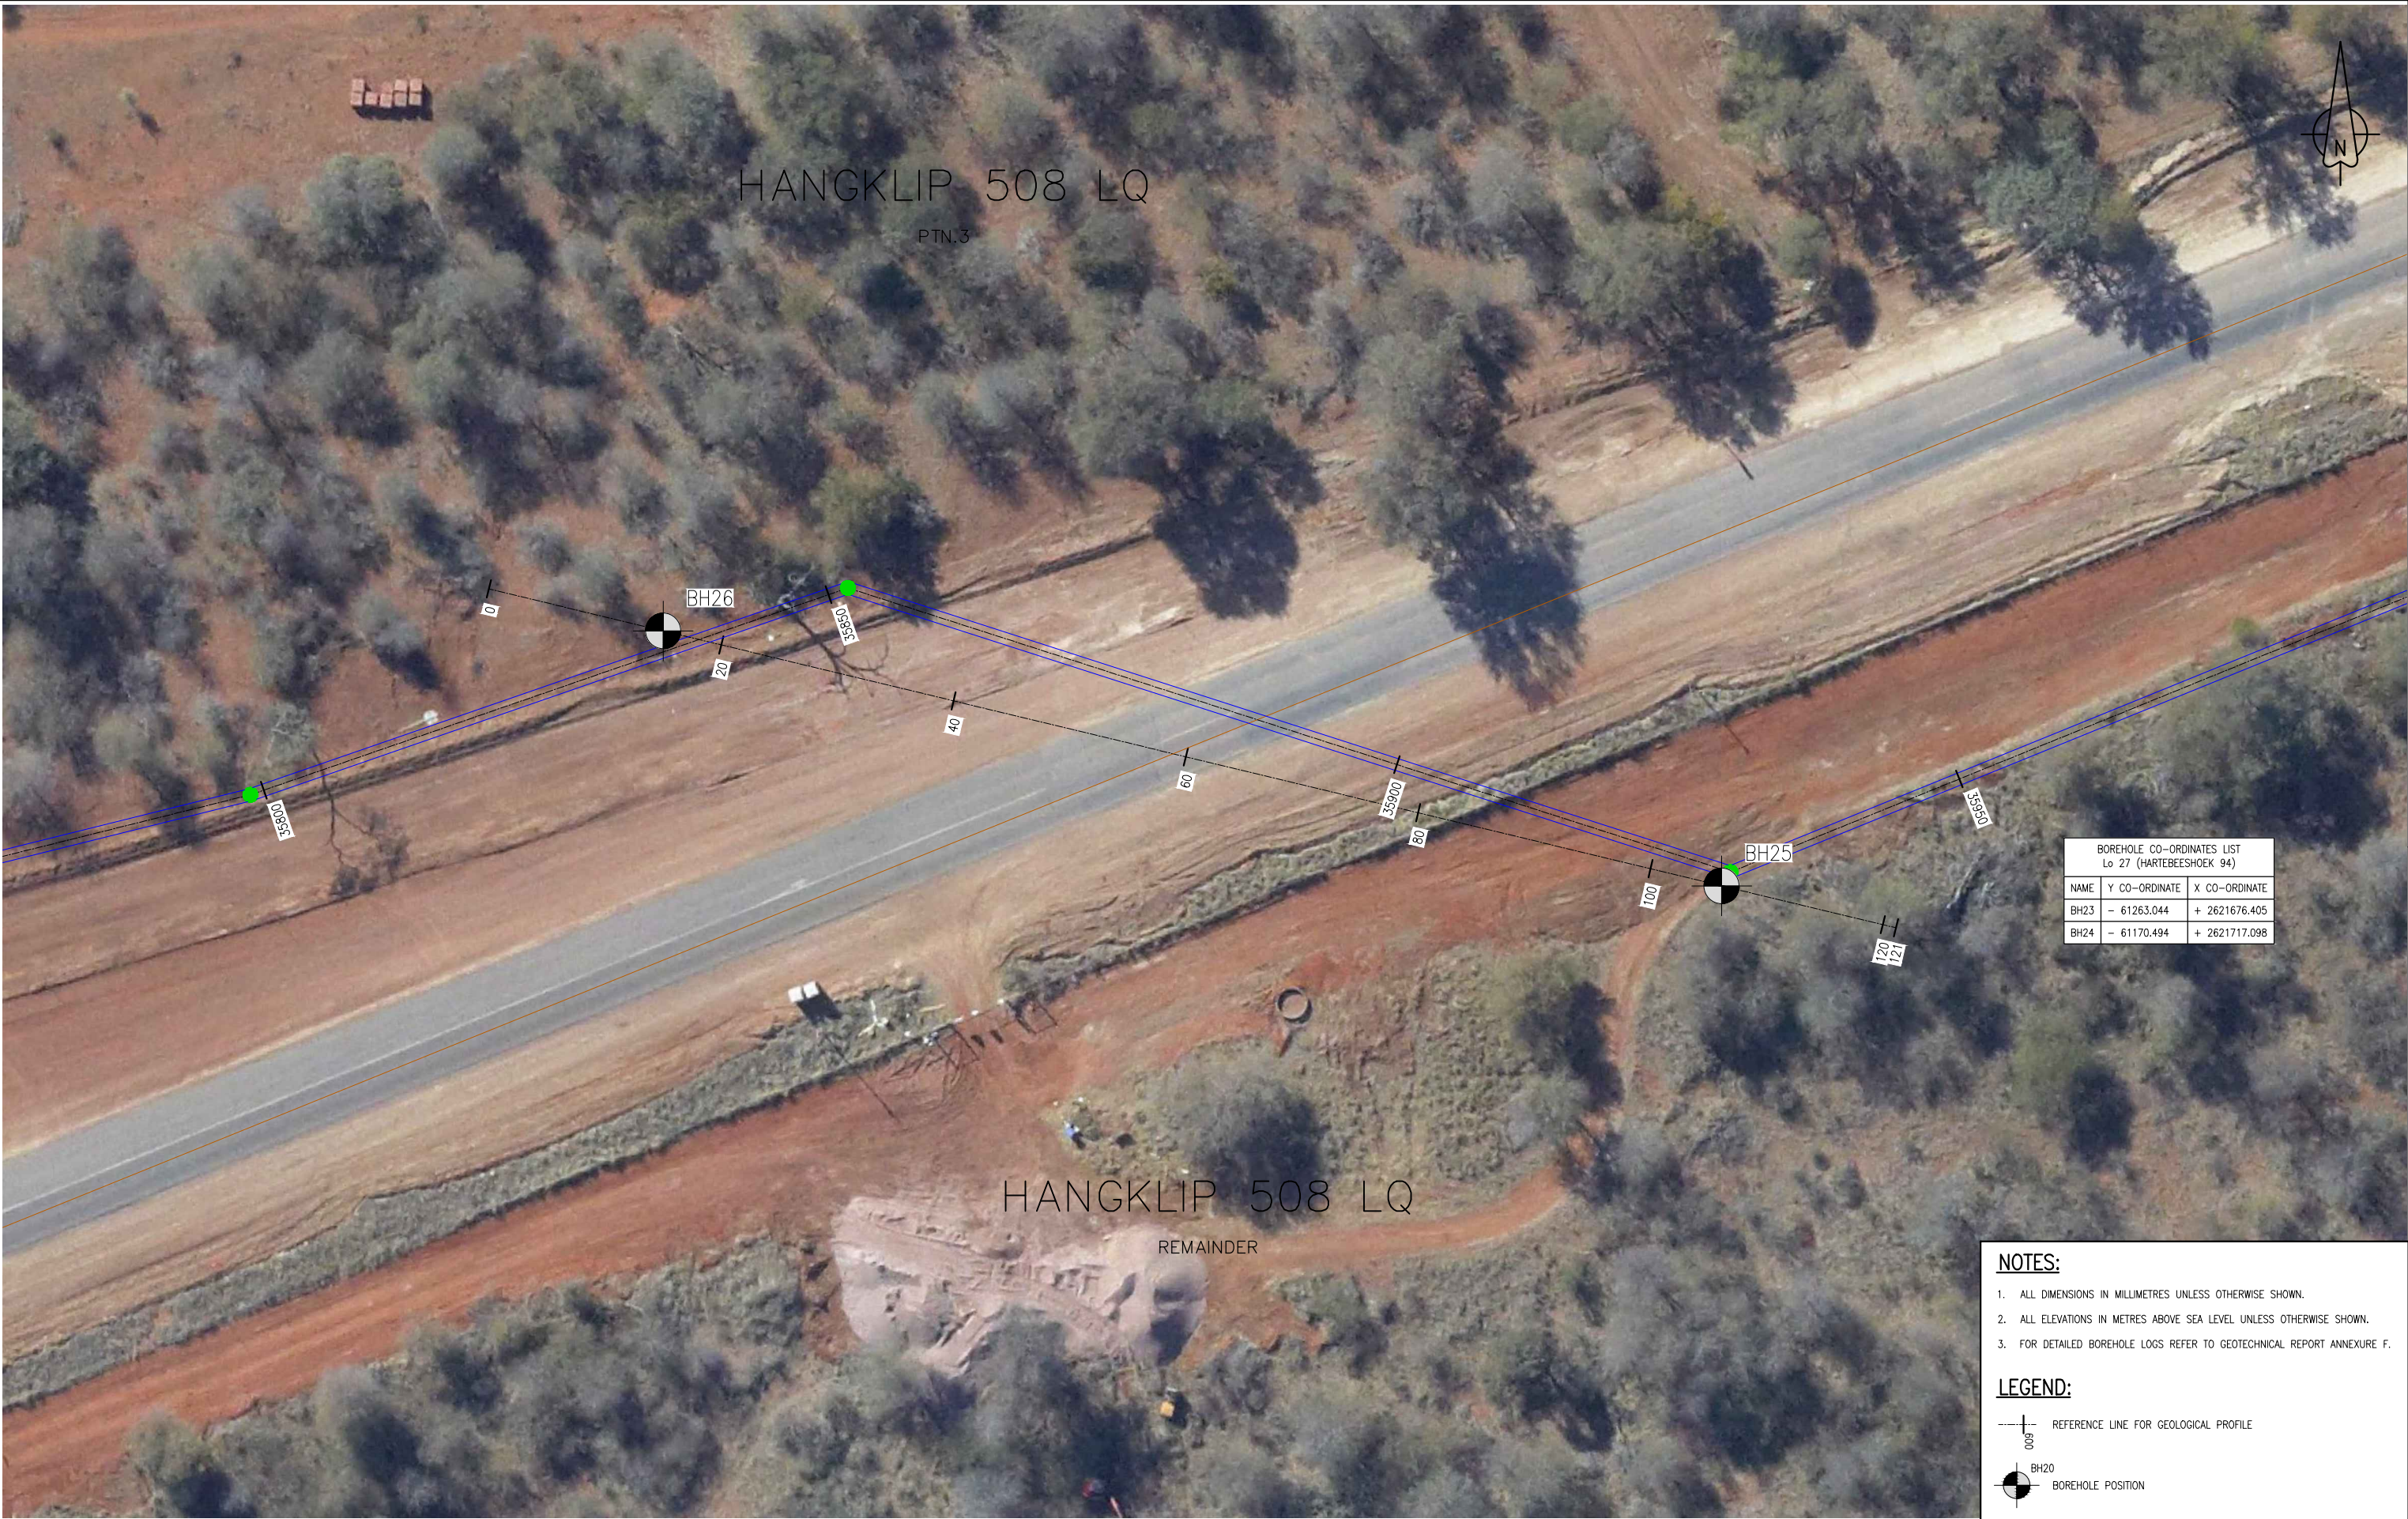
Table 9: Road Crossing (farm Hanglip 508LQ): (Drawing no. 2E-G3-208): Summarised geological profile (depths in metres)

BH no.	Transported material: clayey, silty sand with calcrete or ferricrete nodules	Bedrock: very soft and soft rock sandstone	Soft rock sandstone with hardpan calcrete (hard rock)
BH25	0 – 2.90	2.90 – 7.85	7.85 – 10.17+
BH26	0 – 3.15	3.15 – 8.30	8.30 – 10.20+

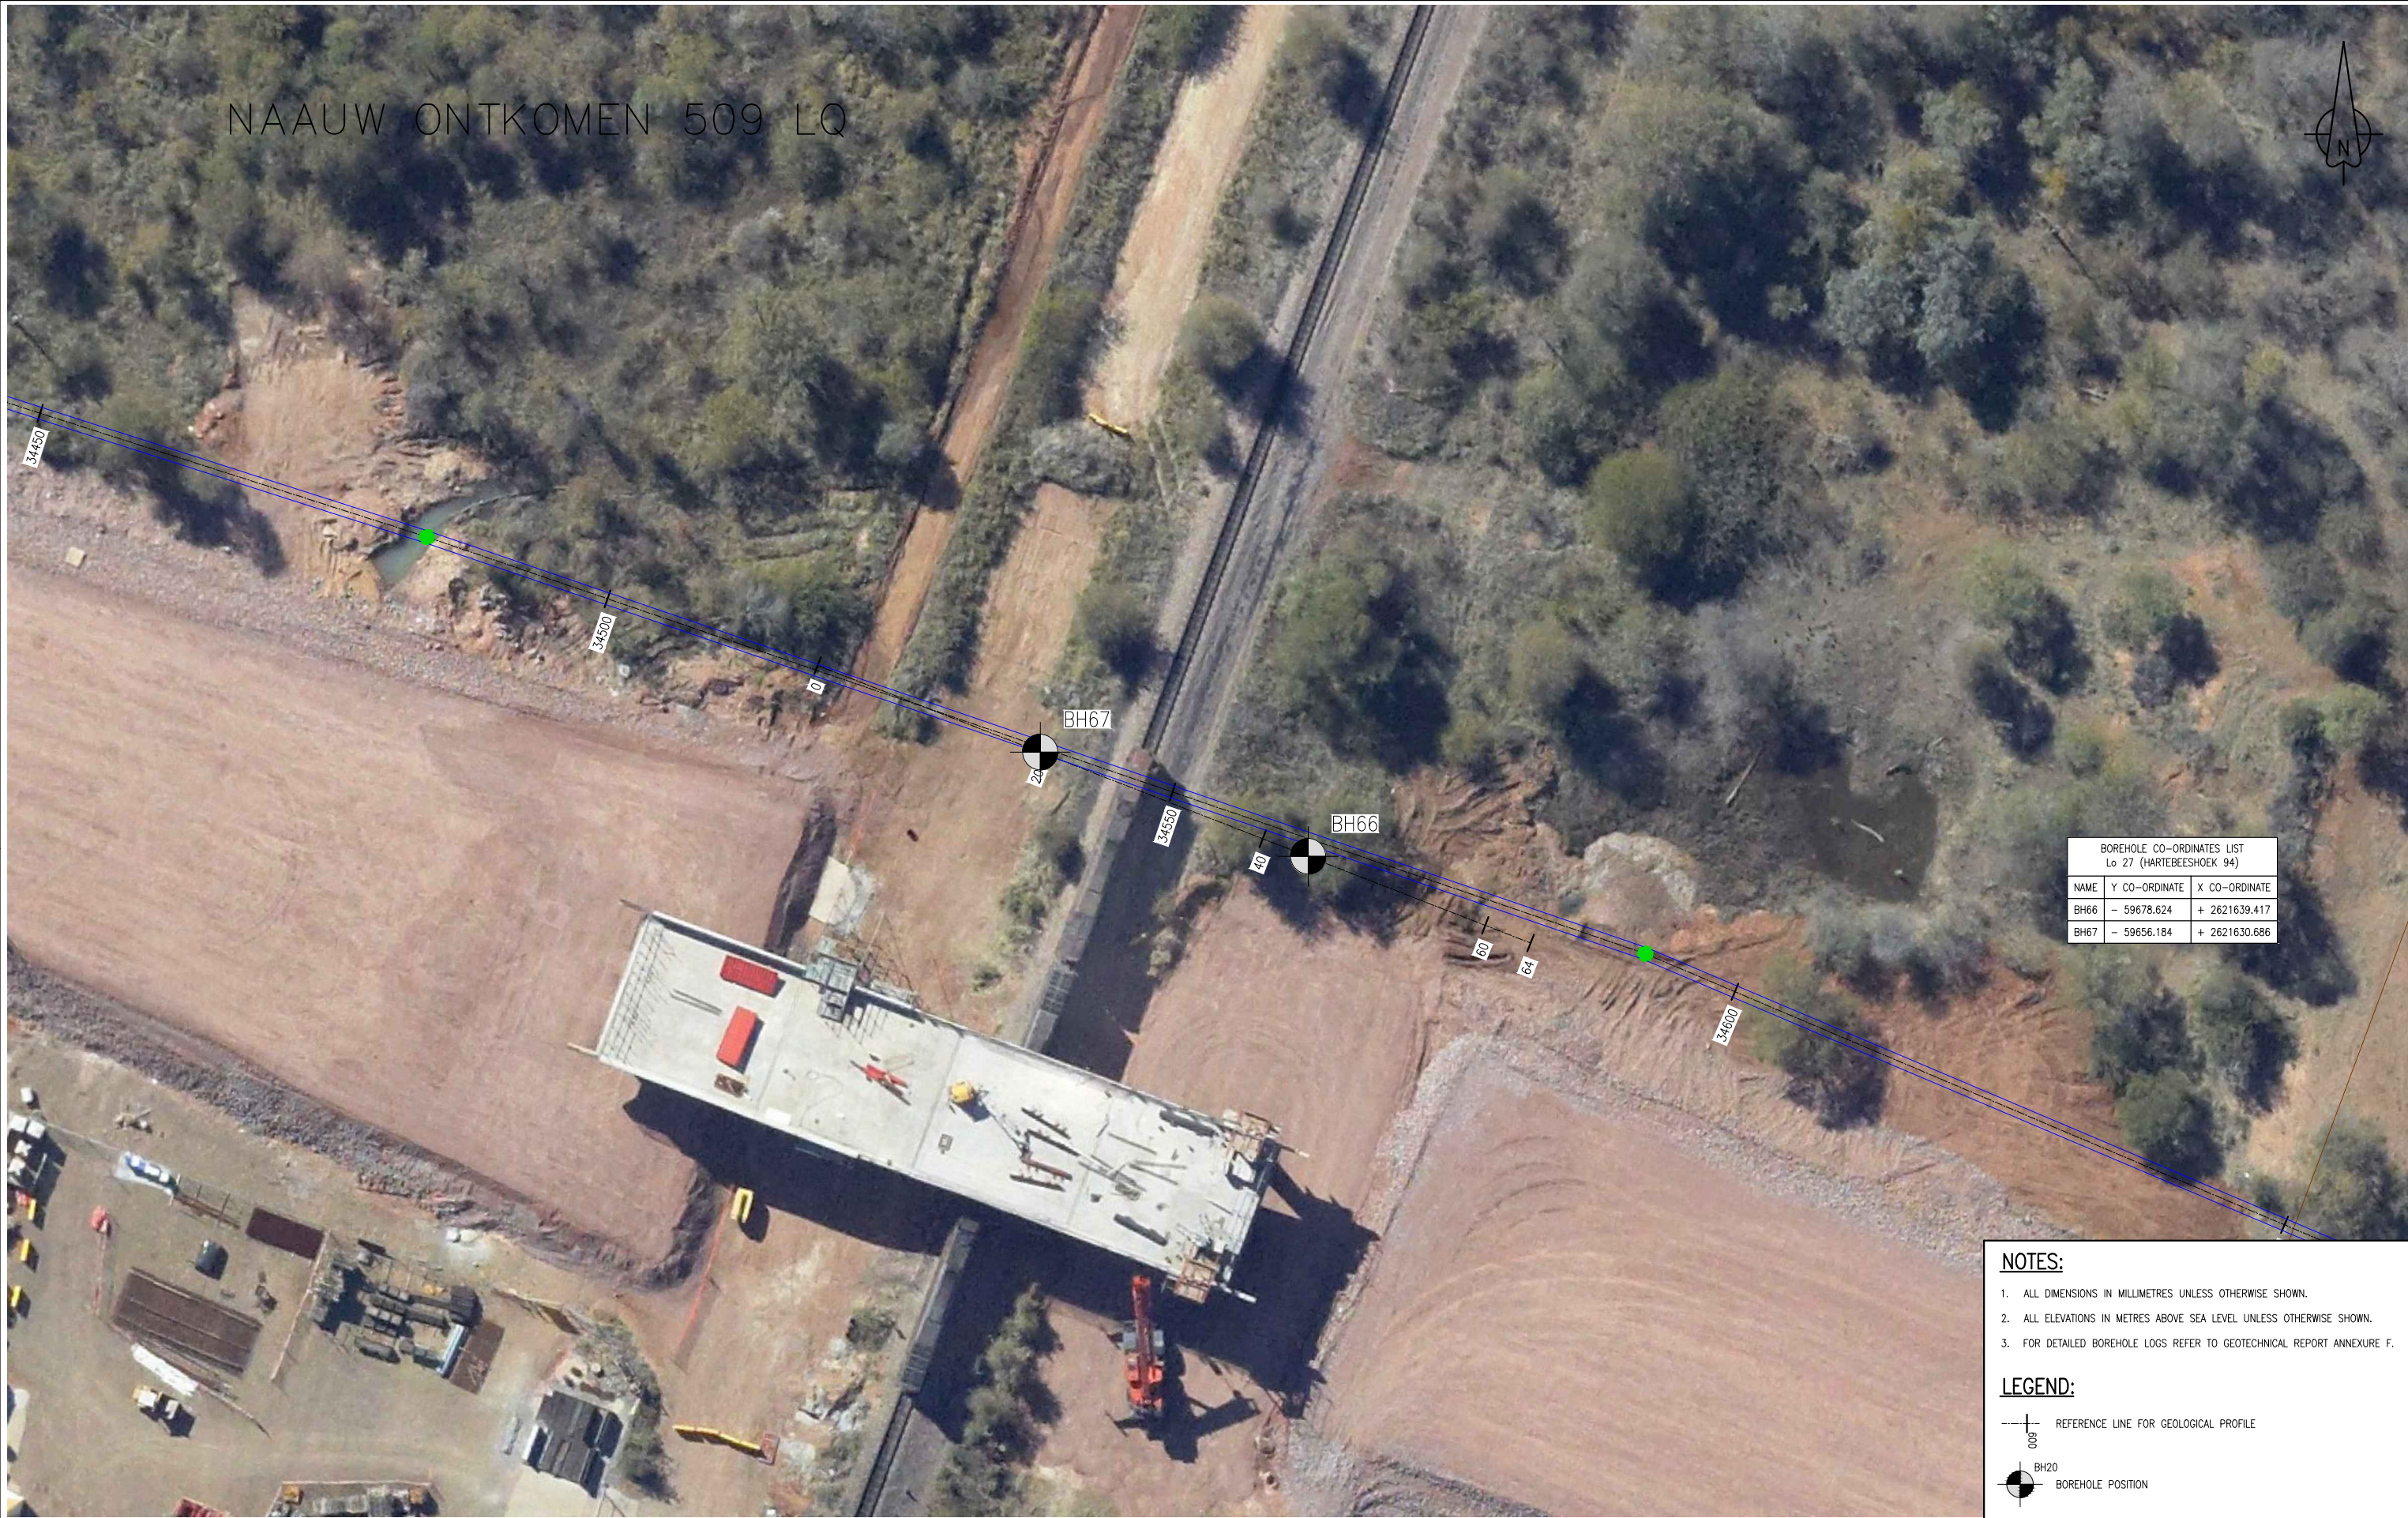
NAAUW ONTKOMEN 509 LQ

BH no.	Fill. Silty and clayey sand	Fill. Quartz gravel with silty sand matrix	Transported gravel of quartz with sandstone cobbles in clayey silty sand matrix	Soft rock sandstone, highly weathered	Medium hard to hard rock sandstone, highly to slightly weathered
BH66	0 – 0.79	0.79 – 1.95	1.95 – 4.30		4.30 – 10.42
BH67	0–1.50 2.76 –3.80	1.50- 2.76	3.80 – 7.93	7.93 – 8.08	8.08 – 10.46
