MONTHLY AIR QUALITY REPORT

MOKOLO CROCODILE WATER AUGMENTATION PROJECT PHASE 2 (MCWAP-2)
ENVIRONMENTAL BASELINE AIR QUALITY - MONTHLY MONITORING REPORT.

DOCUMENT CONTROL			
Document Title	Mokolo Crocodile Water Augmentation Project Phase 2 (MCWAP-2) Environmental Baseline Air Quality Monthly Monitoring Report.		
Report Number	MON-AQR-244-20_21 (21-04)		
Version	0.1		
Date	April 2021		
Submitted to	Umeshree Naicker GIBB	Minenhle Luthuli GIBB	Deon Esterhuizen MDT Environmental
Distribution	Gibb Bigen Nyeleti Joint Venture Environmental Assurance (Pty) Ltd.		
QUALITY CONTROL			
	Originated By	Technical Review	
Name	Damon Nell	Anton Botha	
Designation	Environmental Consultant Pr.Sci.Nat 124378	Environmental Consultant Pr.Sci.Nat 122440	
Signature

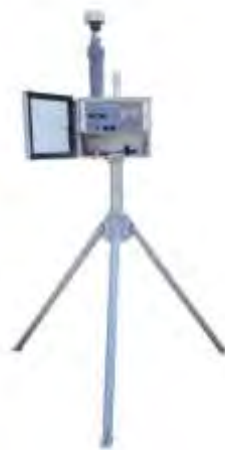
Figure 4: Met One Instruments E-Sampler-9800

After the sample air stream has been measured by the E-Sampler and exits the optical engine, it passes through the built-in 47 mm filter sampler system. This system allows the particulate to optionally be collected on a filter disc as a second method to obtain airborne particulate mass data, or for laboratory analysis of the particulate. The 47 mm filter system can also be used to determine a gravimetric K-factor (slope multiplier) to correct the E-Sampler real-time signal to match the local particulate type. In this case, a filter disc is weighed on a microbalance before and after being run in the E-Sampler for a period of time. The resulting mass of the dust on the filter is correlated with the concentrations that the E-Sampler recorded over the same time period, and a correction factor is calculated. The E-Sampler can be used with no correction factor in applications where relative particulate trending is appropriate.

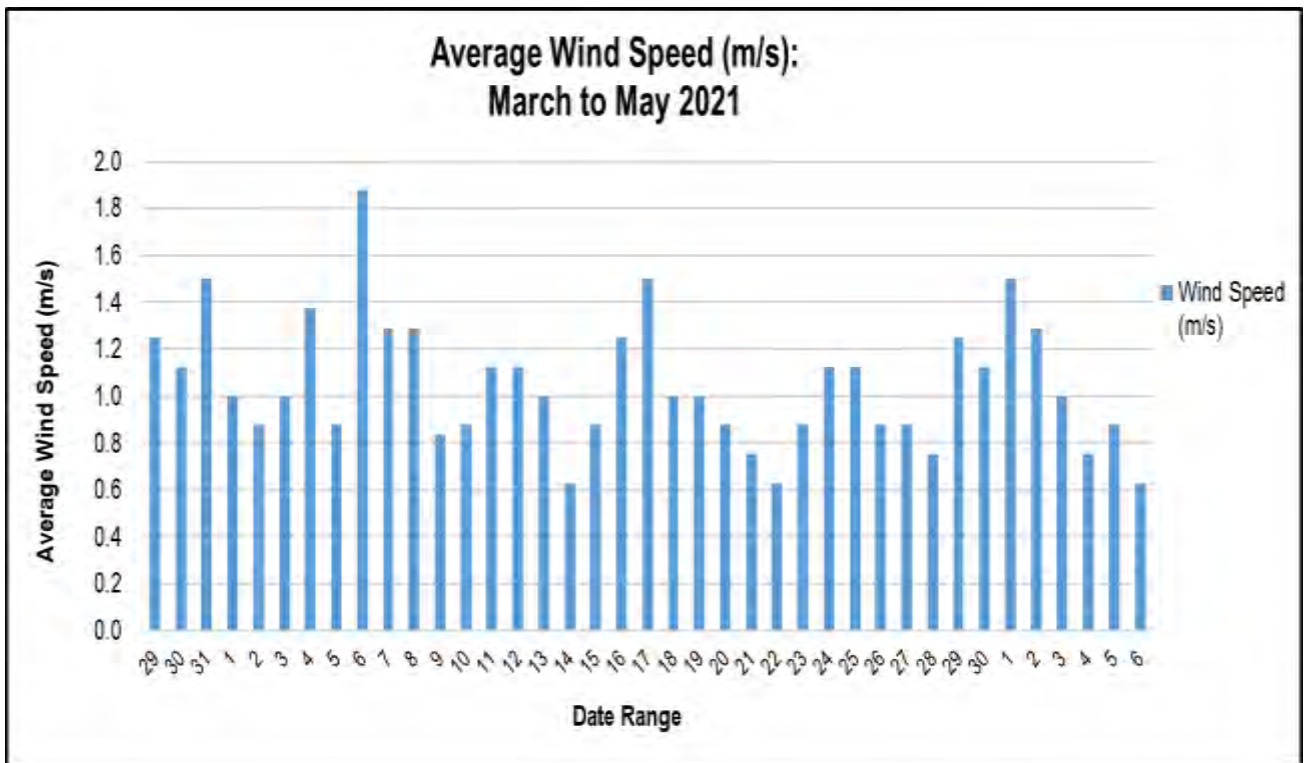
Figure 5: Wind Direction Frequency Average

The following graphs provides an insight into the wind conditions versus the areas which would be affected during the current monitoring period. From Table 7 & 8 and Figure 7 & 8, it is clear that from the average dominating wind direction data that the dominant wind is from a northern direction and to a lesser extent from an north-northeast, east-northeast and southwest directions. Moreover, average wind speeds presented a light air to light breeze (0.6 – 1.9 m/s) during the monitoring period.

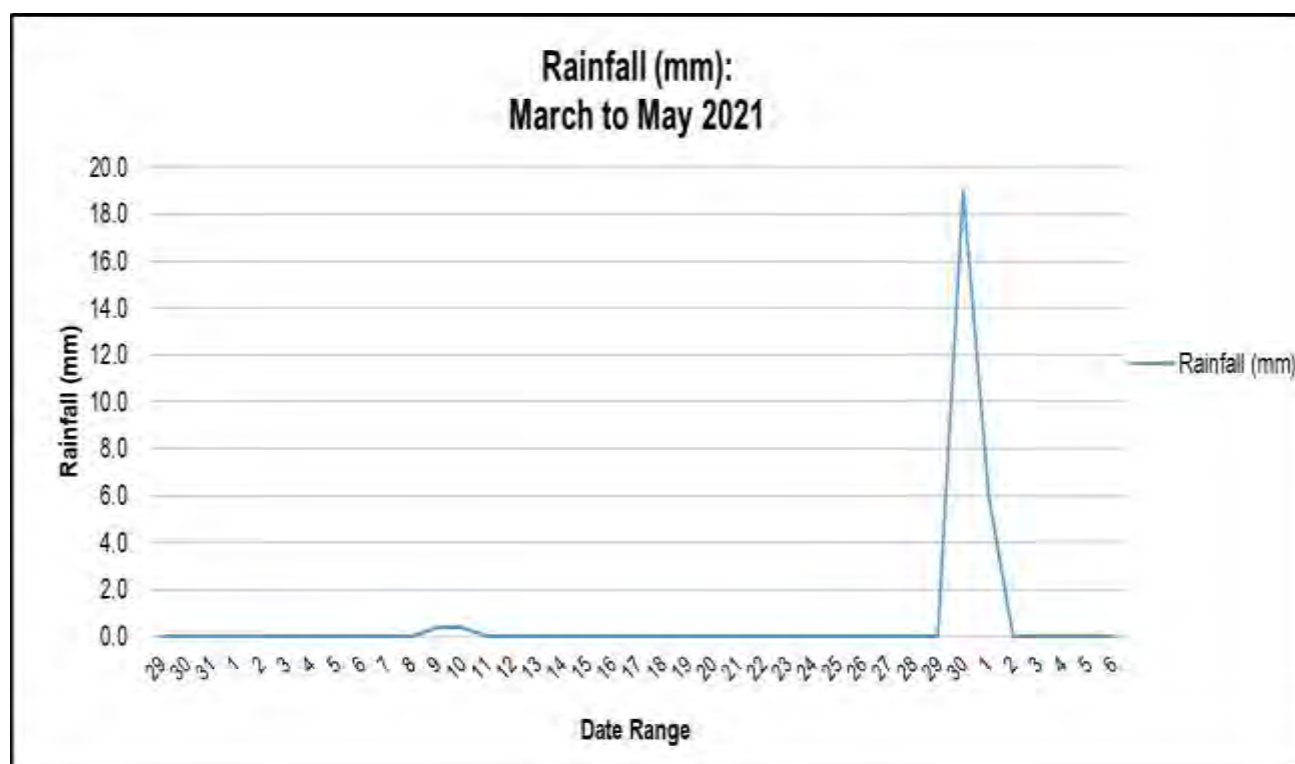
Figure 7: Rainfall for monitoring period

Rainfall Summary: March to May 2021	
Day of Month	Rainfall (mm)
9	0.4
10	0.4
30	19.0
1	6.0
Total	25.8

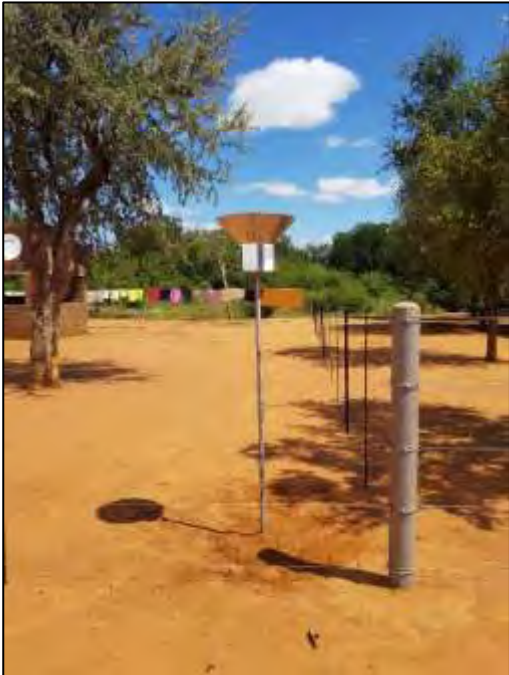
- Sample localities DB86, DB88, and DB99 recorded exceedances in the residential limit of 600 mg/m²/day with values of 886 mg/m²/day, 969 mg/m²/day and 1085 mg/m²/day respectfully. These localities are also situated along the D769 dirt road, further iterating the same conclusion for higher level present in comparison to DB87. The residential exceedance recorded at sample locality DB88 is of most concern as the locality is situated at a small housing community;

<p>Location: 24°34'14.79"S, 27°18'36.10"E</p> <p>Farm: Stratford 462 KO</p> <p>Description: Situated between the houses of the small community</p>

March 2021	Date Installed: 29 th March 2021
April 2021	<p>Date Sampled: 4th May 2021</p> <p>Sample Status: Sampled</p> <p>Air Quality Class: Exceeded Residential Limit</p>
