MONTHLY AIR QUALITY REPORT

MOKOLO CROCODILE WATER AUGMENTATION PROJECT PHASE 2 (MCWAP-2)
ENVIRONMENTAL BASELINE AIR QUALITY - MONTHLY MONITORING REPORT.

Document No:	MON-AQR-244-20_21 (21-05)	GIBB Bigen Nyeleti Joint Venture (GBN-JV)	Client Restricted
Revision:	0.1		Author: D. Nell
Date:	May 2021		i

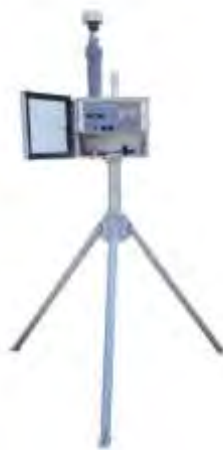
Figure 4: Met One Instruments E-Sampler-9800

After the sample air stream has been measured by the E-Sampler and exits the optical engine, it passes through the built-in 47 mm filter sampler system. This system allows the particulate to optionally be collected on a filter disc as a second method to obtain airborne particulate mass data, or for laboratory analysis of the particulate. The 47 mm filter system can also be used to determine a gravimetric K-factor (slope multiplier) to correct the E-Sampler real-time signal to match the local particulate type. In this case, a filter disc is weighed on a microbalance before and after being run in the E-Sampler for a period of time. The resulting mass of the dust on the filter is correlated with the concentrations that the E-Sampler recorded over the same time period, and a correction factor is calculated. The E-Sampler can be used with no correction factor in applications where relative particulate trending is appropriate.
