# MONTHLY AIR QUALITY REPORT

MOKOLO CROCODILE WATER AUGMENTATION PROJECT PHASE 2 (MCWAP-2)  
ENVIRONMENTAL BASELINE AIR QUALITY - MONTHLY MONITORING REPORT.

DOCUMENT CONTROL			
Document Title	Mokolo Crocodile Water Augmentation Project Phase 2 (MCWAP-2) Environmental Baseline Air Quality Monthly Monitoring Report.		
Report Number	MON-AQR-244-20_21 (21-06)		
Version	0.1		
Date	June to July 2021		
Submitted to	Umeshree Naicker GIBB	Minenhle Luthuli GIBB	Deon Esterhuizen MDT Environmental
Distribution	Gibb Bigen Nyeleti Joint Venture Environmental Assurance (Pty) Ltd.		
QUALITY CONTROL			
	Originated By	Technical Review	
Name	Damon Nell	Anton Botha	
Designation	Environmental Consultant Pr.Sci.Nat 124378	Environmental Consultant Pr.Sci.Nat 122440	
Signature

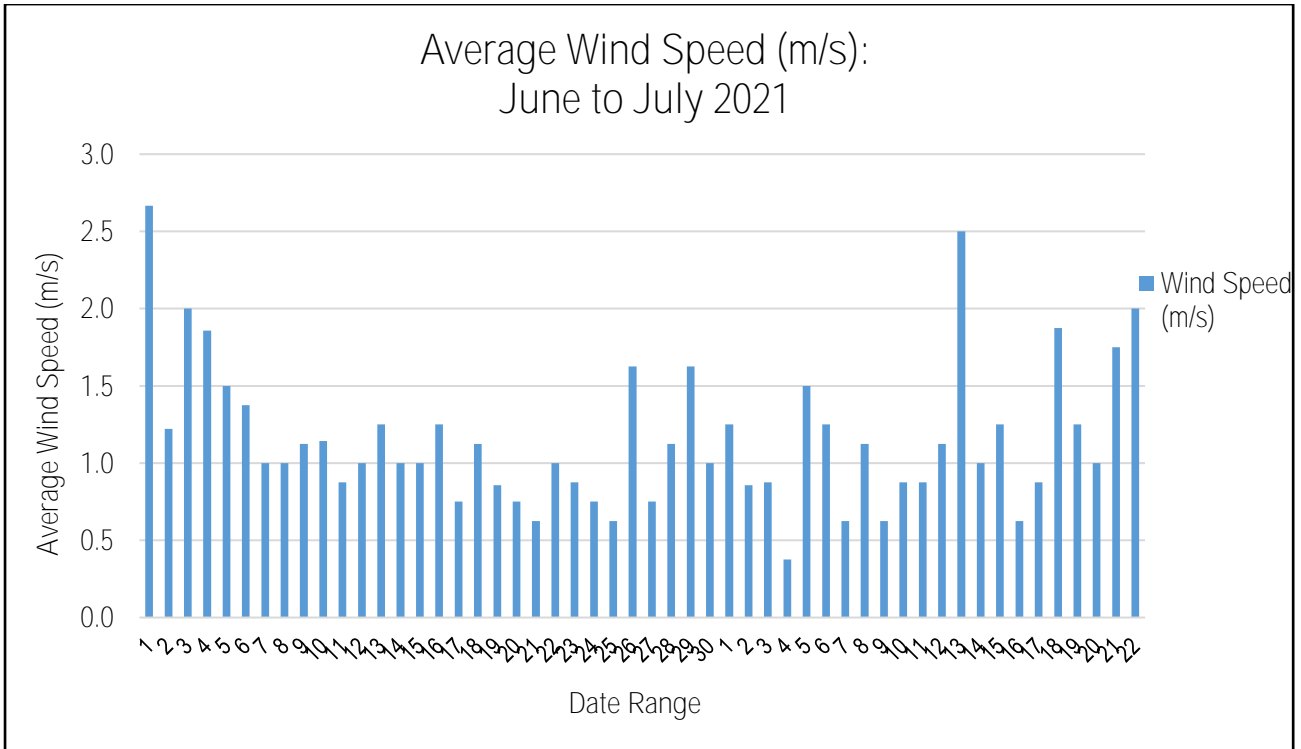
Figure 5: Wind Direction Frequency Average

The following graphs provides an insight into the wind conditions versus the areas which would be affected during the current monitoring period. From Table 8 & 9 and Figure 6 & 7, it is clear that from the average dominating wind direction was from a West-Southwest and to a lesser extent from the north. Moreover, average wind speeds presented a light air to light breeze (0.4 – 2.7 m/s) during the monitoring period.

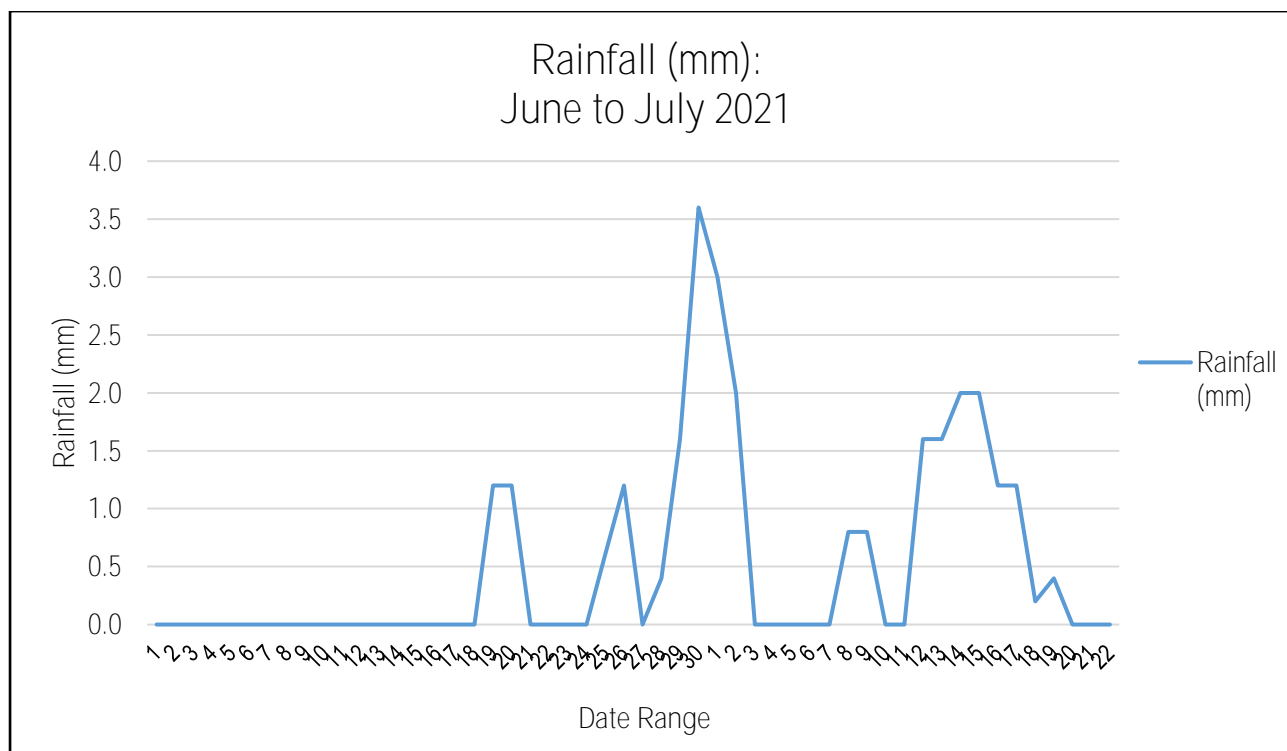
Figure 7: Rainfall for monitoring period

Rainfall Summary: May to June 2021	
Day of Month	Rainfall (mm)
19-June-21	1.2
20-June-21	1.2
25-June-21	0.6
26-June-21	1.2
28-June-21	0.4
29-June-21	1.6
30-June-21	3.6
1-July-21	3.0
2-July-21	2.0
8-July-21	0.8
9-July-21	0.8
12-July-21	1.6
13-July-21	1.6
14-July-21	2.0
15-July-21	2.0
16-July-21	1.2
17-July-21	1.2
18-July-21	0.2
19-July-21	0.4
Total	26.6
