PAULPUTS SUBSTATION
NEAR ONSEEPKANS IN THE
NORTHERN CAPE

GEOTECHNICAL REPORT

**GEOTECHNICAL INVESTIGATION FOR THE PROPOSED
NEW PAUL PUTS SUBSTATION**

REPORT NO : GR-20/99

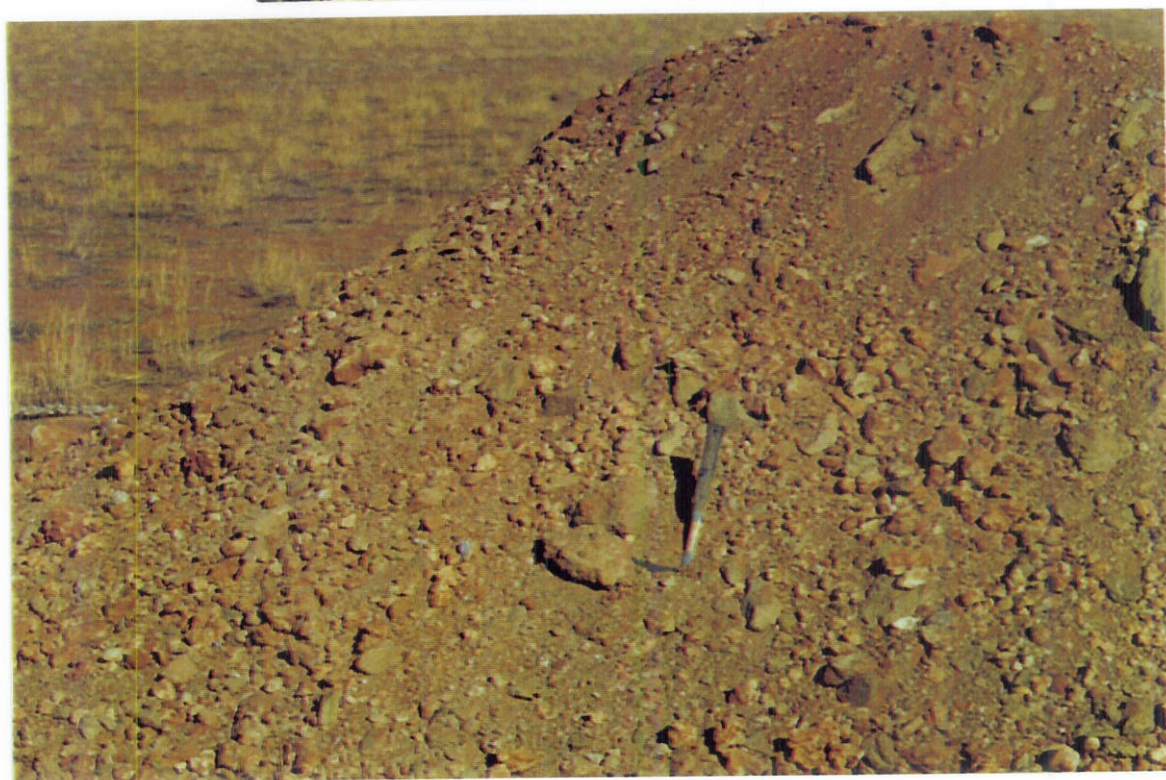
View of Material from Excavation

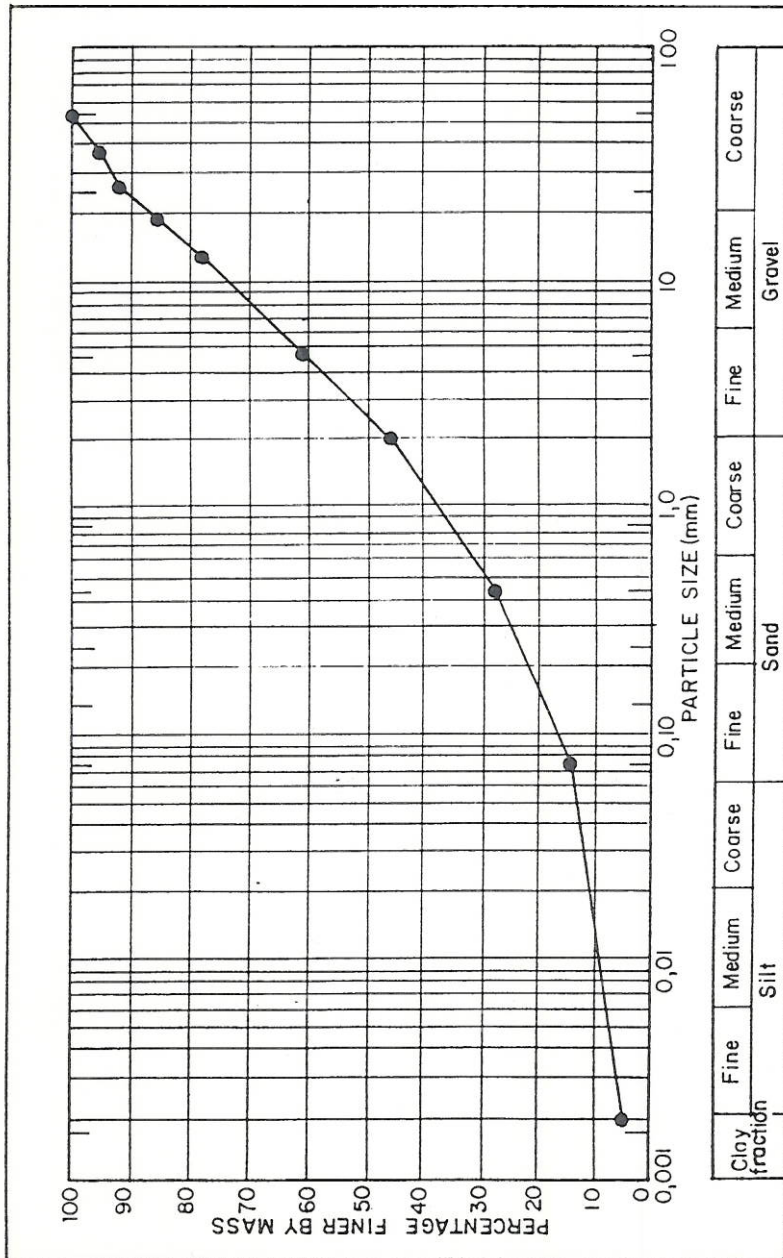
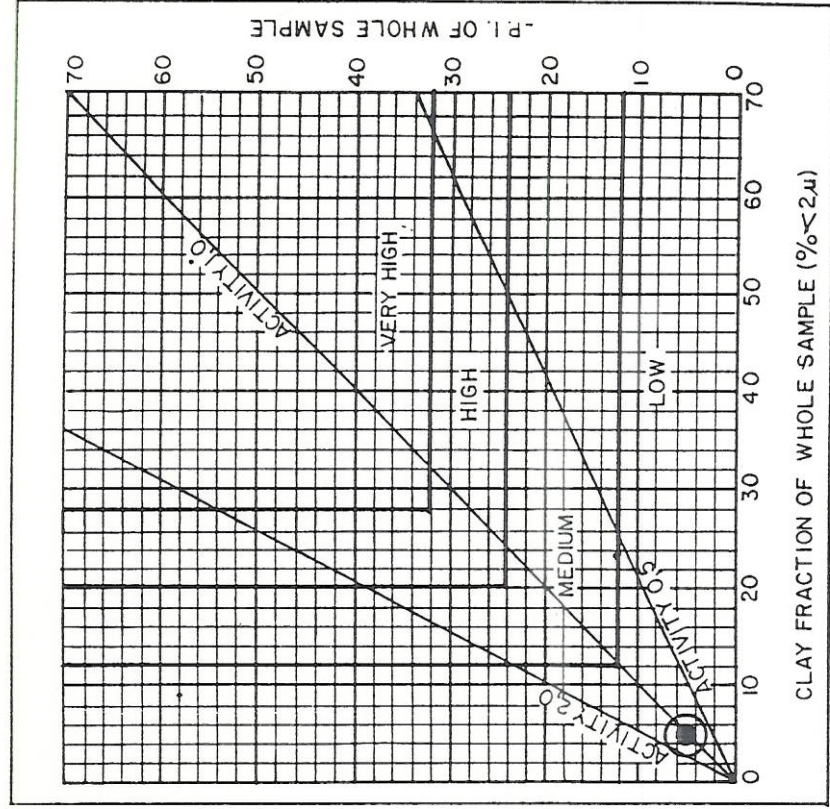
POTENTIAL EXPANSIVENESS TEST

CLIENT BVI RAADGEWENDE INGENIEURS	PROJECT PAUL PUTS KRAGSTASIE	YOUR REF MNR DE KOCK	OUR REF SL 1560	DATE 1999.10.27
SAMPLE No. K21-652	TEST HOLE No. TP 10	DEPTH 0,9-1,5m	DESCRIPTION LIGBRUIN, EFFE NODULÈRE, KALKREETGRUITS

ATTERBERG LIMITS		CLAY FRACTION (%)	
Liquid Limit	45	Soil Fines	18
Plastic Limit	28	Whole Sample	5
Plasticity Index	17		
Linear Shrinkage	7,5

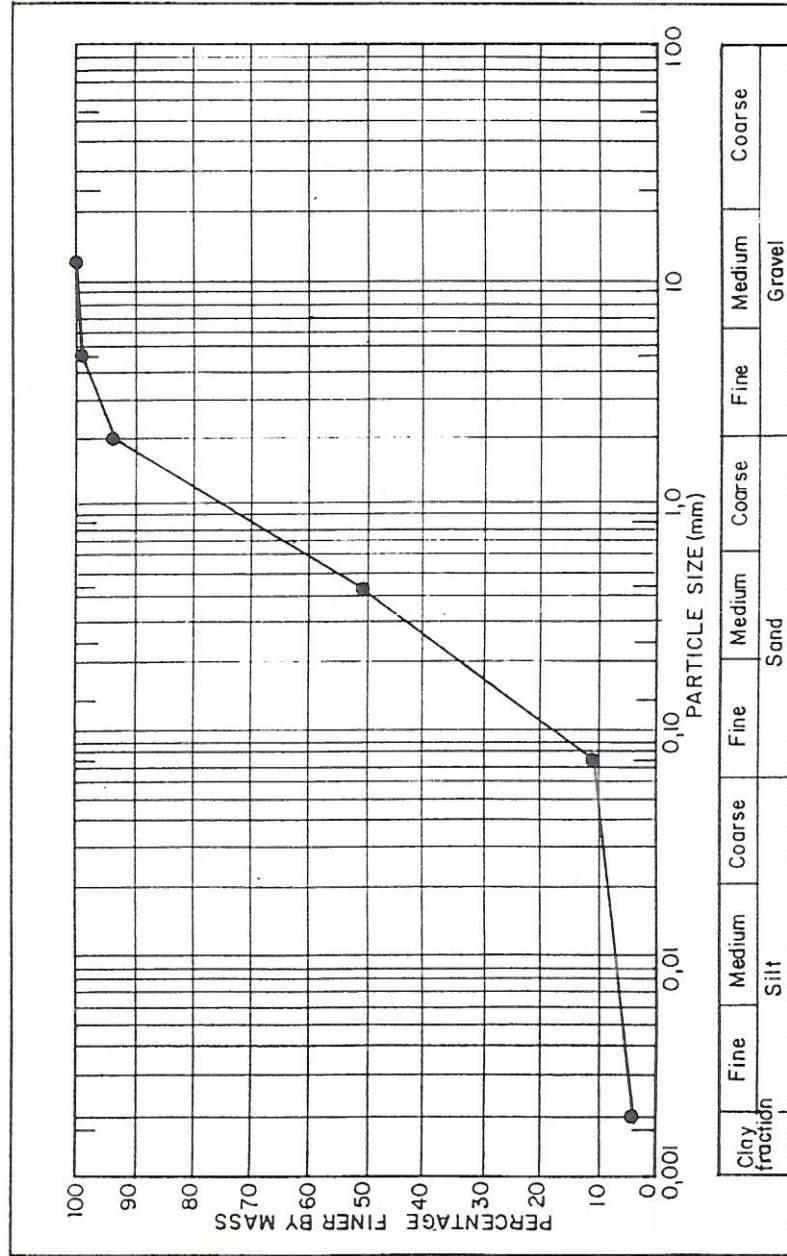
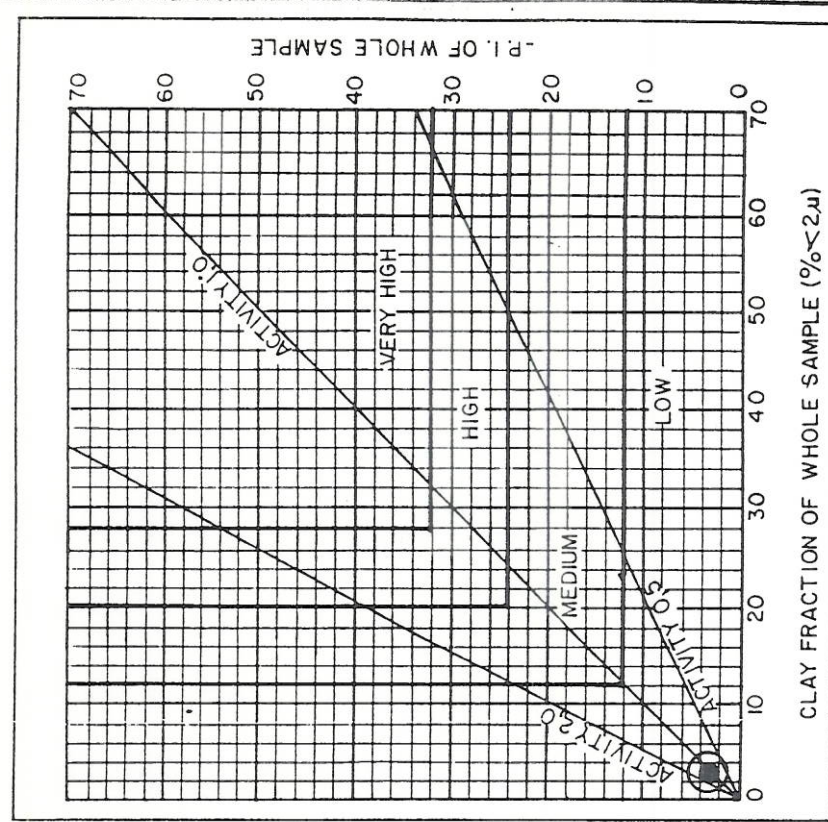
POTENTIAL EXPANSIVENESS TEST

CLIENT BVI RAADGEWENDE INGENIEURS	PROJECT PAUL PUTS SUBSTASIE	YOUR REF MNR DE KOCK	OUR REF SL 1560	DATE 1999.10.27
SAMPLE No. K21-650	TEST HOLE No. TP 4	DEPTH 0,15-1,5m	DESCRIPTION LIGBRUIN, FYN, VERWEERDE, GRANIETIESE GRUIS MET VERSPREIDE HOEKIGE, KWARTSIETKLIPPIES

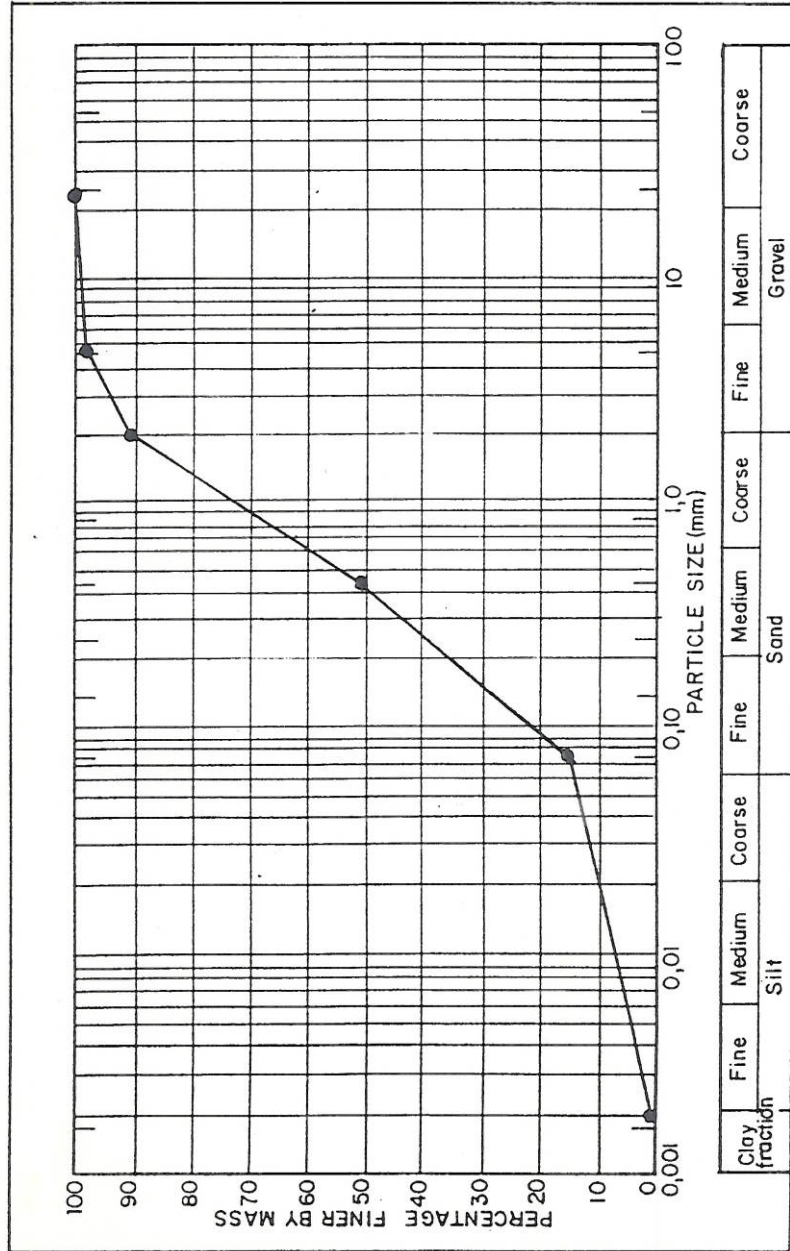
POTENTIAL EXPANSIVENESS TEST

CLIENT	BVI RAADGEWENDE INGENIEURS	PROJECT	PAUL PUTS SUBSTASIE	YOUR REF	MNR DE KOCK	OUR REF	SL 1560	DATE	1999.11.12
SAMPLE No.	K21-730	TEST HOLE No.	TP 12	DEPTH	0,1 - 0,9m	DESCRIPTION	LIGBRUIN TOT LIG-ROOIBRUIN, FYN, VERWEERDE GRANIET EN KWARTSJETGRUIS

ATTERBERG LIMITS		CLAY FRACTION (%)	
Liquid Limit	17	Soil Fines	2
Plastic Limit	14	Whole Sample	1
Plasticity Index	3		
Linear Shrinkage	1,4
