Geotechnical Memo

To:	Bongi Mabaso Mnyandu	Date:	05/12/2025
Company:	Coega Development Corporation (Pty) Ltd	From:	Lyzander Parfitt
Copy to:	Gugulethu Moyo, Lwando Zeka, Visa Barnes, Adah Daniel	Project #:	609782
Subject:	Mpozolo Clinic - Fieldwork and Desktop Study Geotechnical Memo

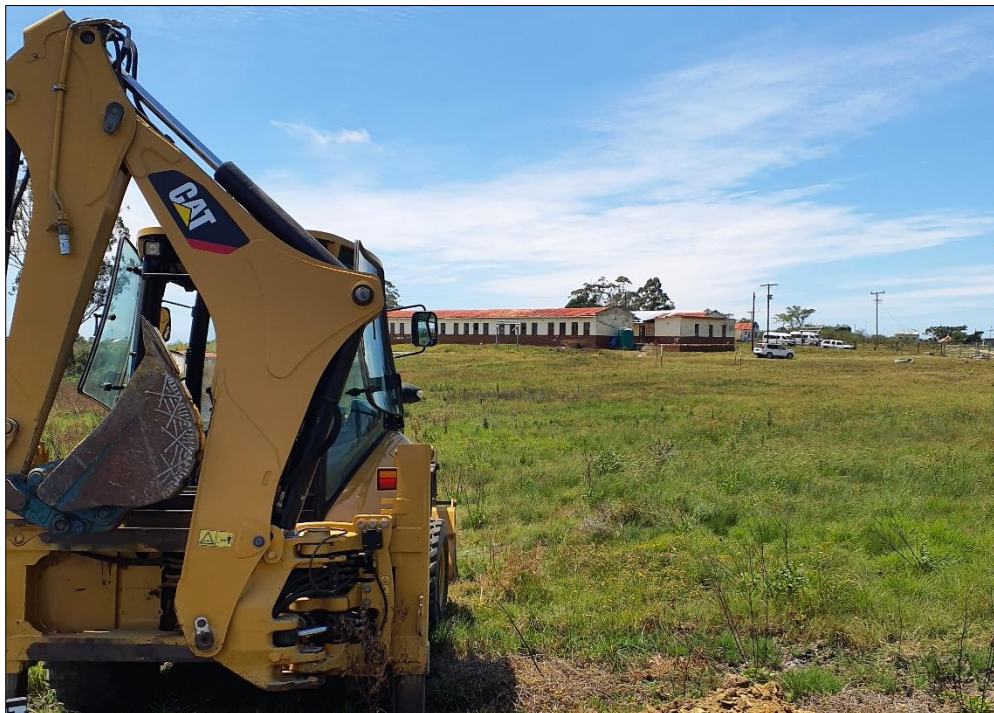
Figure 3-2: Site conditions, looking east from TP02

The site is located to the west of Mpozolo Primary School, within the fenced school property. The area within the confirmed site boundary is grass covered. The site was previously used as a sports field with football goal posts located on the eastern and western sides, respectively, but it is currently overgrown, Figure 3-2. The topography is generally flat and begins to slope gently to the northeast from the centre of the site at an approximate gradient of 1v 19h or 3°.

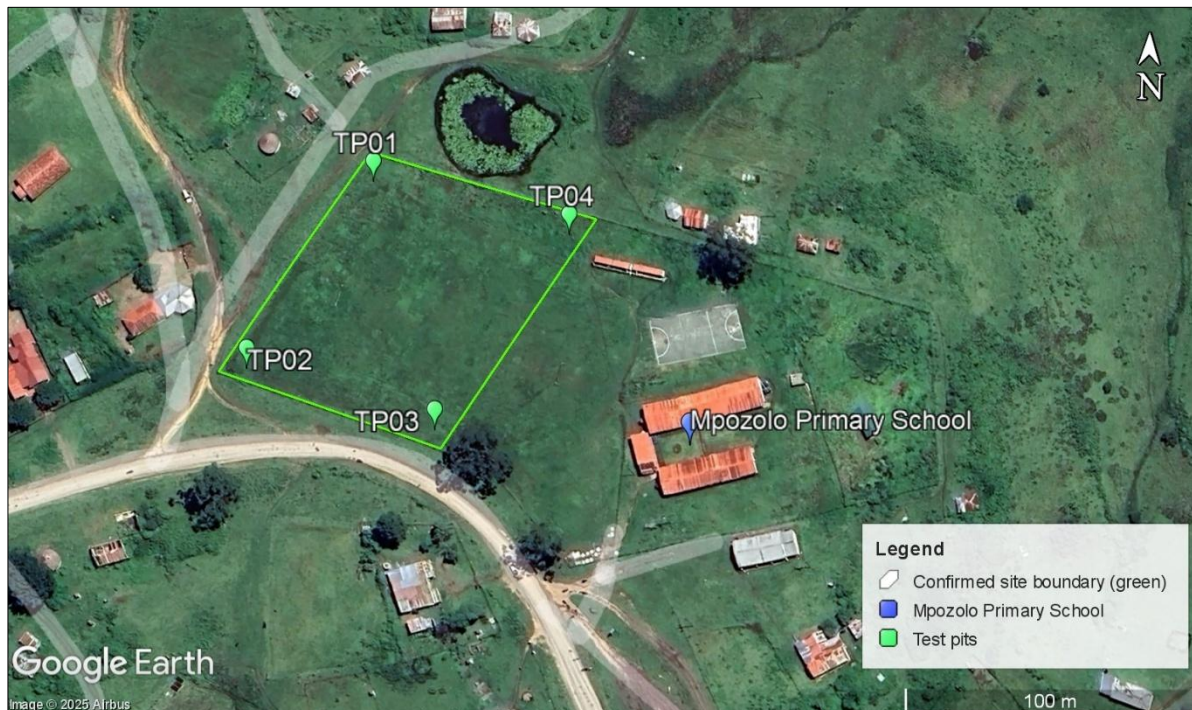
Figure 4-1: TP layout

The TP refusal depths are summarised in Table 4-1 with the layout of the positions shown in Figure 4-1. The samples submitted for laboratory testing are summarised in Table 4-2.

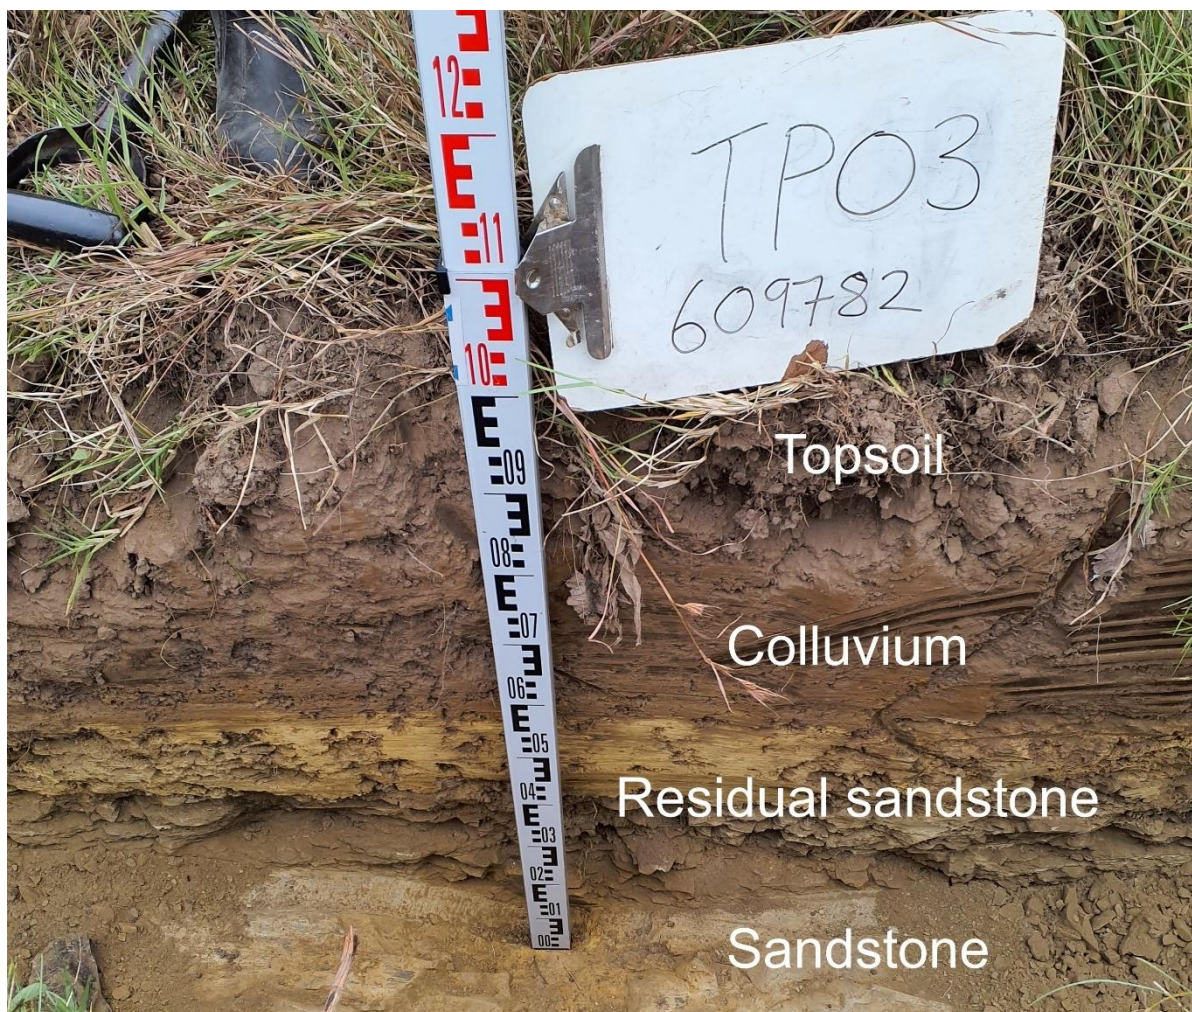
Figure 5-2: Cropped image of the sidewall in TP03 showing the typical ground profile

In summary, the site is underlain by a sequence of soil horizons with improving, although variable, consistency/relative density overlying an assumed undulating bedrock contact, between 0.60 m and 1.70 m below surface. Soil consistency/relative density descriptions are provided in Table 5-4. The presence of gravel, cobbles and bedrock in the profile prevented DCP penetration to the target depth of 3.00 m. The ground profile intersected in TP01 is 'softer' compared to the others based on a deeper excavation depth and higher DCP penetration rate.

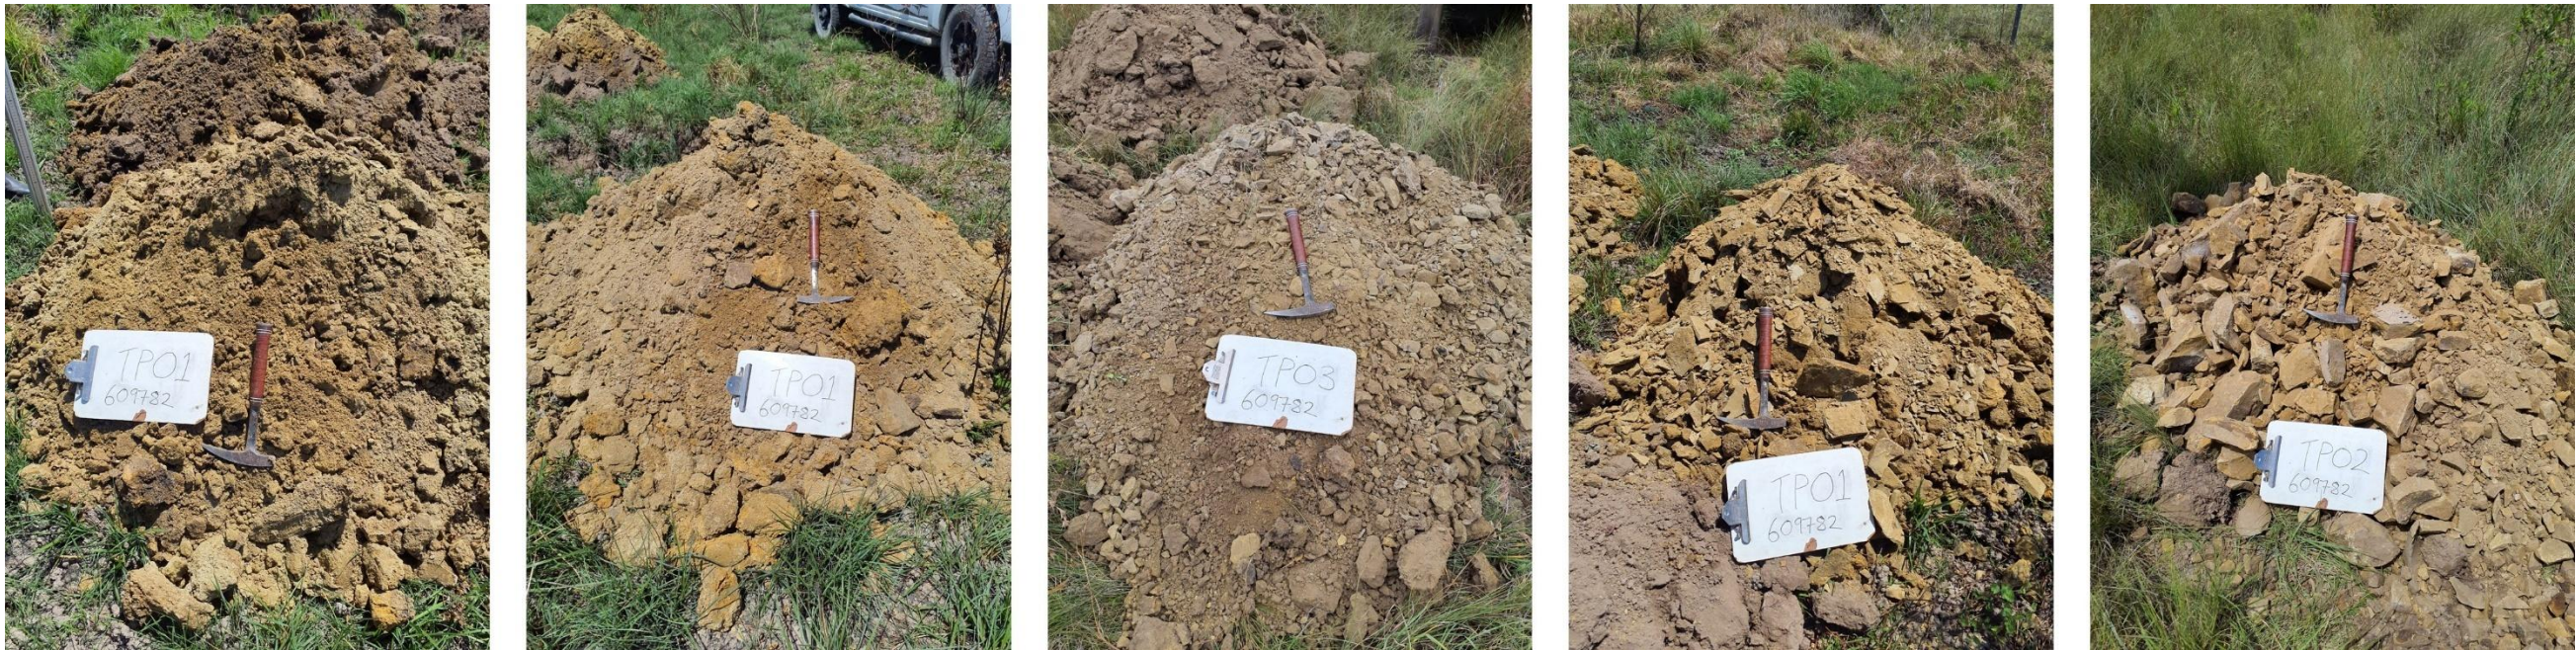
Figure 5-3: Excavated stockpiles of Layer 2 (left), Layer 4 (left centre), Layer 5 (centre), Layer 6 (right centre) and Layer 7 (right)

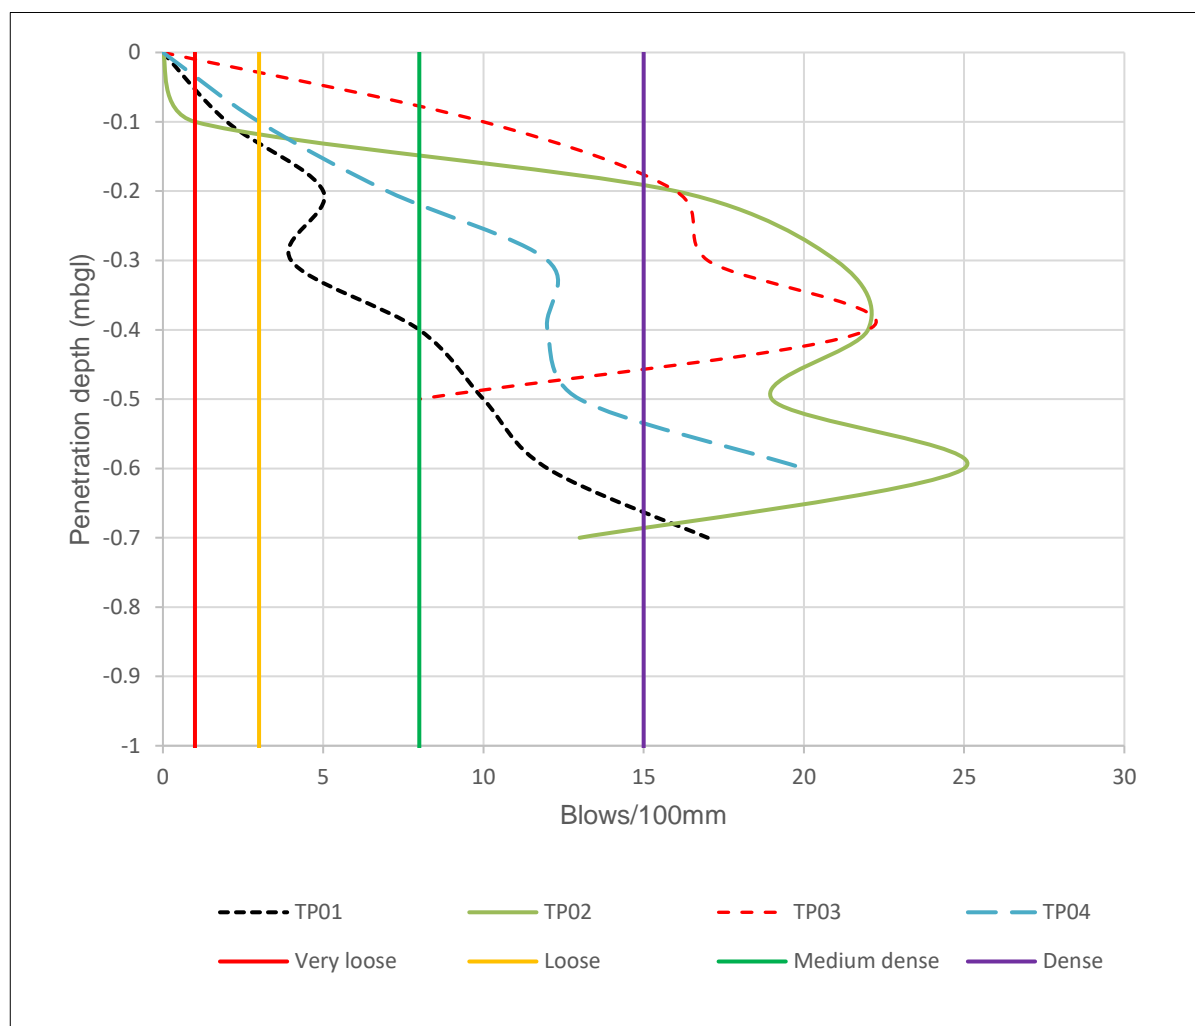
**Figure 5-4: DCP penetration rate**

The detailed ground profile exposed in the TPs is summarised in Table 5-3. A typical ground profile is shown in Figure 5-2 with images showing excavated stockpiles of selected soil/rock layers included in Figure 5-3. The penetration rate of the DCP, used to derive the relative density of the soil layers, is shown in Figure 5-4.
