BID No: ALMT 14/2025

THE CONSTRUCTION OF EMPULUZI/METHULA BULK WATER SUPPLY SCHEME IN CHIEF ALBERT LUTHULI LOCAL MUNICIPALITY, PHASE 1, EMPULUZI DAM

SITE INFORMATION AND GEOTECHNICAL REPORT

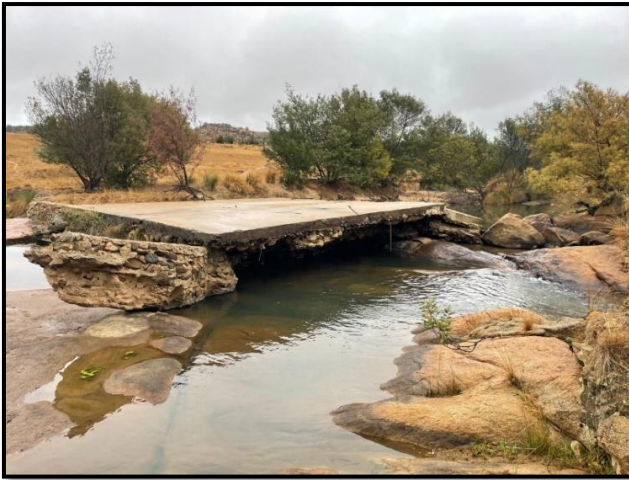
Plate 1: Causeway over Swartwater River

Current access to the dam basin and quarry sites is via the historical gravel road from Fernie to Mpuluzi which had become redundant after the causeway over the Swartwater River was washed away some time ago – refer to Plate 1 on the following page.

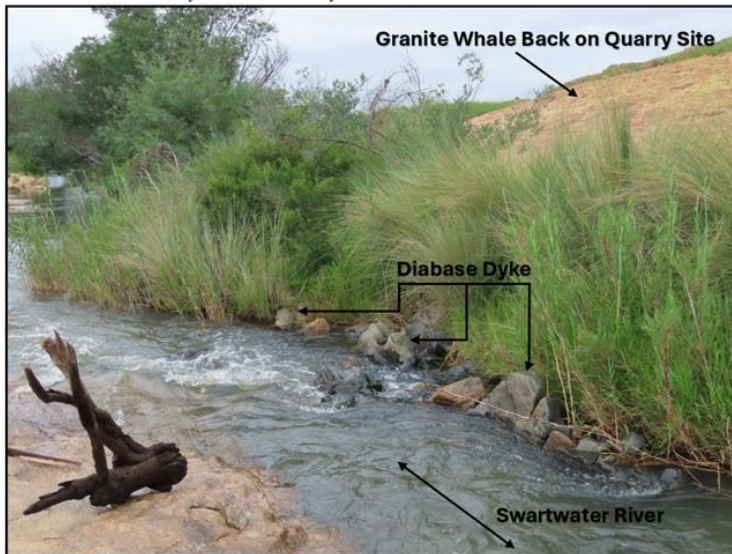
Plate 7: Diabase Dyke Bounded by Granite

An intrusive diabase dyke, striking south-east and partially obscured by the reed beds and wattle tree saplings occurs along the right flank of the Swartwater River, extending from the causeway towards the confluence, ostensibly pinching out against a granite whaleback – refer to Plate 7 below.

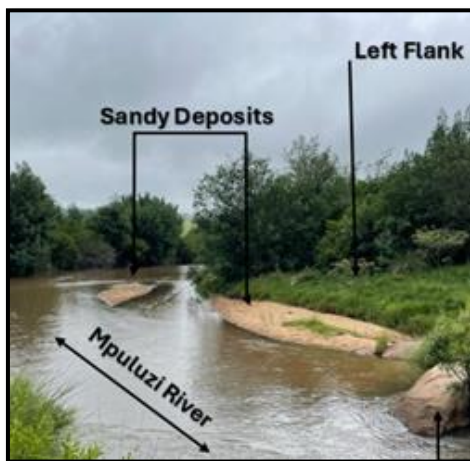
Plate 9: Sandy Deposit Distribution

After a thorough inspection of potential fine aggregate sources required for concrete mixes on site, it was found that the local deposits along the banks of the Mpuluzi River and especially the left flank as well as the central area in the vicinity of the confluence with the Swartwater River predominantly comprise silt-sand mixes suitable for concrete mixes – refer to Figure 2B, the Site Plan, Volume 6B.

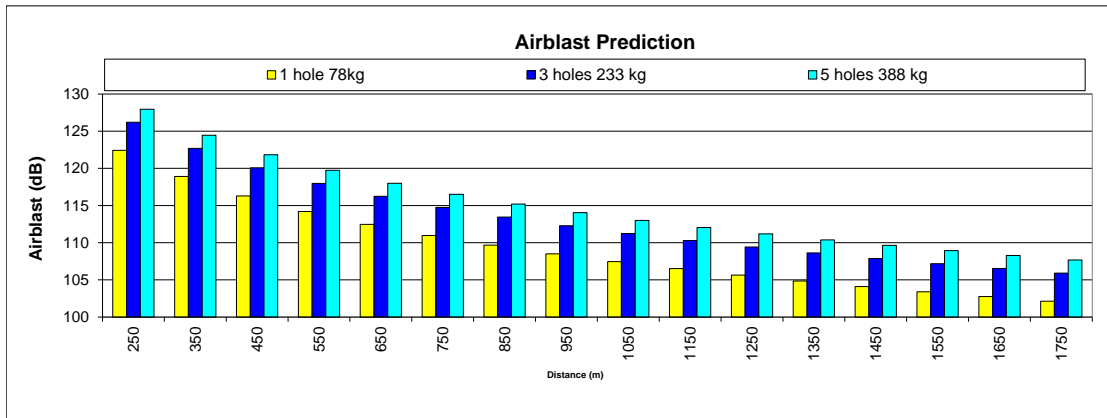
Figure 2: Predicted airblast levels plotted against distance.
