Specification

**TRANSNET NATIONAL PORTS AUTHORITY
PORT OF CAPE TOWN**

Caisson groove repairs on Sturrock Dry Dock in the Port of Cape Town

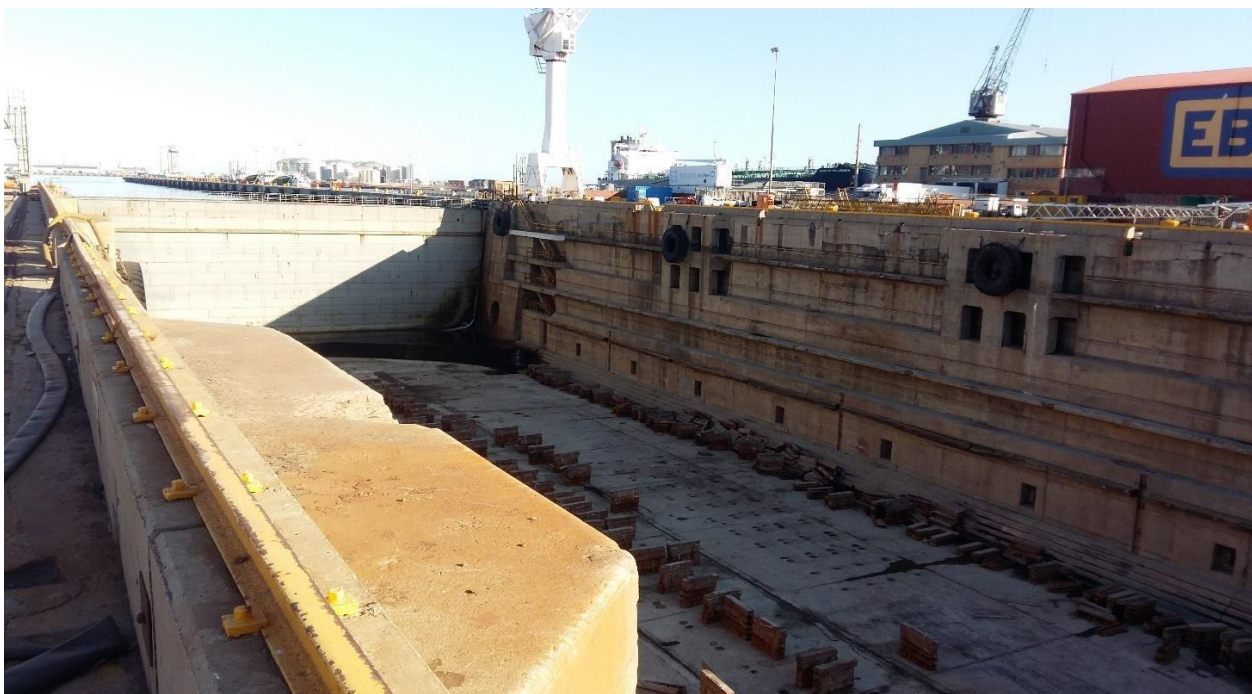
Figure 1-3: Sturrock Dry Dock overview

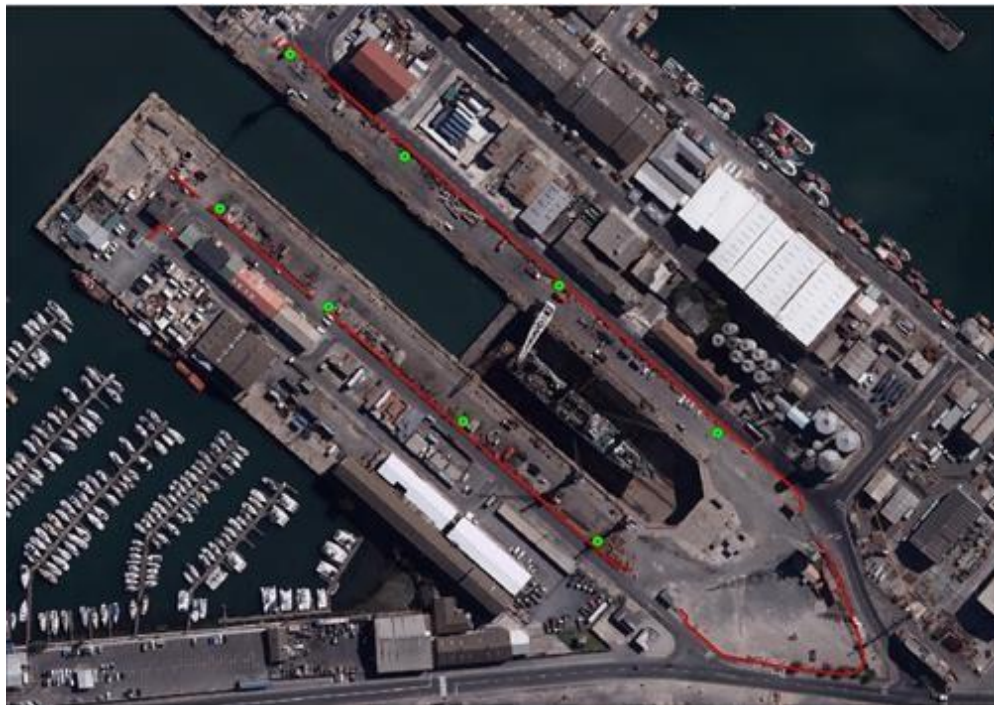
The SDD was commissioned in 1945, and is one of the two graving dry docks in the port of Cape Town that is used for the repair and maintenance of marine vessels. It is essentially a narrow basin with one end open to the sea. During docking, a vessel is manoeuvred into the basin and the open end closed off by means of a caisson gate. The basin is then dewatered such that the vessel rests on the dry dock floor for repairs to commence. It was of high concern that the existing condition of the caisson groove is not satisfactory. It is leaking due to concrete deterioration and other conditions. This might hinder the operation of the new inner caisson gate. A portion of the caisson groove surface is concrete and granite type. All necessary proposed test should be conducted during assessments. The general layout of the dock and location of the caisson groove is shown in the Figure below.
