MOKOLO CROCODILE WATER AUGMENTATION PROJECT PHASE 2 (MCWAP-2)

ROADS AND TRAFFIC BASELINE ASSESSMENT REPORT

February 2022

Project No: GP084

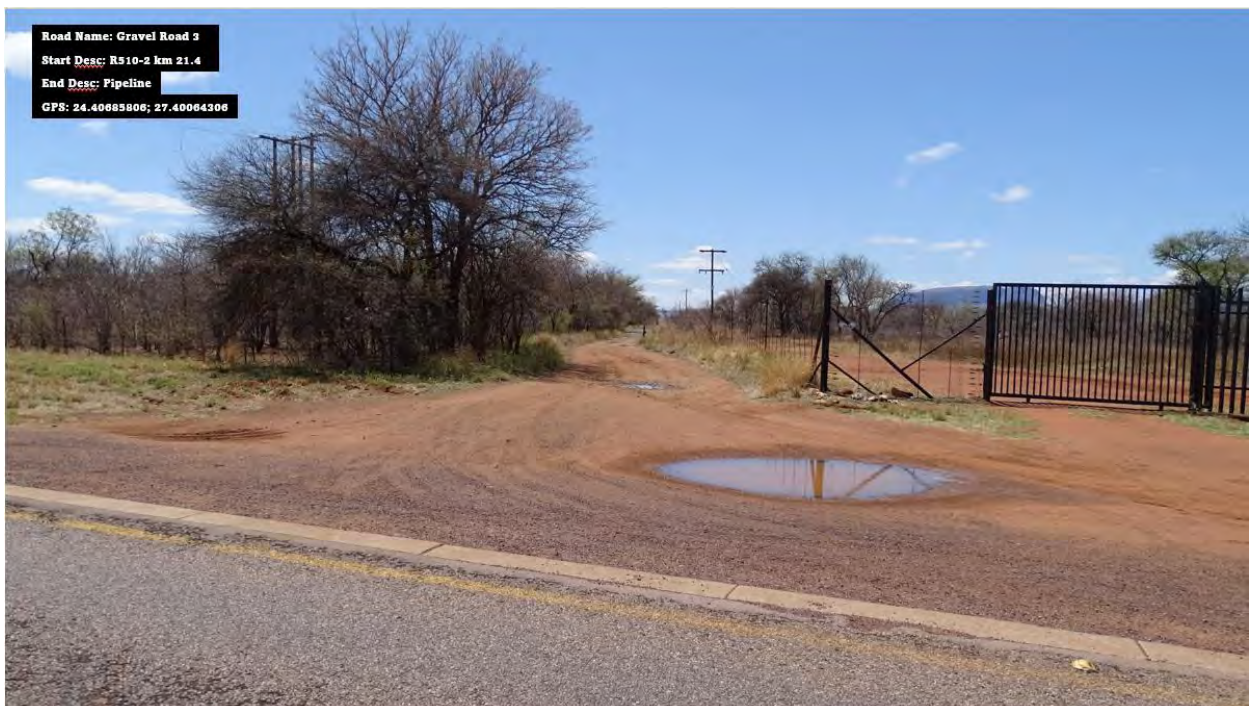
Gravel Road 3 follows a boundary fence line separating two farm properties and appears to traverse private property. The roadway has potholes in places as well as corrugated sections. See Photo 3.16 and Photo 3.17

Photo 3.16: Gravel Road 3 (km 0,0): Potholes in road, narrow roadway

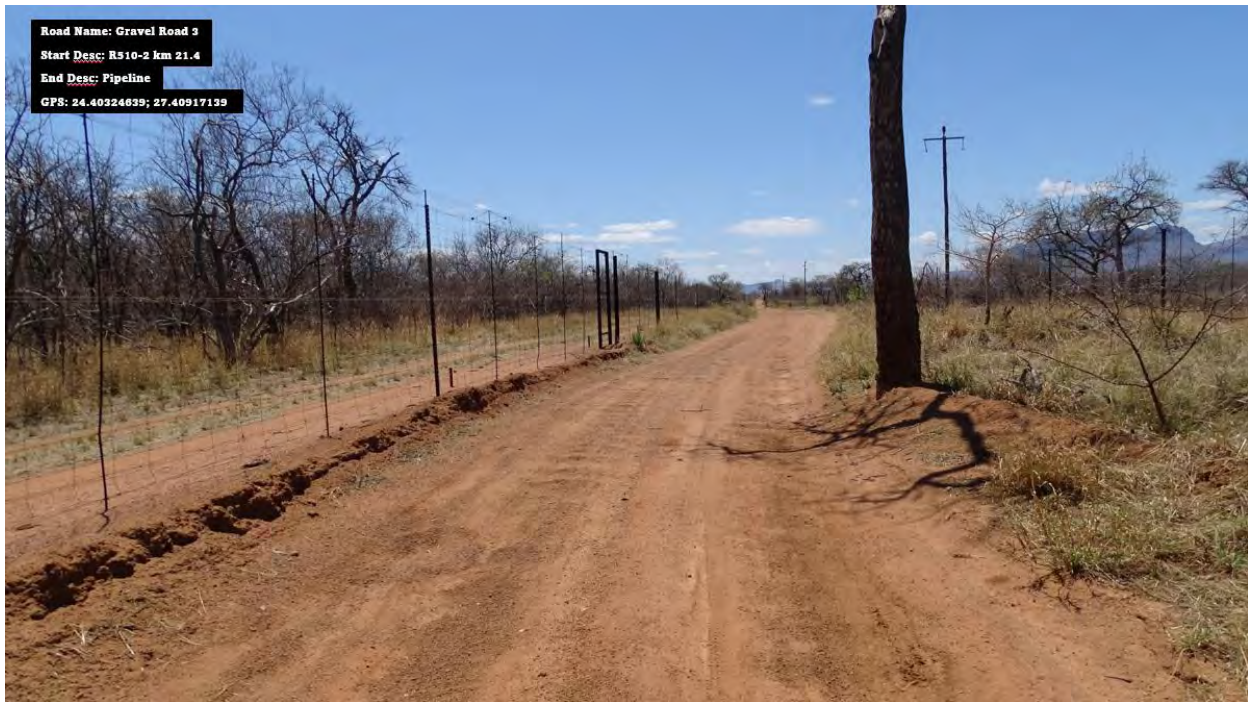
Photo 3.17: Gravel Road 3 (km 0,9): Corrugation, Narrow roadway

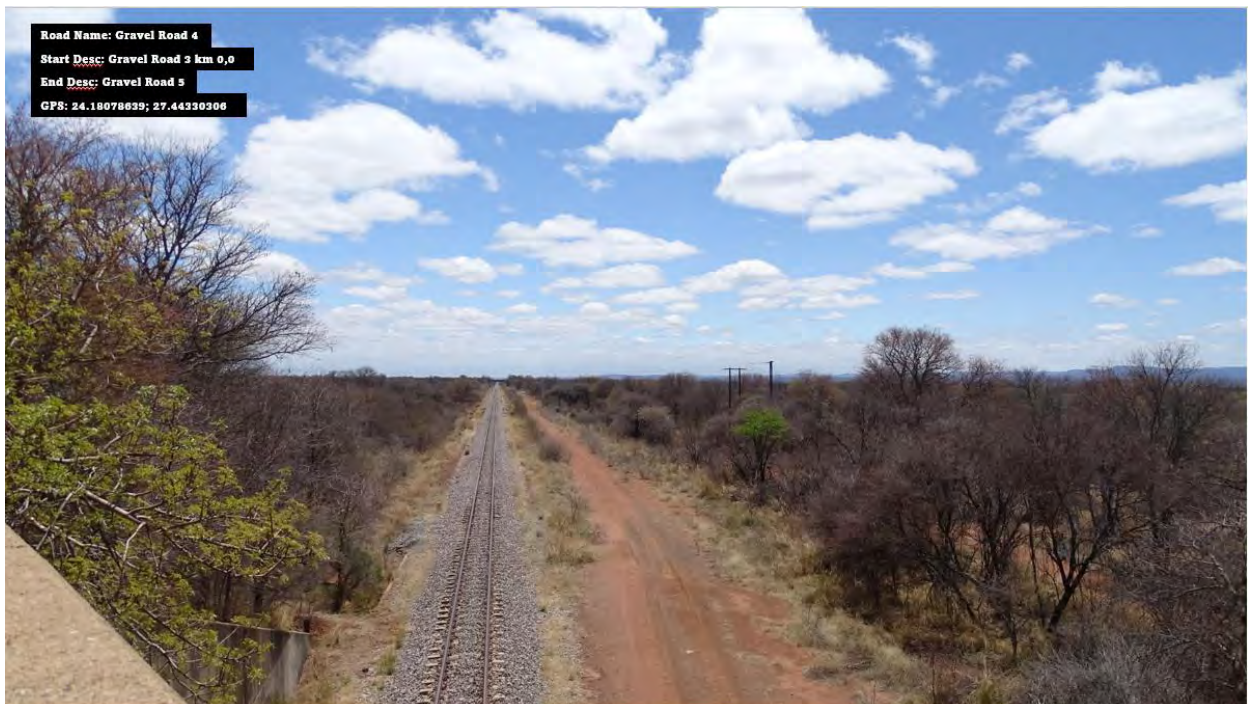
Gravel Road 4 is located within a rail line servitude, and over some sections the road reduces to two-wheel tracks. The road has no surfacing layer of any kind with vehicles essentially driving over natural ground. Some places potholes are evident. See Photo 3.18 and Photo 3.19.

Photo 3.18: Gravel Road 4 (km 12.2): Photo taken facing the North-direction

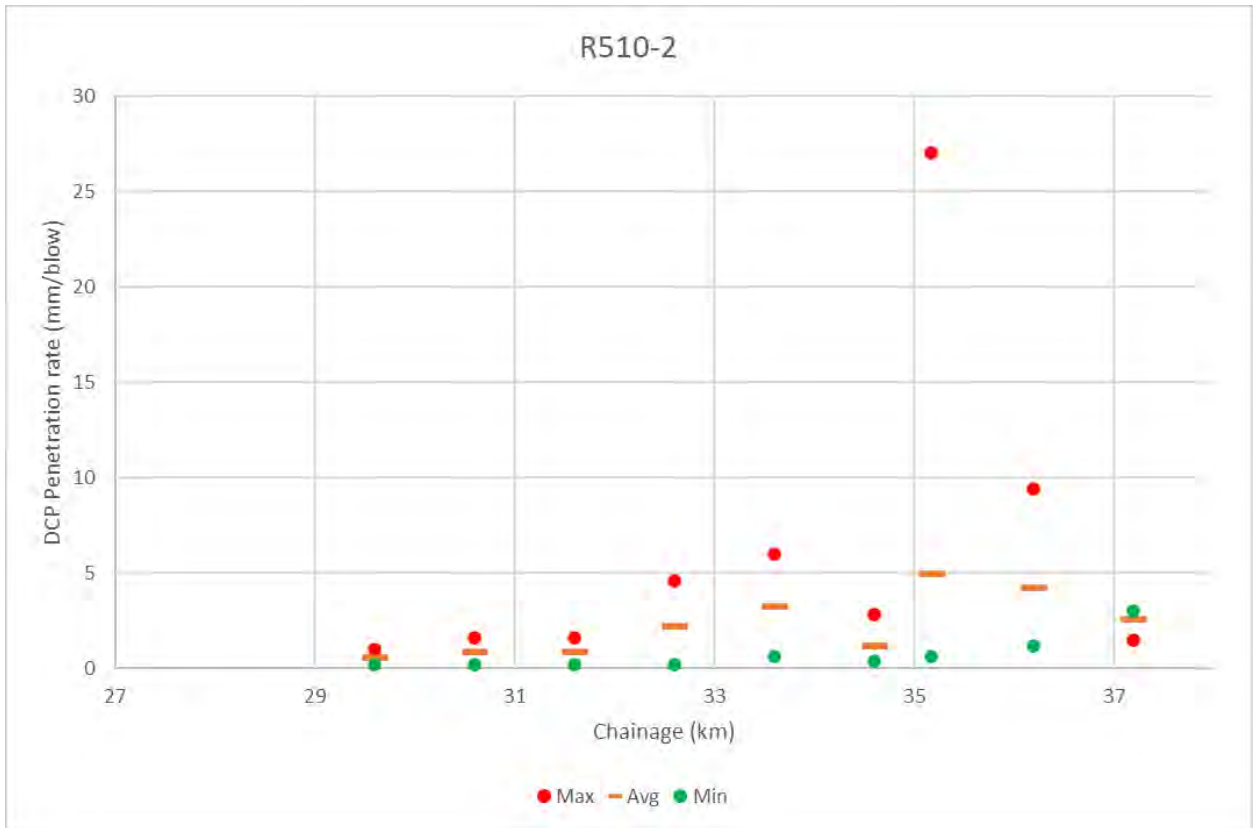
Figure 3-17: Road R510-2 DN-values

Average DN-values along Road R510-2 as indicated in Figure 3-17 generally show that the penetration is less than 5 mm/blow with only one position where this value is exceeded. This indicates that the typical material quality in the lower layers of the pavement is G5-quality or better. When the maximum values are considered, material quality can be estimated as G6-quality or better. The single high maximum value of 27 mm/blow is indicative of a G10-quality layer, which is not uncommon in the lower layers of the pavement structure.

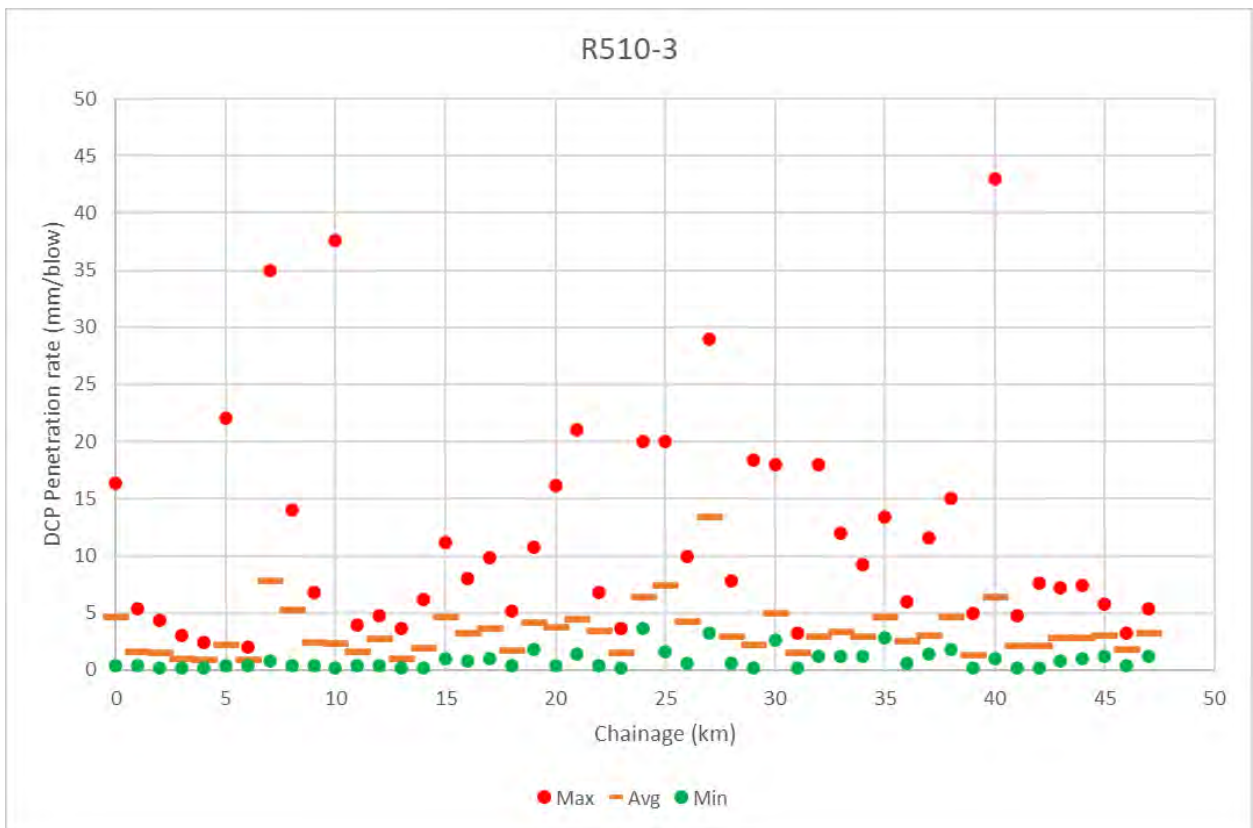
Figure 3-18: Road R510-3 DN-values

Average values along **Road R510-3** vary from 2 to 13 (Figure 3-18), indicating in most instances material quality of G6 or better. Maximum values between 3 and 43 were determined, again indicating that some material can be classified as G10-quality.

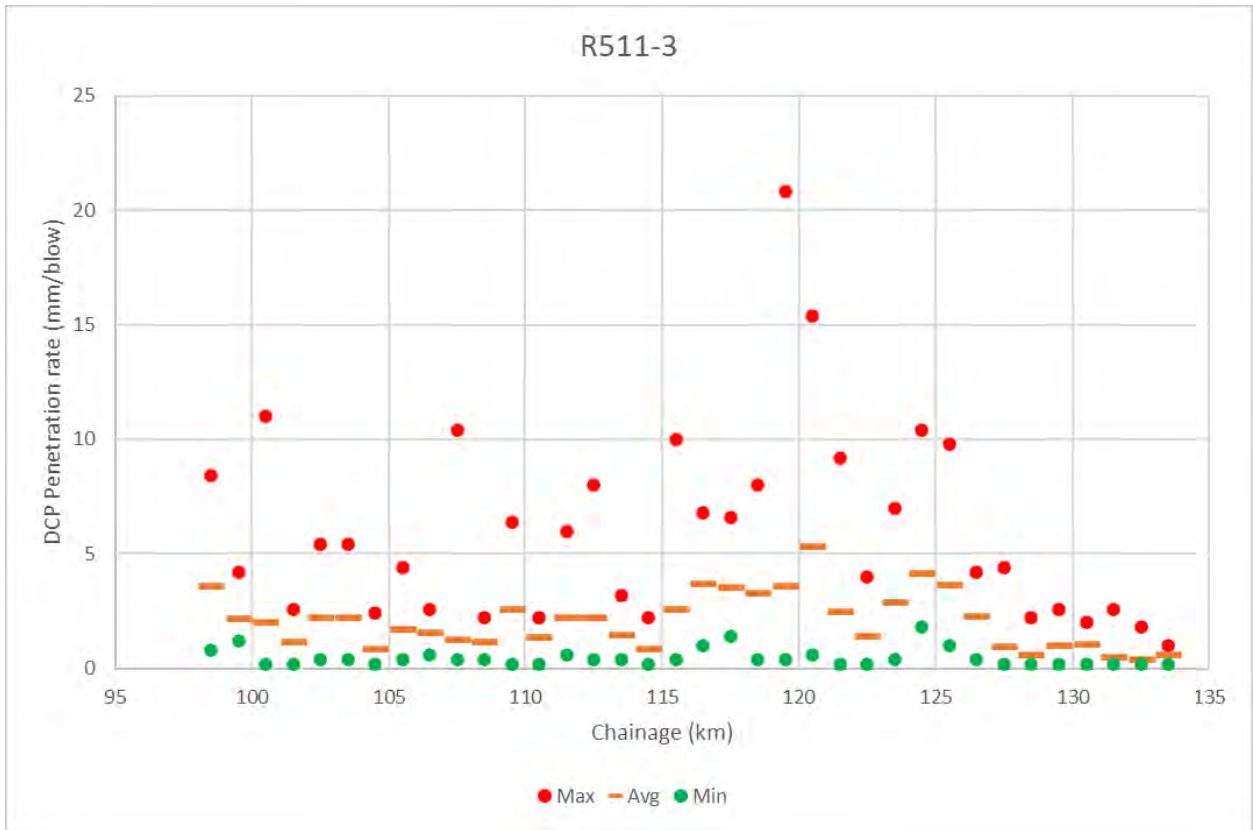
Figure 3-19: Road R511-3 DN-values

DN-values along **Road R511-3** (Figure 3-19) are similar to that along Road R510-2 with average penetration rates below or equal to 5 mm/blow. Maximum rates were generally below 12 with only two measurements at 15 mm/blow and 21 mm/blow. The latter is indicative of G9-quality material and better.

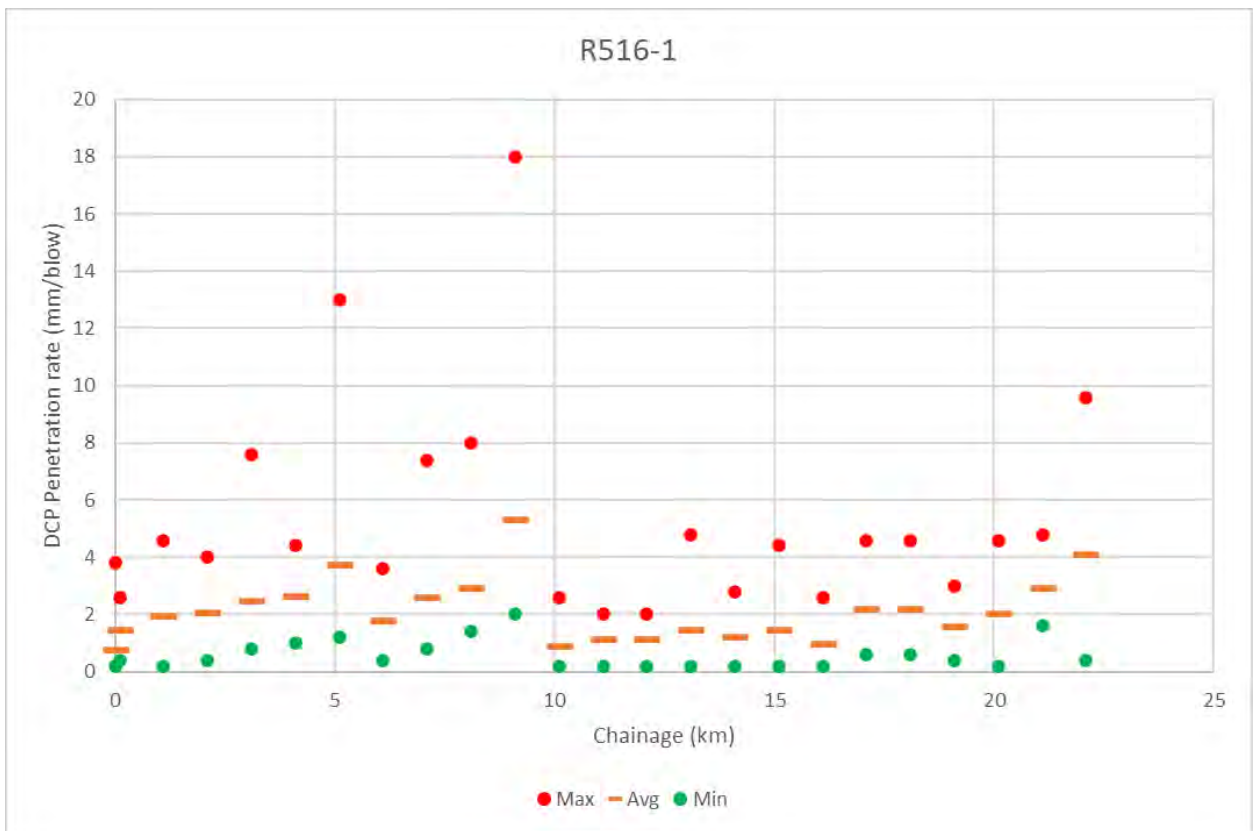
Figure 3-20: Road R516-1 DN-values

Similar to the above, average DN-values along **Road R516-1** (Figure 3-20) indicate material of G5-quality or better, while maximum values indicate material of G9-quality or better. This is again indicative of a structurally sound pavement.

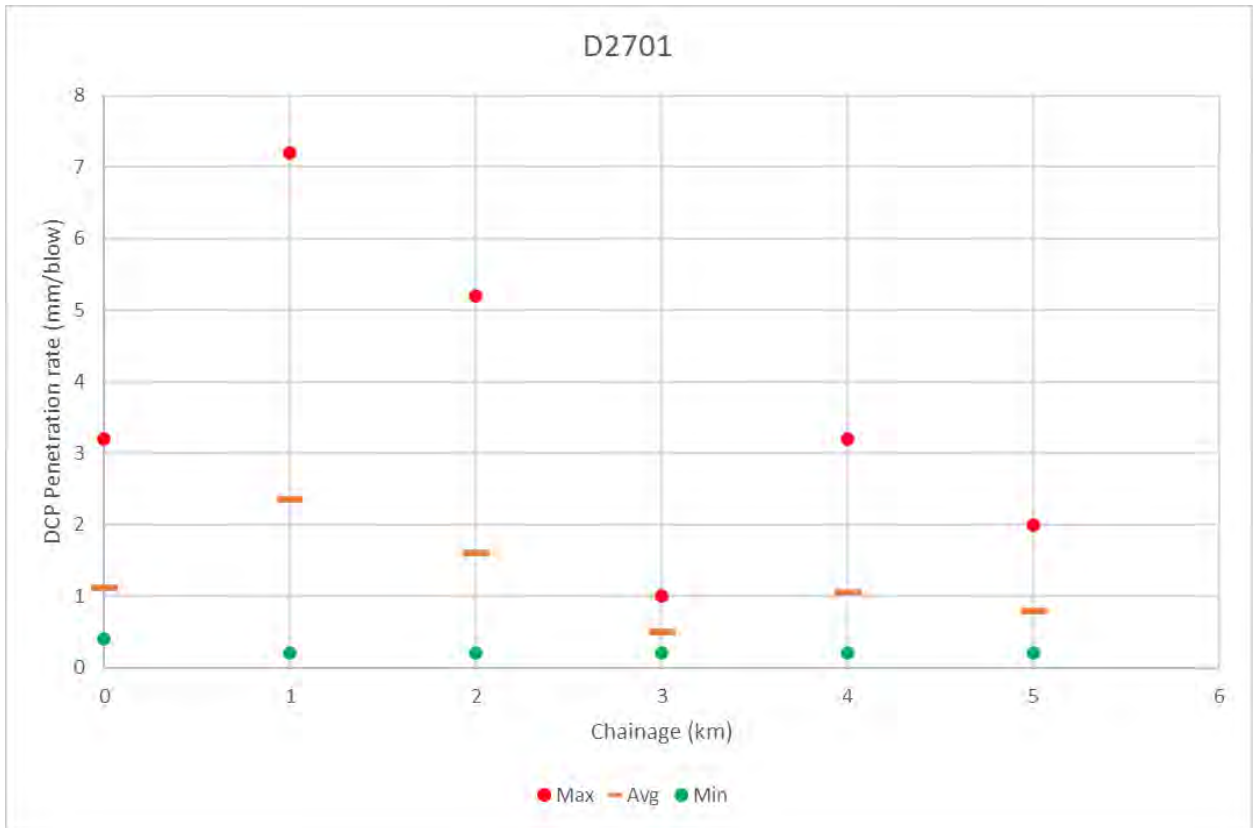
Figure 3-21: Road D2701 DN-values

Average DN-values along **Road D2701** (Figure 3-21), **Road D1675** (Figure 3-22) and **Road D2649** (Figure 3-24) are below 3 mm/blow with maximum values below 8 mm/blow, indicative of G5-quality material and better. These values are better compared to those along the previous road sections however, it can also be indicative of a highly consolidated pavement structure.

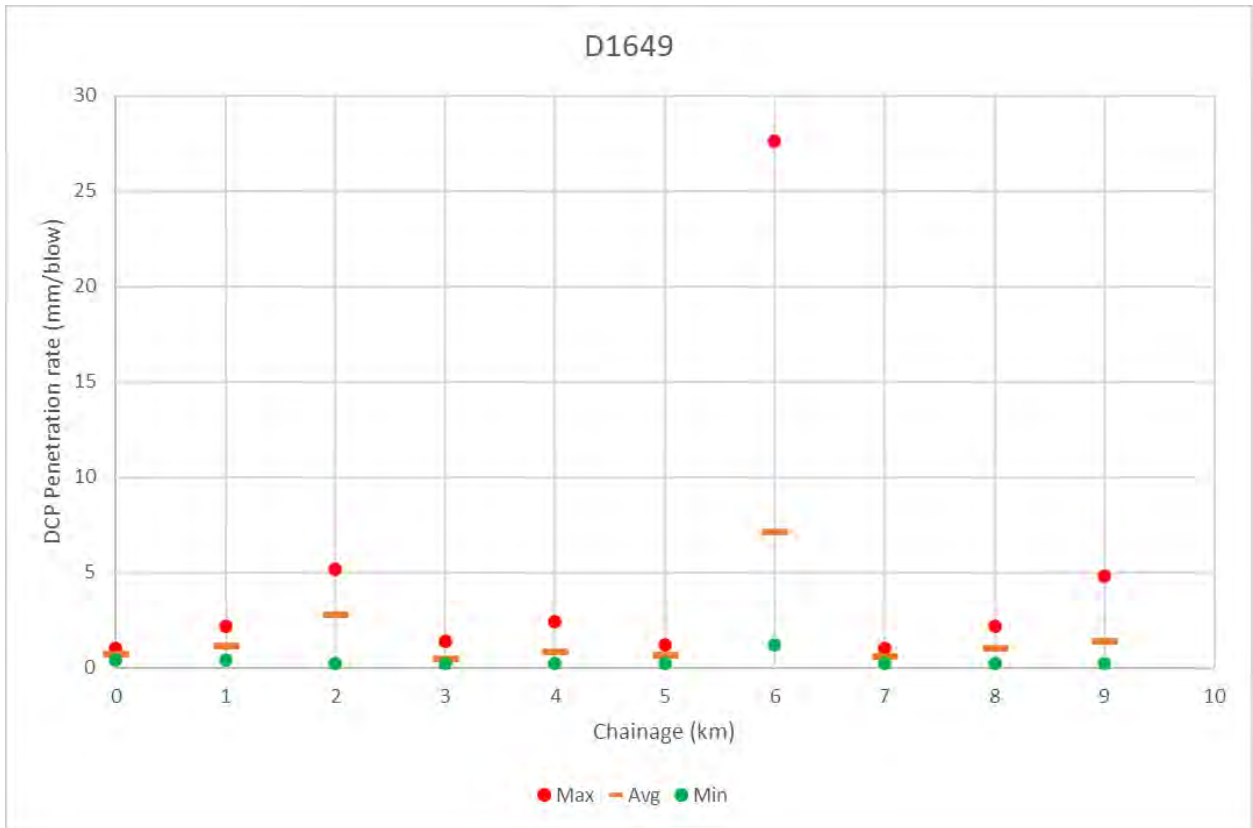
Figure 3-23: Road D1649 DN-values

DN-values along **Road D1649** (Figure 3-23) are similar to those for Road D2701 and Road D1675 with one measurement having an average DN-value of 7 mm/blow and a maximum value of 28 mm/blow.

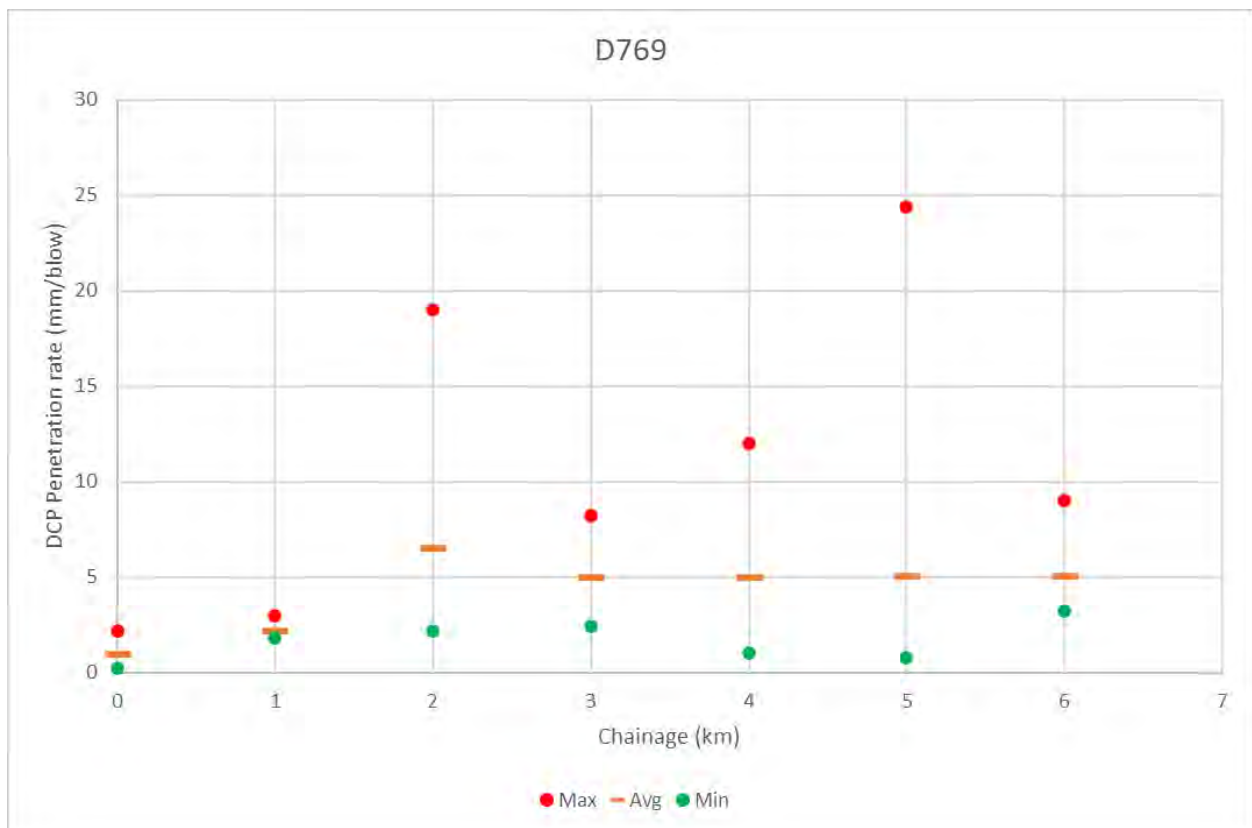
Figure 3-25: Road D769 DN-values

Average DN-values along **Road D769** (Figure 3-25) and **Road D2701** (Figure 3-26) generally show that the penetration is less than 9 mm/blow. This indicates that the typical material quality in the lower layers of

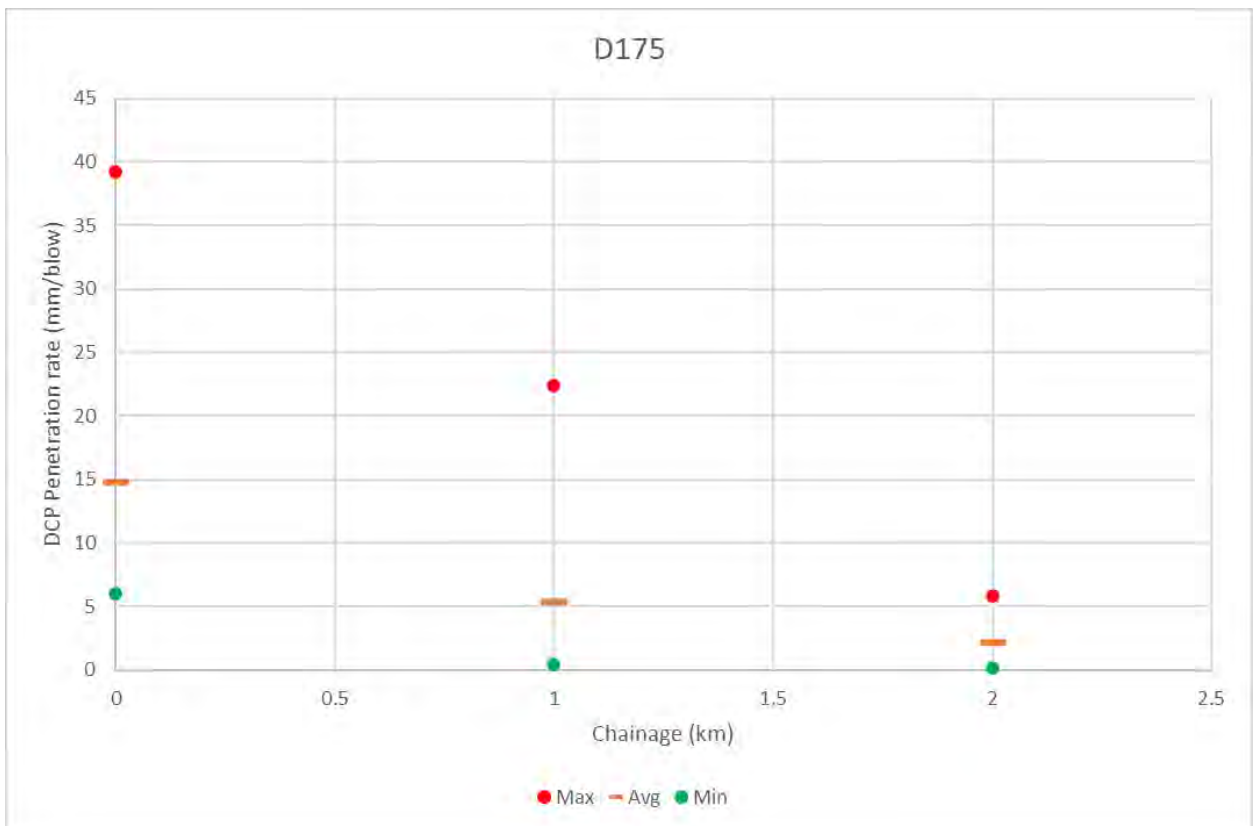
Figure 3-27: Road D175 DN-values

DN-values along **Road D175** as indicated in Figure 3-27 vary along its length, however due to the short section only three measurements were done. The measurement at km 0,0 is at the intersection with Road D1925, the results of which are described below. With the exception of this result, average DN-values are below 6 mm/blow with a maximum penetration rate of 23 mm/blow.

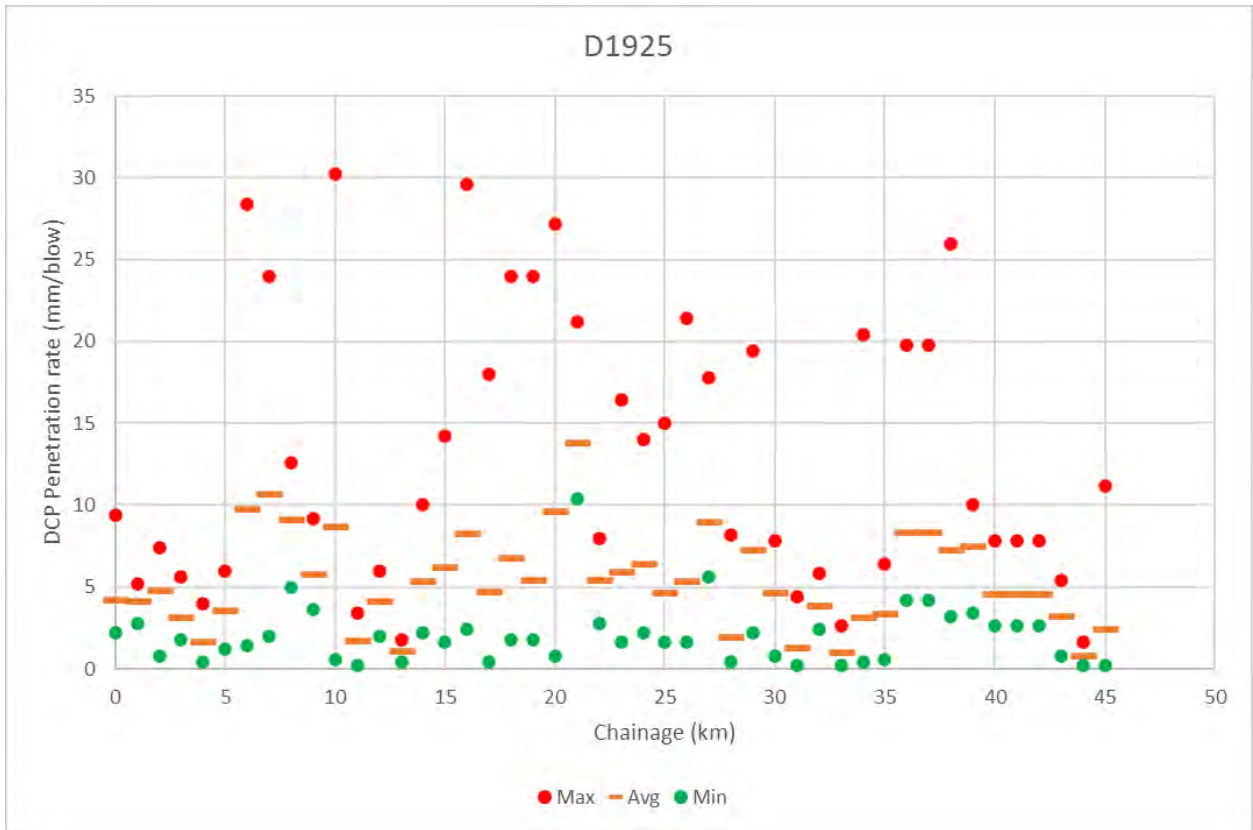
Figure 3-28: Road D1925 DN-values

Average DN-values along **Road D1925** (Figure 3-28) are in the order of 2 mm/blow to 14 mm/blow, indicating material quality of G7 or better. Maximum values vary from 2 mm/blow to 30 mm/blow indicating material quality of G9 or better.

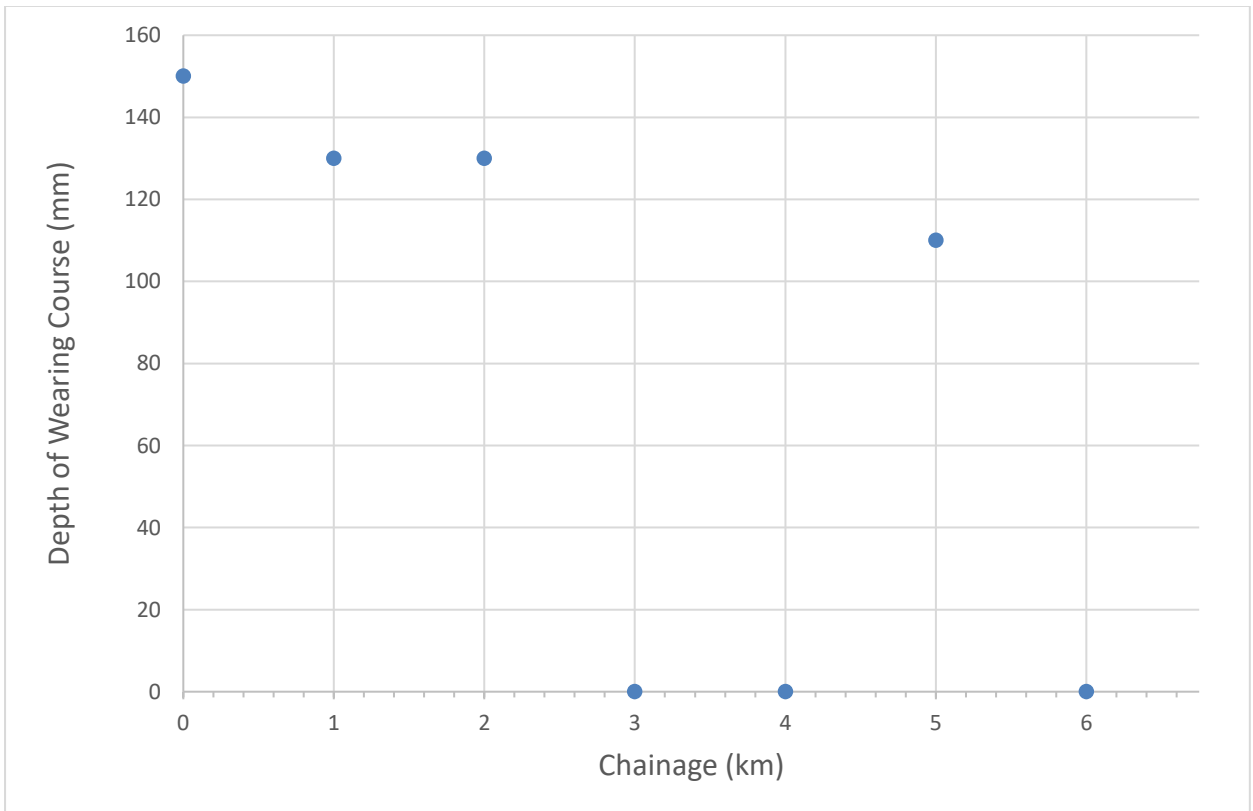
Figure 3-29: D769 Wearing Course Thickness

- The first 2.9 km of **Road D769** contains good gravel wearing course of around 130 mm thick and although a full classification of the material has not been carried out, visually the material looks like a G7/G8 quality. The remaining section of the road has either not been gravelled for some time, or if it has been previously gravelled, the material has been displaced or washed away. In the areas where the subgrade is exposed, it is mainly sand which would meet the requirements of G8/G9 quality if properly compacted.

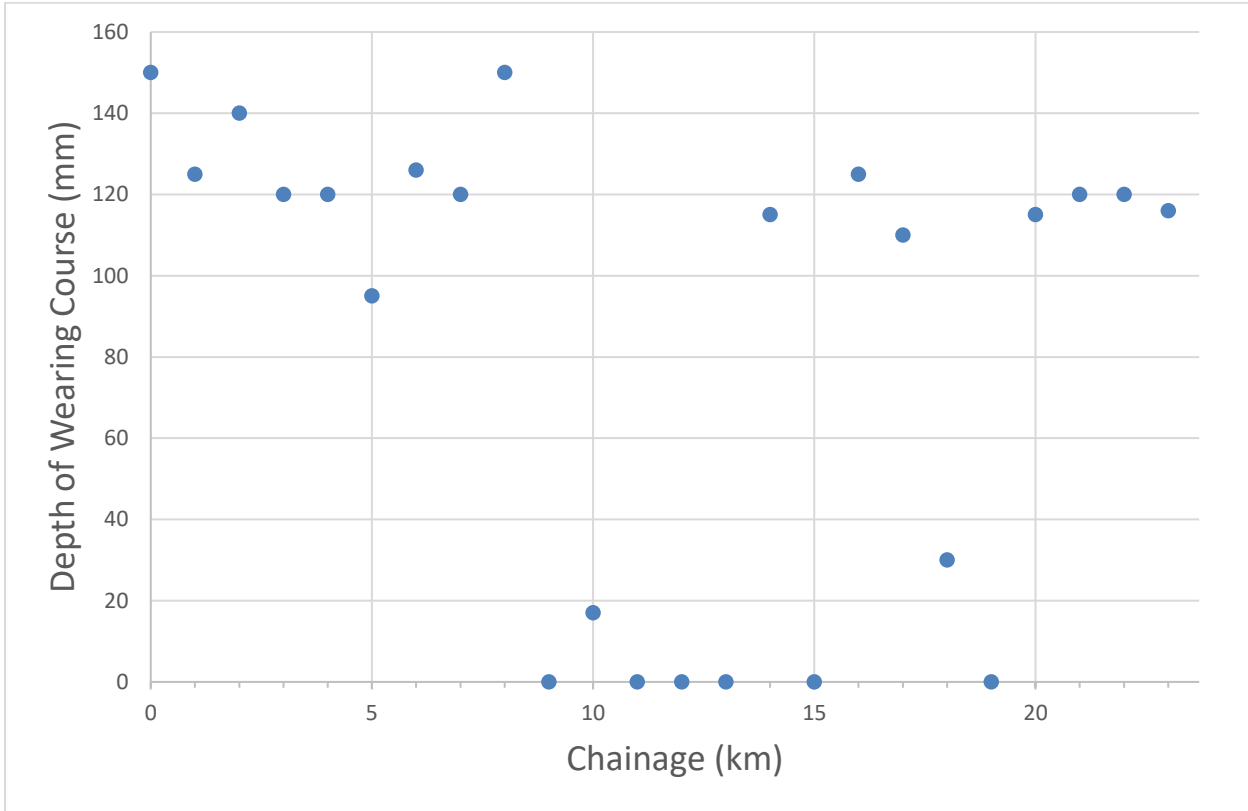
Figure 3-30: D2701 Wearing Course Thickness

- The first 9 km of **Road D2701** has a good gravel wearing course averaging 120 – 150 mm in thickness, and again the material seems to be of G7/G8 quality. From km 9 to km 20, although the road is trafficable, the gravel wearing course varies between 0 and 120 mm thick. From km 20 to the end of the section, the road is very sandy with an approximate depth of 120 mm which at times makes traversing it challenging, especially with smaller vehicles. A 3 km section, between km 11 and km 13, the subgrade is exposed but still drives well.

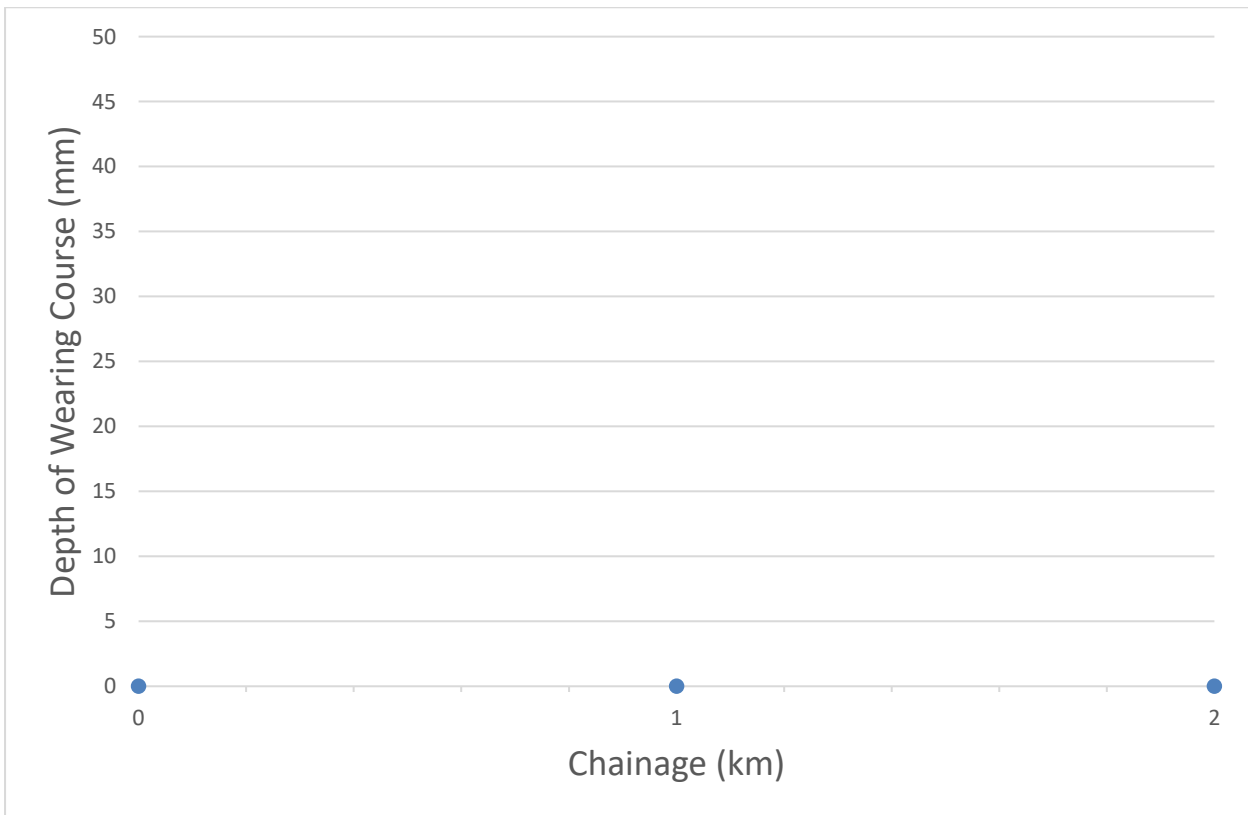
Figure 3-31: D175 Wearing Course Thickness

- **Road D175**, a 2.6 km section of road, has no gravel wearing course and has only sand as a surface layer. The road is smooth in some sections and rough in others.

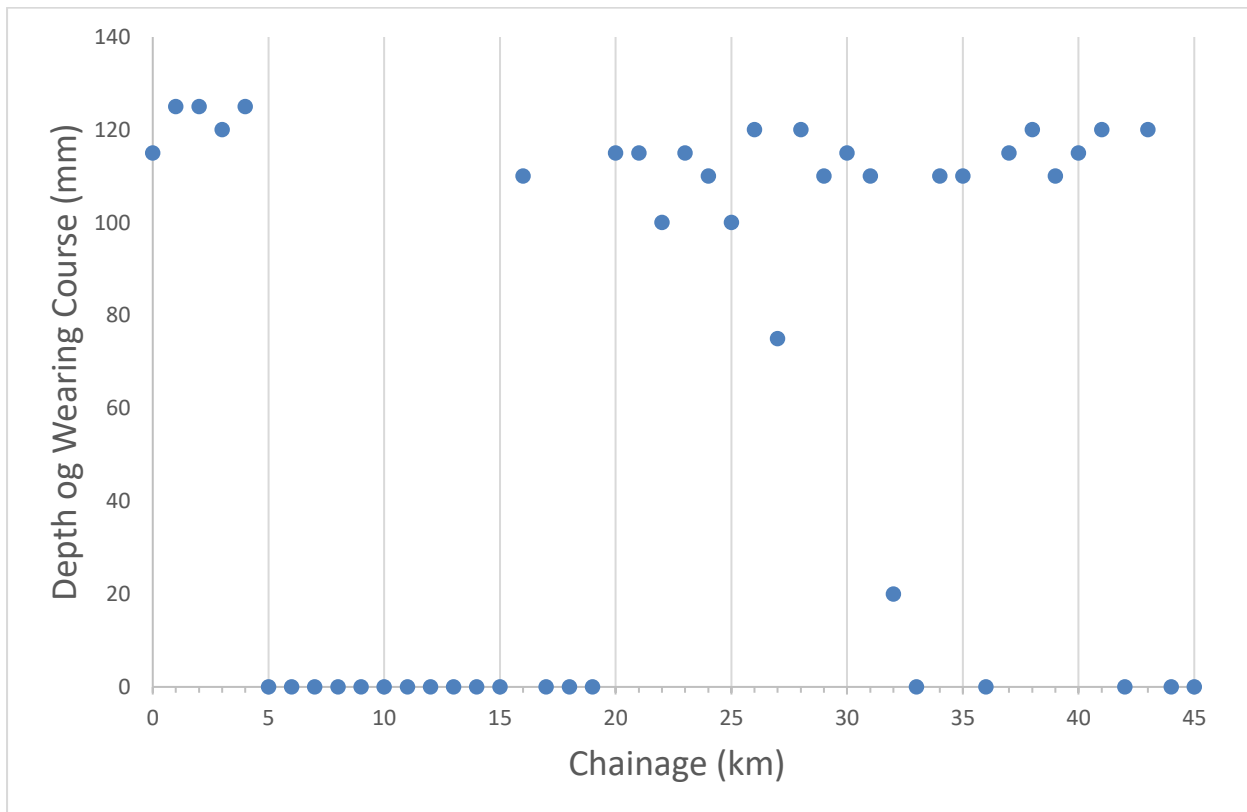
Figure 3-32: D1925 Wearing Course Thickness

- **Road D1925** has very little gravel wearing course over most of its length with the exception of the first 4 km where the gravel varies between 115 mm and 125 mm thick and appears to be of a G8 quality. The rest of the road is generally sandy with a section of exposed calcrete-type material which would normally constitute a G7/G8 quality. Other than the first 4 km, the road is generally extremely uneven and in need of re-gravelling. It is essentially a sand track with windrows built up along the edges of the road over most of the section.

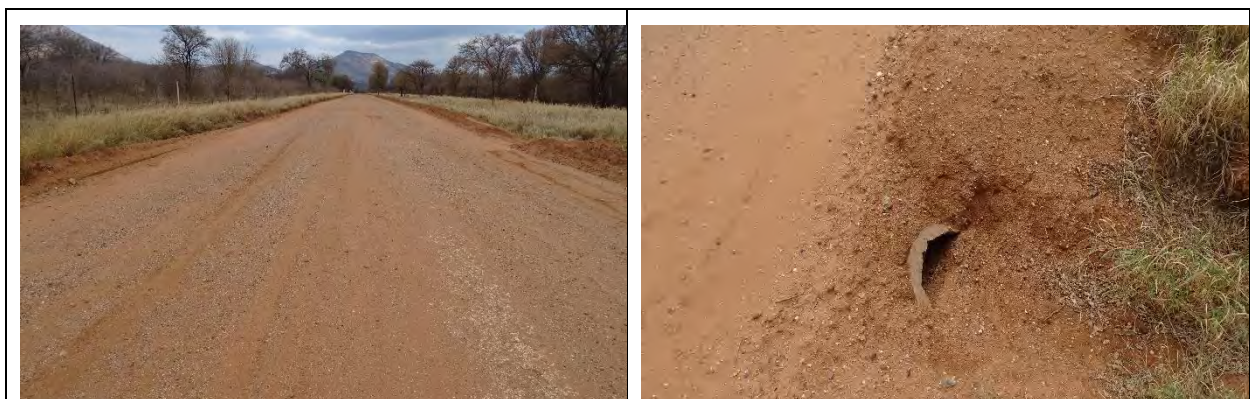
In addition, all culverts are without headwalls, most are blocked and inaccessible due to a total lack of maintenance. This has resulted in many culverts being exposed due to the displacement of gravel and ongoing grading over the years.

Road D769 does not have any shape or profile over its entire length, which is also evident on most of the other gravel roads. Ongoing grading has by implication flattened the road surface and created windrows with no evidence of outlet channels for drainage from the road surface, hence stormwater is trapped on the roadway leading to erosion and potholes.

A: Roadway surface - rough

B: Blocked culvert

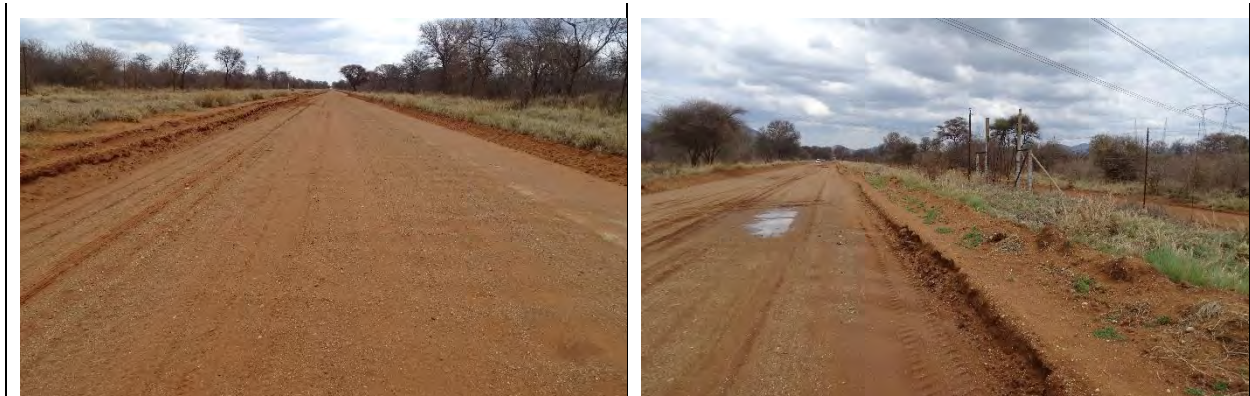
C: Corrugation on roadway

D: Windrows and pothole in roadway

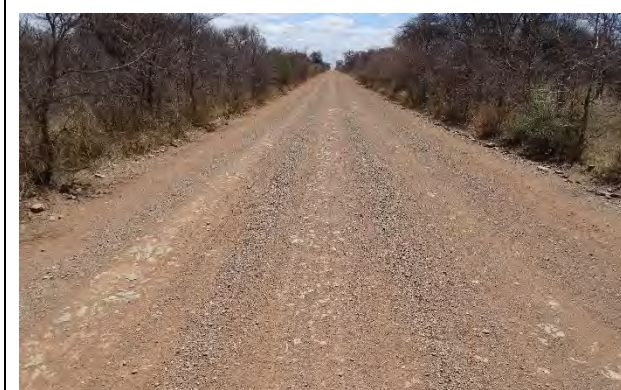
Figure 3-43: Road D2701

A: Gravel Road

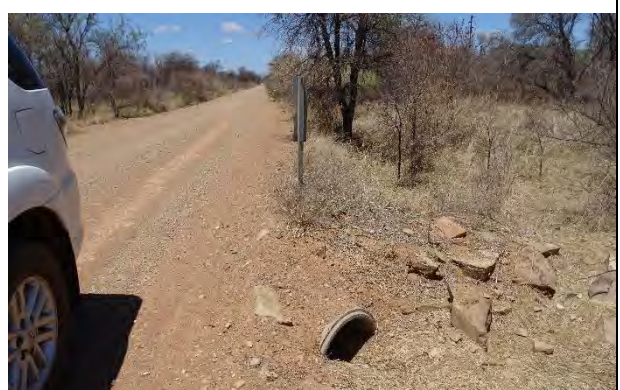
B: Blocked culvert; Little cover

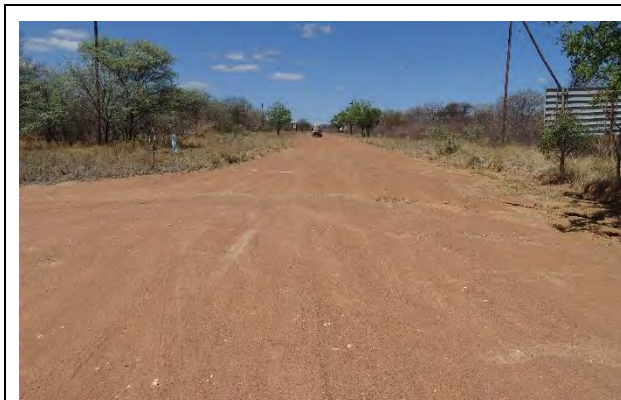
Figure 3-44: Road D175

Road D175 shows signs of erosion in many places over its entire length which may prove to be challenging to traverse during the rainy season unless rebuilt and properly gravelled. The roadway has little shape with windrows at various places along the route.

A: Roadway

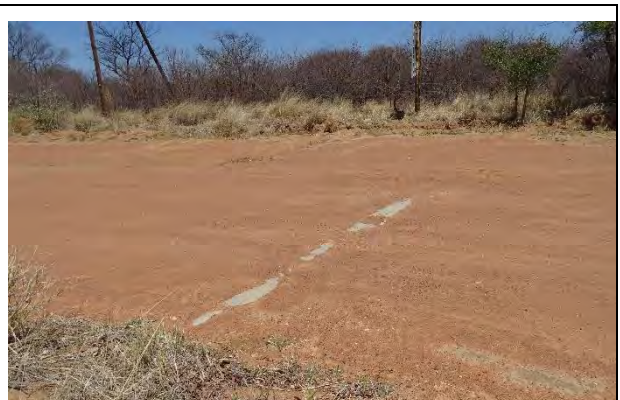
B: Top of culvert exposed on roadway

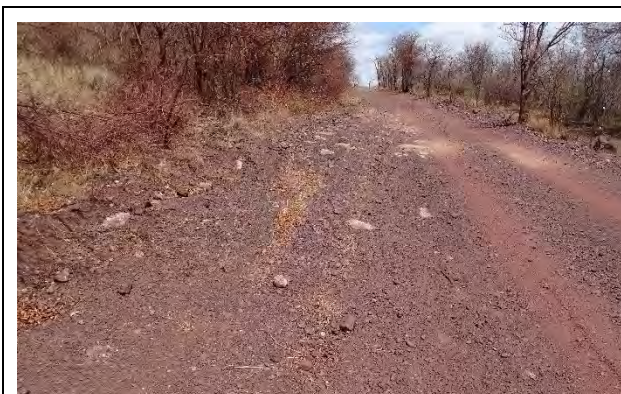
Figure 3-46: Gravel Road 2

Gravel Road 2 essentially provides access to a couple of farms. The road has no structured drainage of any kind. There is little sign of any erosion with the exception of the section around the koppie (km 1.80 to km 2.80) where the road is very rough.

A: Gravel roadway; Big stones on surface

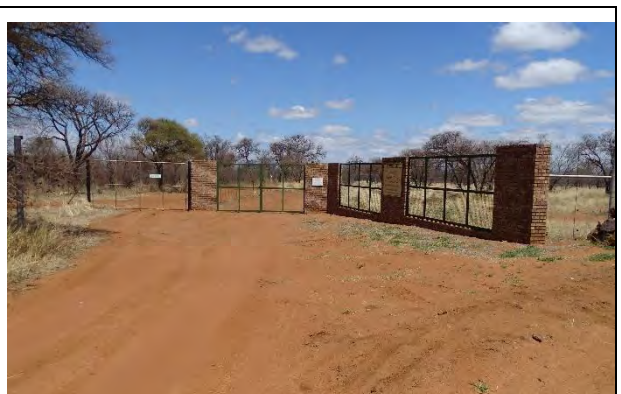
B: Road blocked by gate

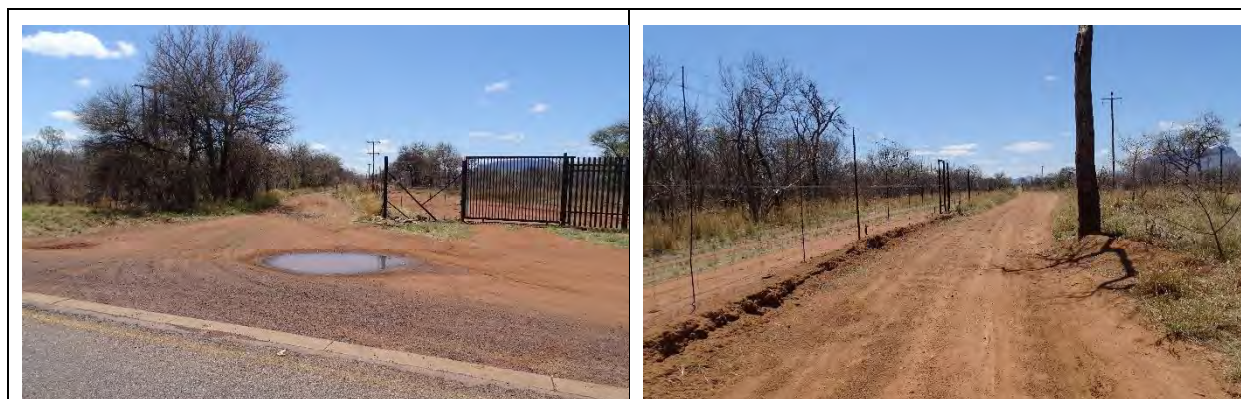
Gravel Road 3, like **Gravel Road 2**, has no structured drainage, but shows little sign of any erosion.

A: Entrance to Gravel Road 3; Pothole

B: Narrow Road; Corrugated

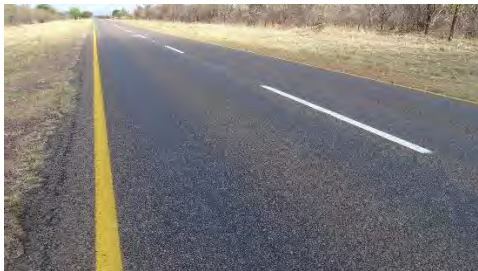
Road Name	Observations: Advantages	Observations: Defects/Problems
R516 (Surfaced)

<ul style="list-style-type: none"> iv. Signage is very good v. Grass/verge is well maintained along most of the road vi. Gravel shoulders available for emergency stopping 	<ul style="list-style-type: none"> iii. 2-lane cross section, no climbing lanes, insufficient overtaking opportunities for light vehicles to overtake slow moving trucks iv. Grass needs to be cut along certain sections to maintain visibility of road signs

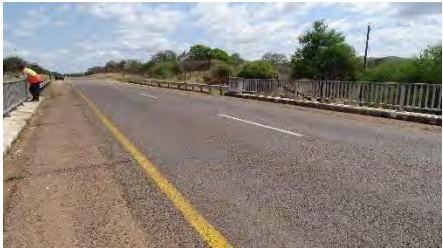
Road Name	Observations: Advantages	Observations: Defects/Problems
<p>R511 (Surfaced)</p>

<ul style="list-style-type: none"> vii. 2-lane cross section with good overtaking opportunities viii. Signage is good ix. Truck/rest stop just after the R511/R516 intersection x. Grass/verge is well maintained along most of the road xi. Gravel/grass shoulders available for emergency stopping xii. Low traffic volumes 	<ul style="list-style-type: none"> ii. Slow moving tractors/farm vehicles from adjacent properties make use of the road
<p>R510 (Surfaced)</p>

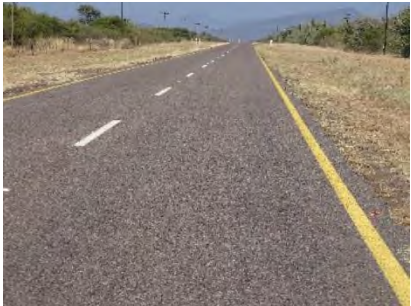
<ul style="list-style-type: none"> iv. Gravel/grass shoulders available for emergency stopping v. High pedestrian, minibus taxi and informal trading activity around the town area of Thabazimbi with some NMT safety measures present – street lighting, bollards to separate motorists from pedestrians, zebra crossings at intersections etc. vi. Intermittent sidewalks of various widths and material 	<ul style="list-style-type: none"> vi. 2-lane cross section with few overtaking opportunities as one approaches Thabazimbi from the south, overtaking improves past the town section vii. Grass verge at the R510/R511 Intersection needs to be kept short to maintain good sight distance at the intersection at all times viii. Edge breaks present ix. High volume of heavy vehicles present x. High volume of traffic in the Thabazimbi town area

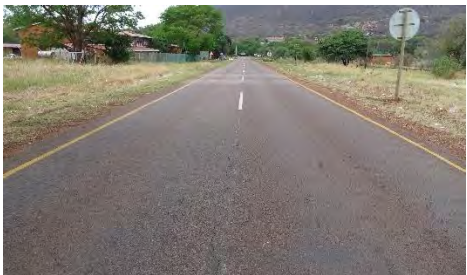
<p>D1649 (Surfaced)</p>

<ul style="list-style-type: none"> iii. Good sight distance at the R510/D1649 Intersection iv. 2-lane cross section with sufficient overtaking opportunities 	<ul style="list-style-type: none"> iii. Trolley pushers present – going to the rubbish dump close to km 3/4 iv. Grass along the verge needs to be cut
<p>D769 (Gravel)</p>	<ul style="list-style-type: none"> iv. Good sight distance at the D769/D1649 Intersection, and an additional shared right/through lane on the eastern approach of D1649 	<ul style="list-style-type: none"> iii. Primary school adjacent to the road (just after intersection with D1649) – scholar patrol appears to be in operation (signage present)

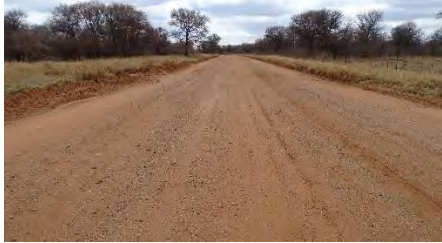
<ul style="list-style-type: none"> improves safety at the junction v. Fences present on either side of the road vi. Little to no traffic 	<ul style="list-style-type: none"> iv. Road is very wide – no drainage channels
