MOKOLO CROCODILE WATER AUGMENTATION PROJECT PHASE 2 (MCWAP-2)

ROADS AND TRAFFIC BASELINE ASSESSMENT REPORT

February 2022

Project No: GP084

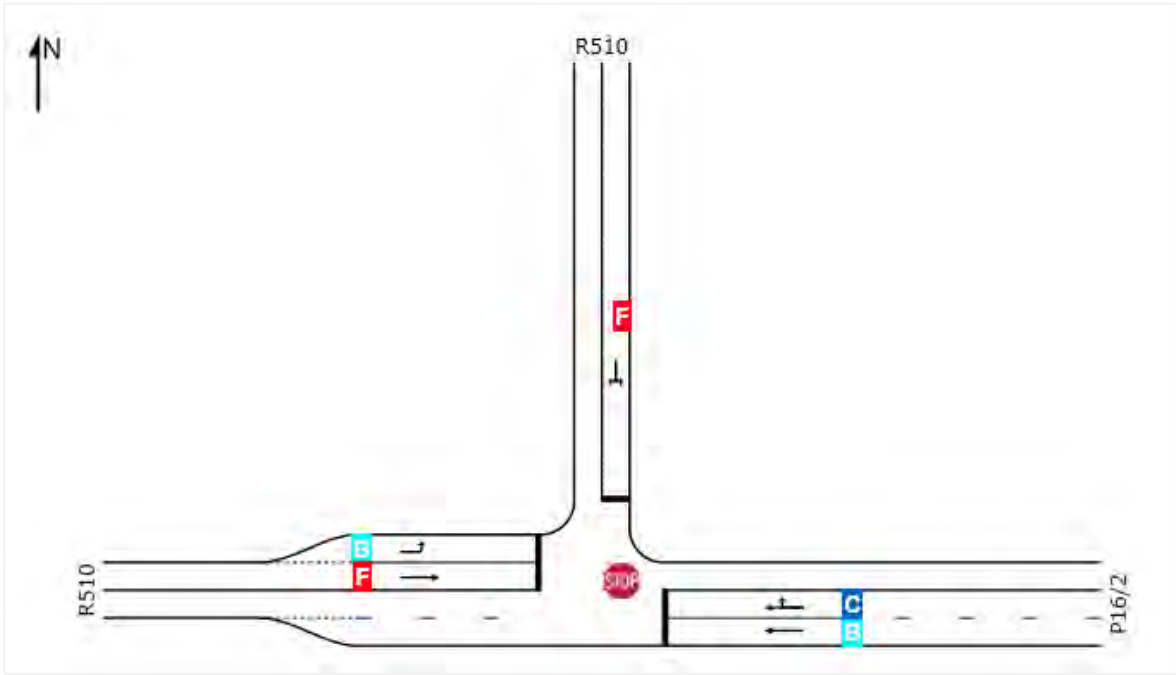
Figure 4-7 R510/P16/2 Intersection layout and LOS summary - Winter

This intersection shown in Figure 4-7 consistently fails during the PM Peak hour during both the Thursday and Friday capacity analysis. The intersection is an All-Way Stop Controlled (AWSC) junction with additional lane provision on the R510.

It is recommended that the intersection is monitored during the construction period and should queues greater than 4 vehicles form on any of the approaches (signal warrant as per SARTSM Vol. 3) then a temporary signal is installed by the Contractor.

Although a signal might be required under current conditions it is recommended that the local municipality is first consulted as they may not have the capacity or resources to maintain the signal. It was noted during the site investigation, that one of the signals along this section of road was switched off and the intersection had reverted to an AWSC, which could be owing to the aforesaid lack of resources.
