Title: SCOPE OF WORKS ALPHA
 BETA 1 765KV TOWER 672 GUY
 ANCHOR FAILURE

Unique Identifier: 240-98155775

This document shall apply to Alpha Beta Line 1 765kV tower 672.

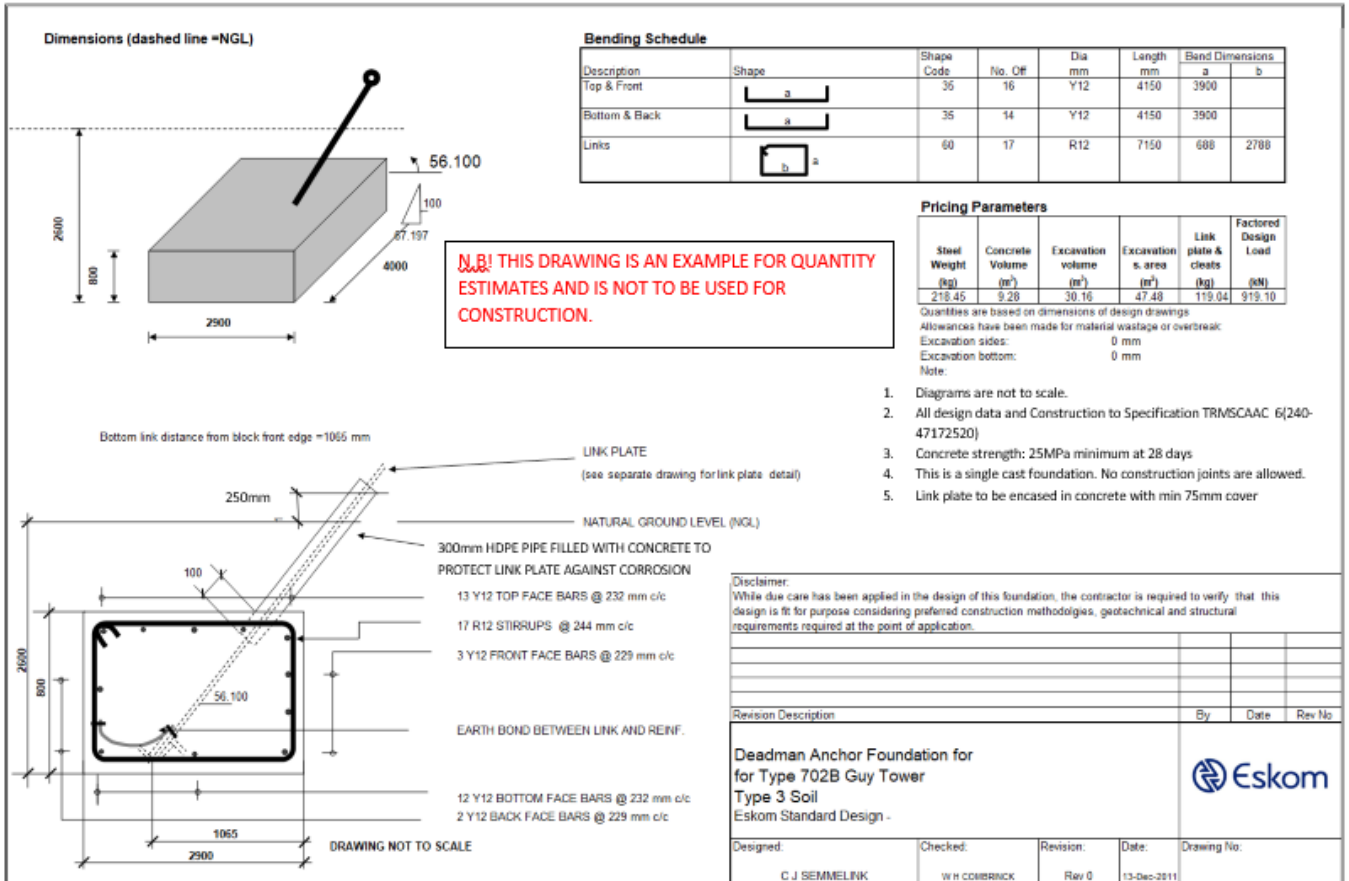
Figure 16: Foundation concept drawing

A new guy anchor foundation will need to be installed for all four anchors. Figure 13 below shows the new anchor position(A',B',C',D') in respect to the existing foundation position(A,B,C,D).

- The new foundations is to be designed (by a professionally registered (ECISA) engineer) and constructed by the Contractor as per the TRMSCAAC 6 (Ref 2.1 Normative section [1]).

- The design should be approved by Eskom LES before construction commences.
- Care must be taken when installing the new foundation to ensure that it does not clash with the existing foundation.

- The Contractor will need to confirm the soil type prior to the execution of works to ensure that the correct foundation can be design and constructed.
