## 2. Background

## 2.1 Problem description

This document aims to clarify the scope of work for the mechanical refurbishment of the cross over plant at Kendal Power Station

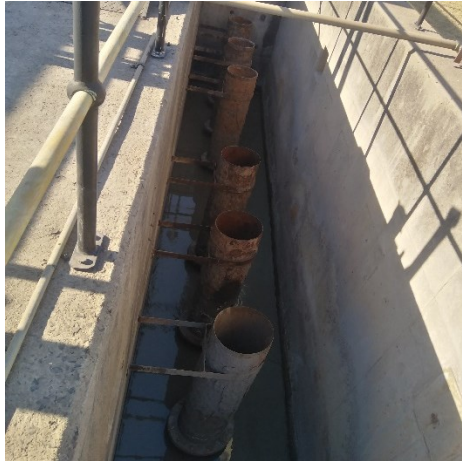
All 12 clarifier separator tubes are rusted and needs to be replaced and 2 of the 12 are leaking at the bottom

- Replacement of all 12 clarifier separator vertical pipes/tubes with stainless steel tubes – 12 of 3m 350mm Schedule 40 stainless steel pipes

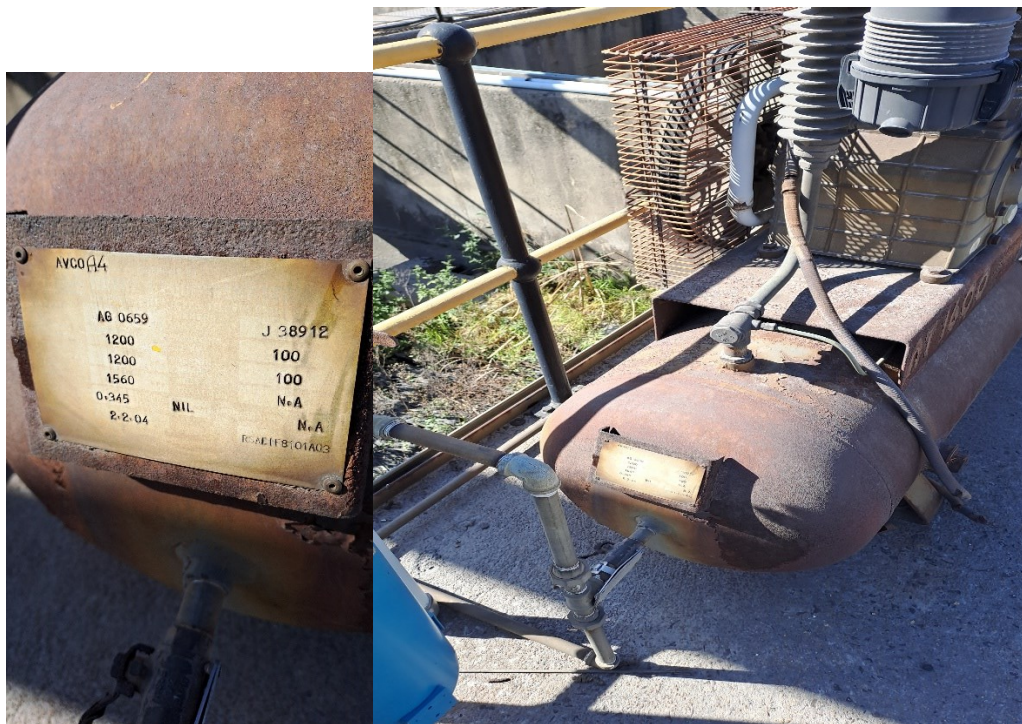
Oil separation compressor plant has been out of service for a very long time. The compressor itself is rusty due to exposure to unfavourable weather conditions. The system needs to be replaced completely.

- Replacement of 2 all clarifier discharge valves - 50mm Saunders diaphragm valve
- Replacement of all 8 clarifier sludge sump pump supply isolation valves - 100mm Saunders diaphragm valve
- Servicing of both pneumatic pump system
  - ARO pneumatic pump
  - Model : 666150 – 322
  - Serial No.: 10043810
  - Max working pressure: 8 Bar
- Replacement of all filters
  - Ultraspil filter
- Replacement of oil separation compressor system

- Min pressure output = 1200 kPa
- Max pressure output = 1560 kPa
