OUTAGE SCOPE OF WORK FORM/TEMPLATE

**Matla Power Station
Outage Scope of Work for Cooling Towers (CT) 1 to 6**

Reference No.	MEA-
Revision:	0
Unit No.	4
Genix ID.	24423
Date:	13/08/2026

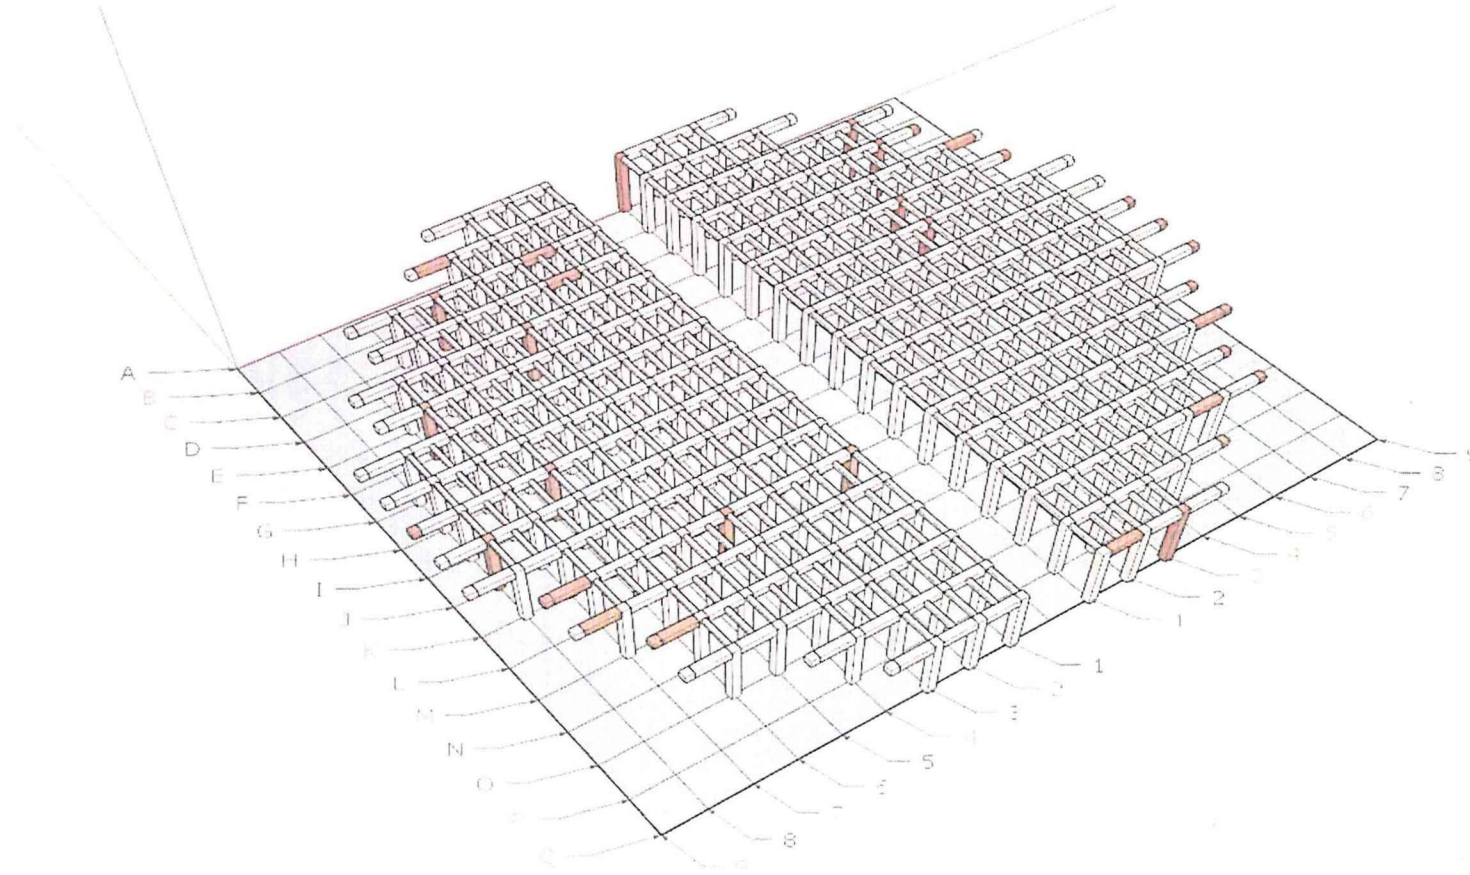
Figure 1: Tower internal arrangement

Evidence of damages in the Cooling Towers.

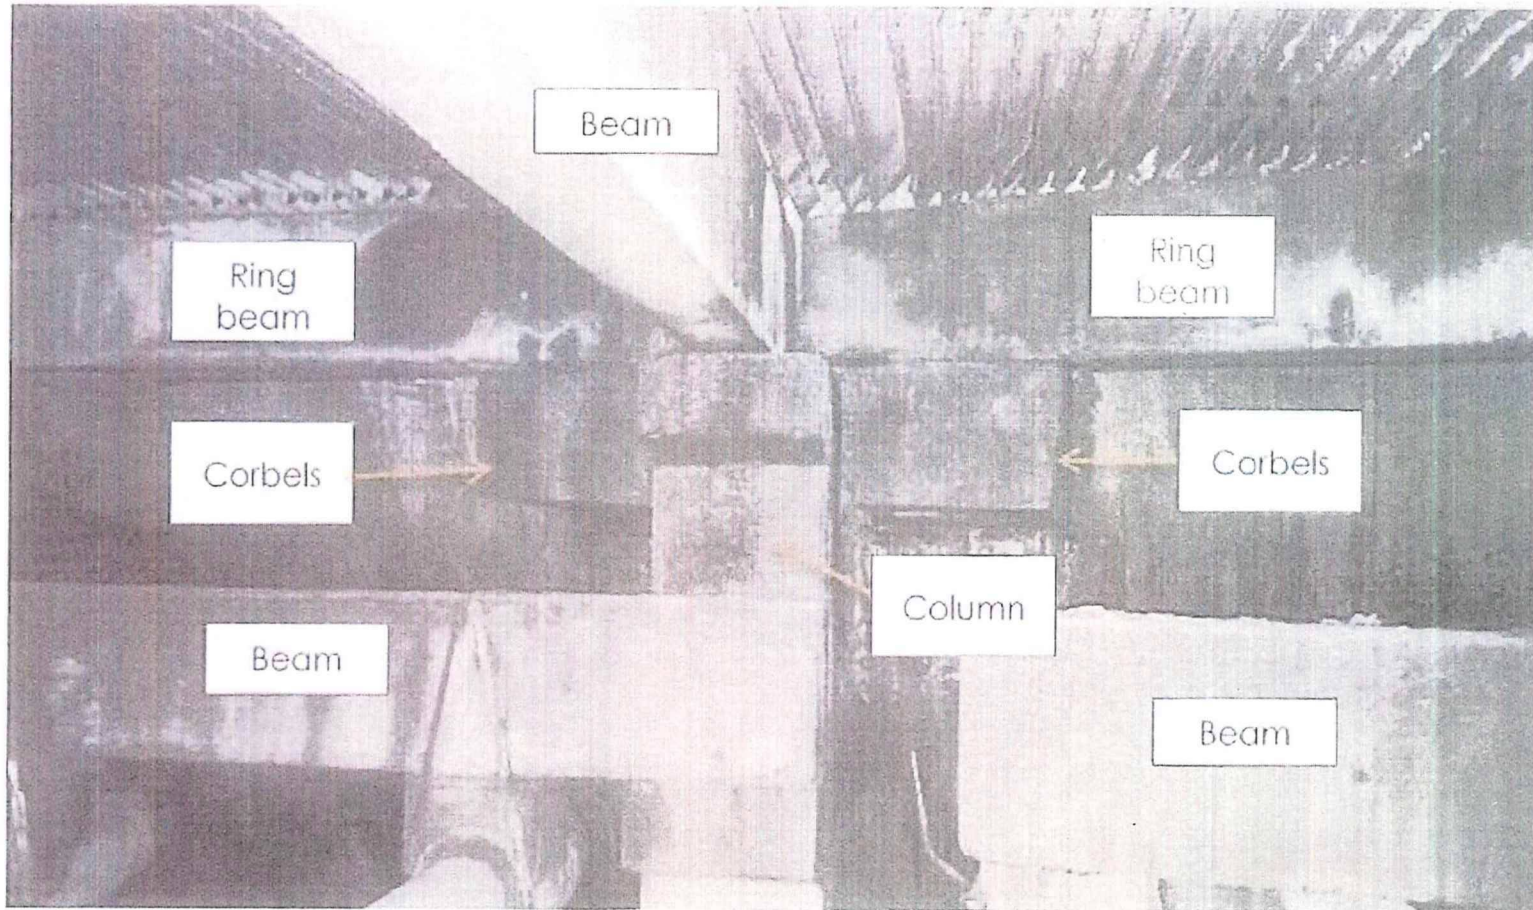
Figure 2: Basic labelling of the Structural components.

Columns, beams, Ring beam and corbel connections.

The columns, ring beams and corbels generally have a low degree of damage, but there are a few beam connections that have a medium degree of damage with misalignment and cracking due to thermal movement. These beam connections need to be repaired or sealed per the concrete repair method (Please refer to method stated below. Knee braces (see below) should be installed at all affected column beam connections. The knee brace will tie the columns to the beams and prevent any future movement.

The knee braces are to be installed at all affected column beam connection. The knee brace will tie the columns to the beams and prevent any future movement. The knee brace consists of 150x150x10 angle 300mm long with 4 M16 grade 8.8 stainless steel chemical anchors and a 10mm stiffener between the bolts.
