**Report Name** : CTCT Substations Conditional Assessment

Transnet Port Terminals Engineering team has been tasked to undertake a conditional assessment of substations in the Port of Cape Town. The idea is to ensure a safe and reliable electrical infrastructure. The current infrastructure is now old with limited available spares which poses a risk of power supply to operations. It is a requirement by law to entirely make a substation compliant to at least the minimum enforced regulations once you attempt to undertake upgrades of plant such as switchgear. It is for this reason that a thorough conditional assessment was conducted. This document is a resultant assessment report to recommend the required upgrades especially for compliance to regulations.

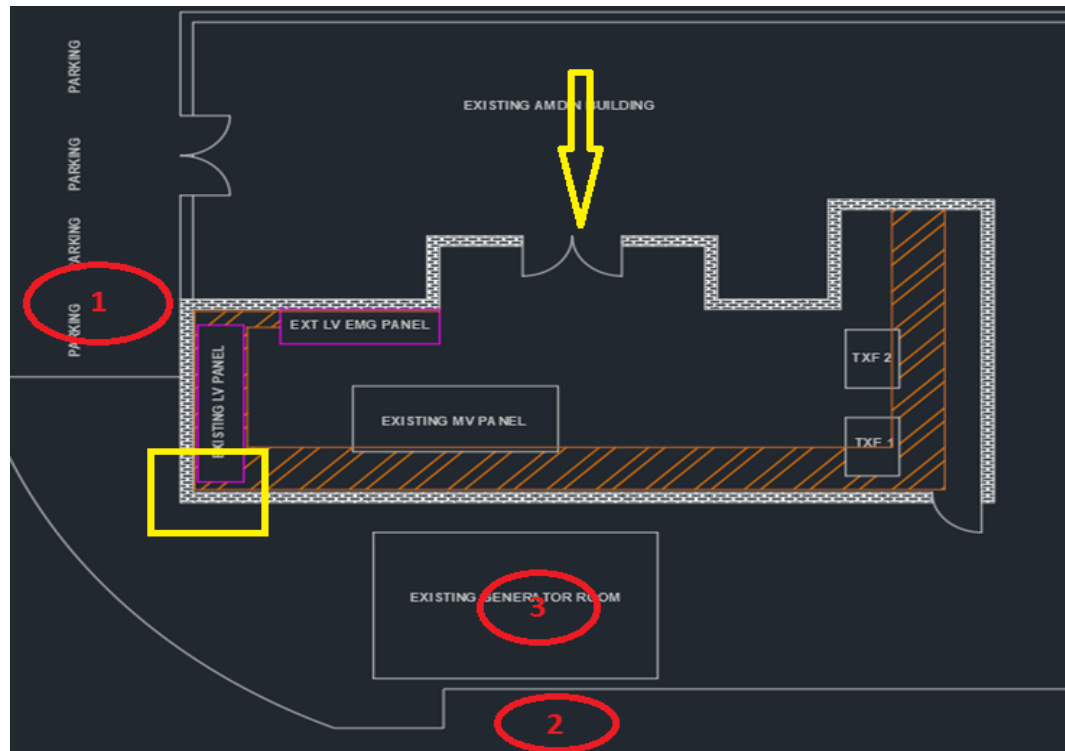
Figure 9: Container admin Building layout and surrounding arrangement:

- 1.1.2.3.3 The LV switchgear makes use of circuit breakers which is recommended than the fuse technology. The switchgear shown in figure 9 is now old and is an old design that is not compact. See figure 9.
- 1.1.2.3.4 Next to the main LV switchgear that is fed from the transformers, there's a Generator LV panel that is also fitted with circuit breakers. See figure 9,2. This panel is also old strictly dedicated to supply the lifts, UPS (*in the same room for the third floor*) and the third floor which is a control room. The installation is not simple to follow, with some unnamed breakers, but can be made simpler in the proposed upgrades.

The room is congested with all plant in one room, the solution making the substation complaint to working space requirements is to relocate the transformers to a proposed new room outside the substation. The proposed positions for the room are highlighted in red as shown in figure 10. Position 1 is a parking space behind the wall that is adjacent to the existing LV switchgear, position 2 is the roof space of the generator room and position three is also a special parking position as show in figure 11.
