MEMORANDUM NO. 03	
SUBJECT	: SCOPE OF ADDITIONAL FIELD INVESTIGATION: GEOTECHNICAL SUB-TASK 1.1.1E (2)
REVISION	: A
TO	: S Kelefetswe (TCTA)
FROM	: P du Plessis/P van Heerden/S Seath/R Tluczek
DATE	: 19 July 2019

1 OBJECTIVE OF THIS TECHNICAL MEMORANDUM

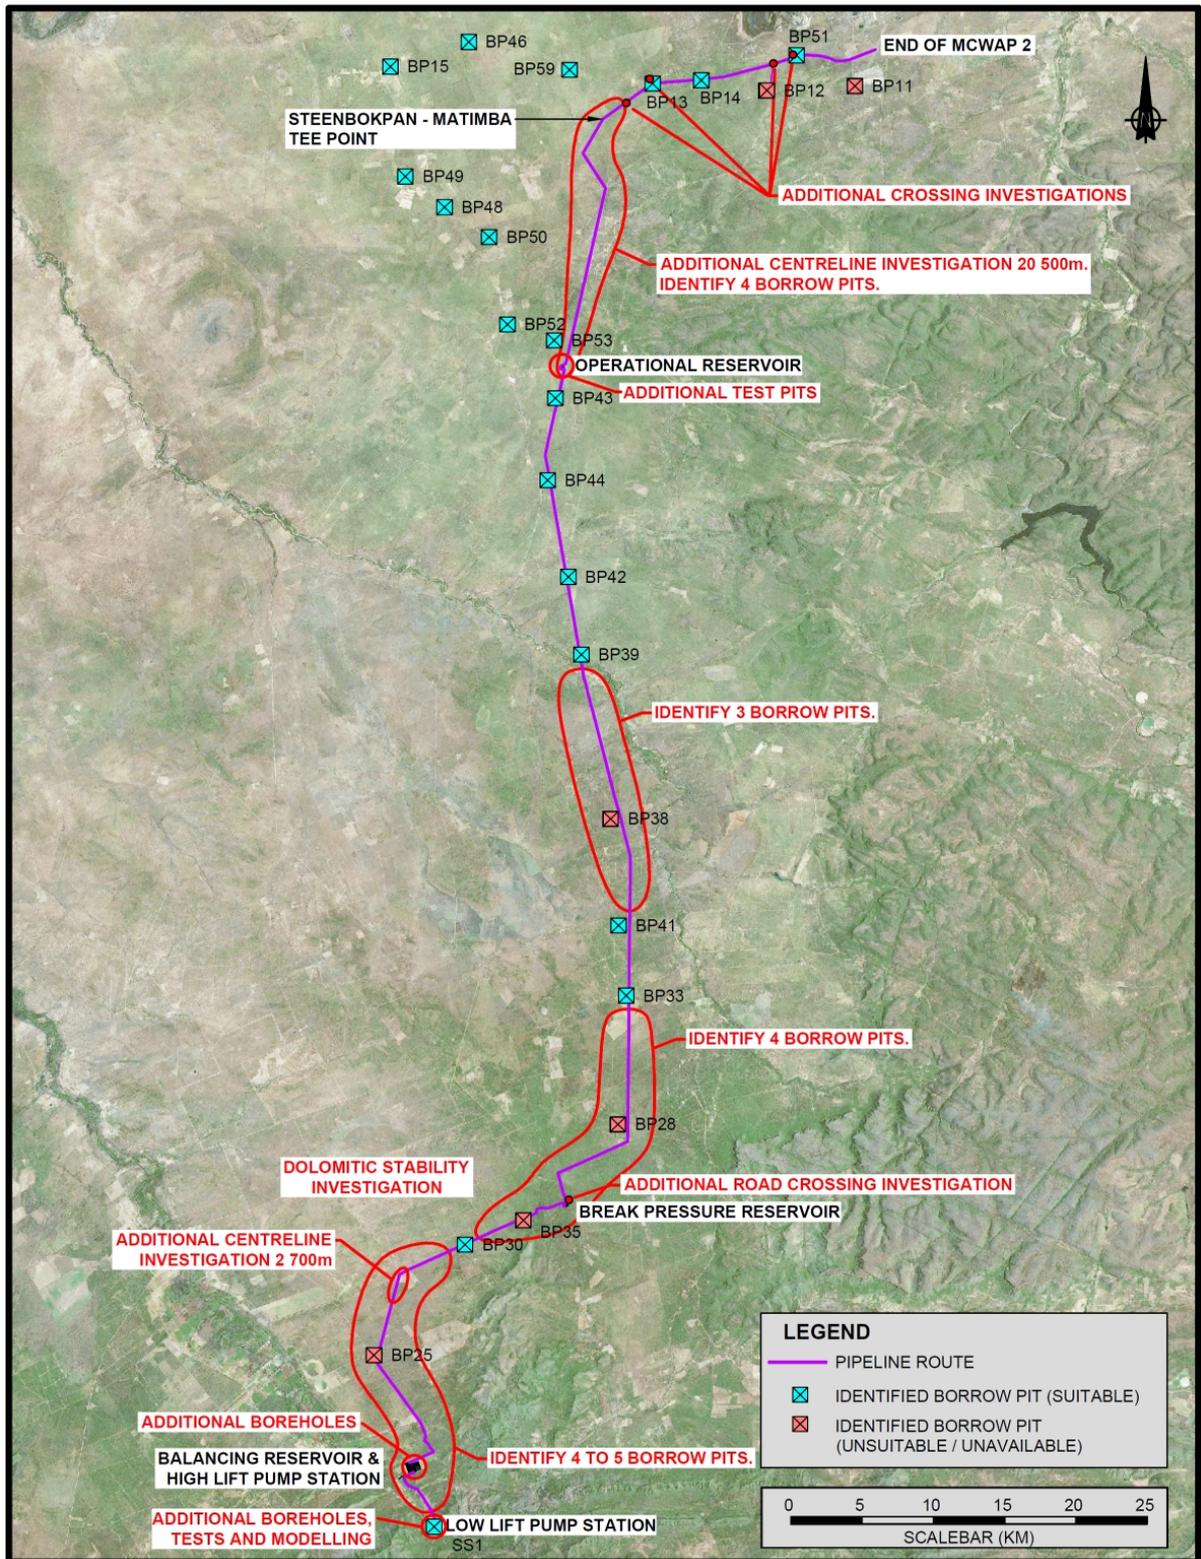
Figure 5: Extent of Required Additional Geotechnical Field Investigations

Recommended additional geotechnical investigations to be undertaken are indicated in **Figure 5** below and are summarized in **Sections 5.1** and **5.2** below.

- a) Monitoring boreholes (for water level, water quality and geohydrological modelling);
- b) Rotary core boreholes;
- c) Cone Penetration Test including pore pressure measurements (CPTu);
- d) Geohydrological modelling; and
- e) Geophysical surveys at the position of potential new weir location.

It is proposed that the rotary core boreholes be drilled at least 10 m into the underlying rock, to confirm whether the thickness of the upper ironstone layer is sufficient over the underlying dolomites, i.e. that the dolomites do not have to be considered in the project design.

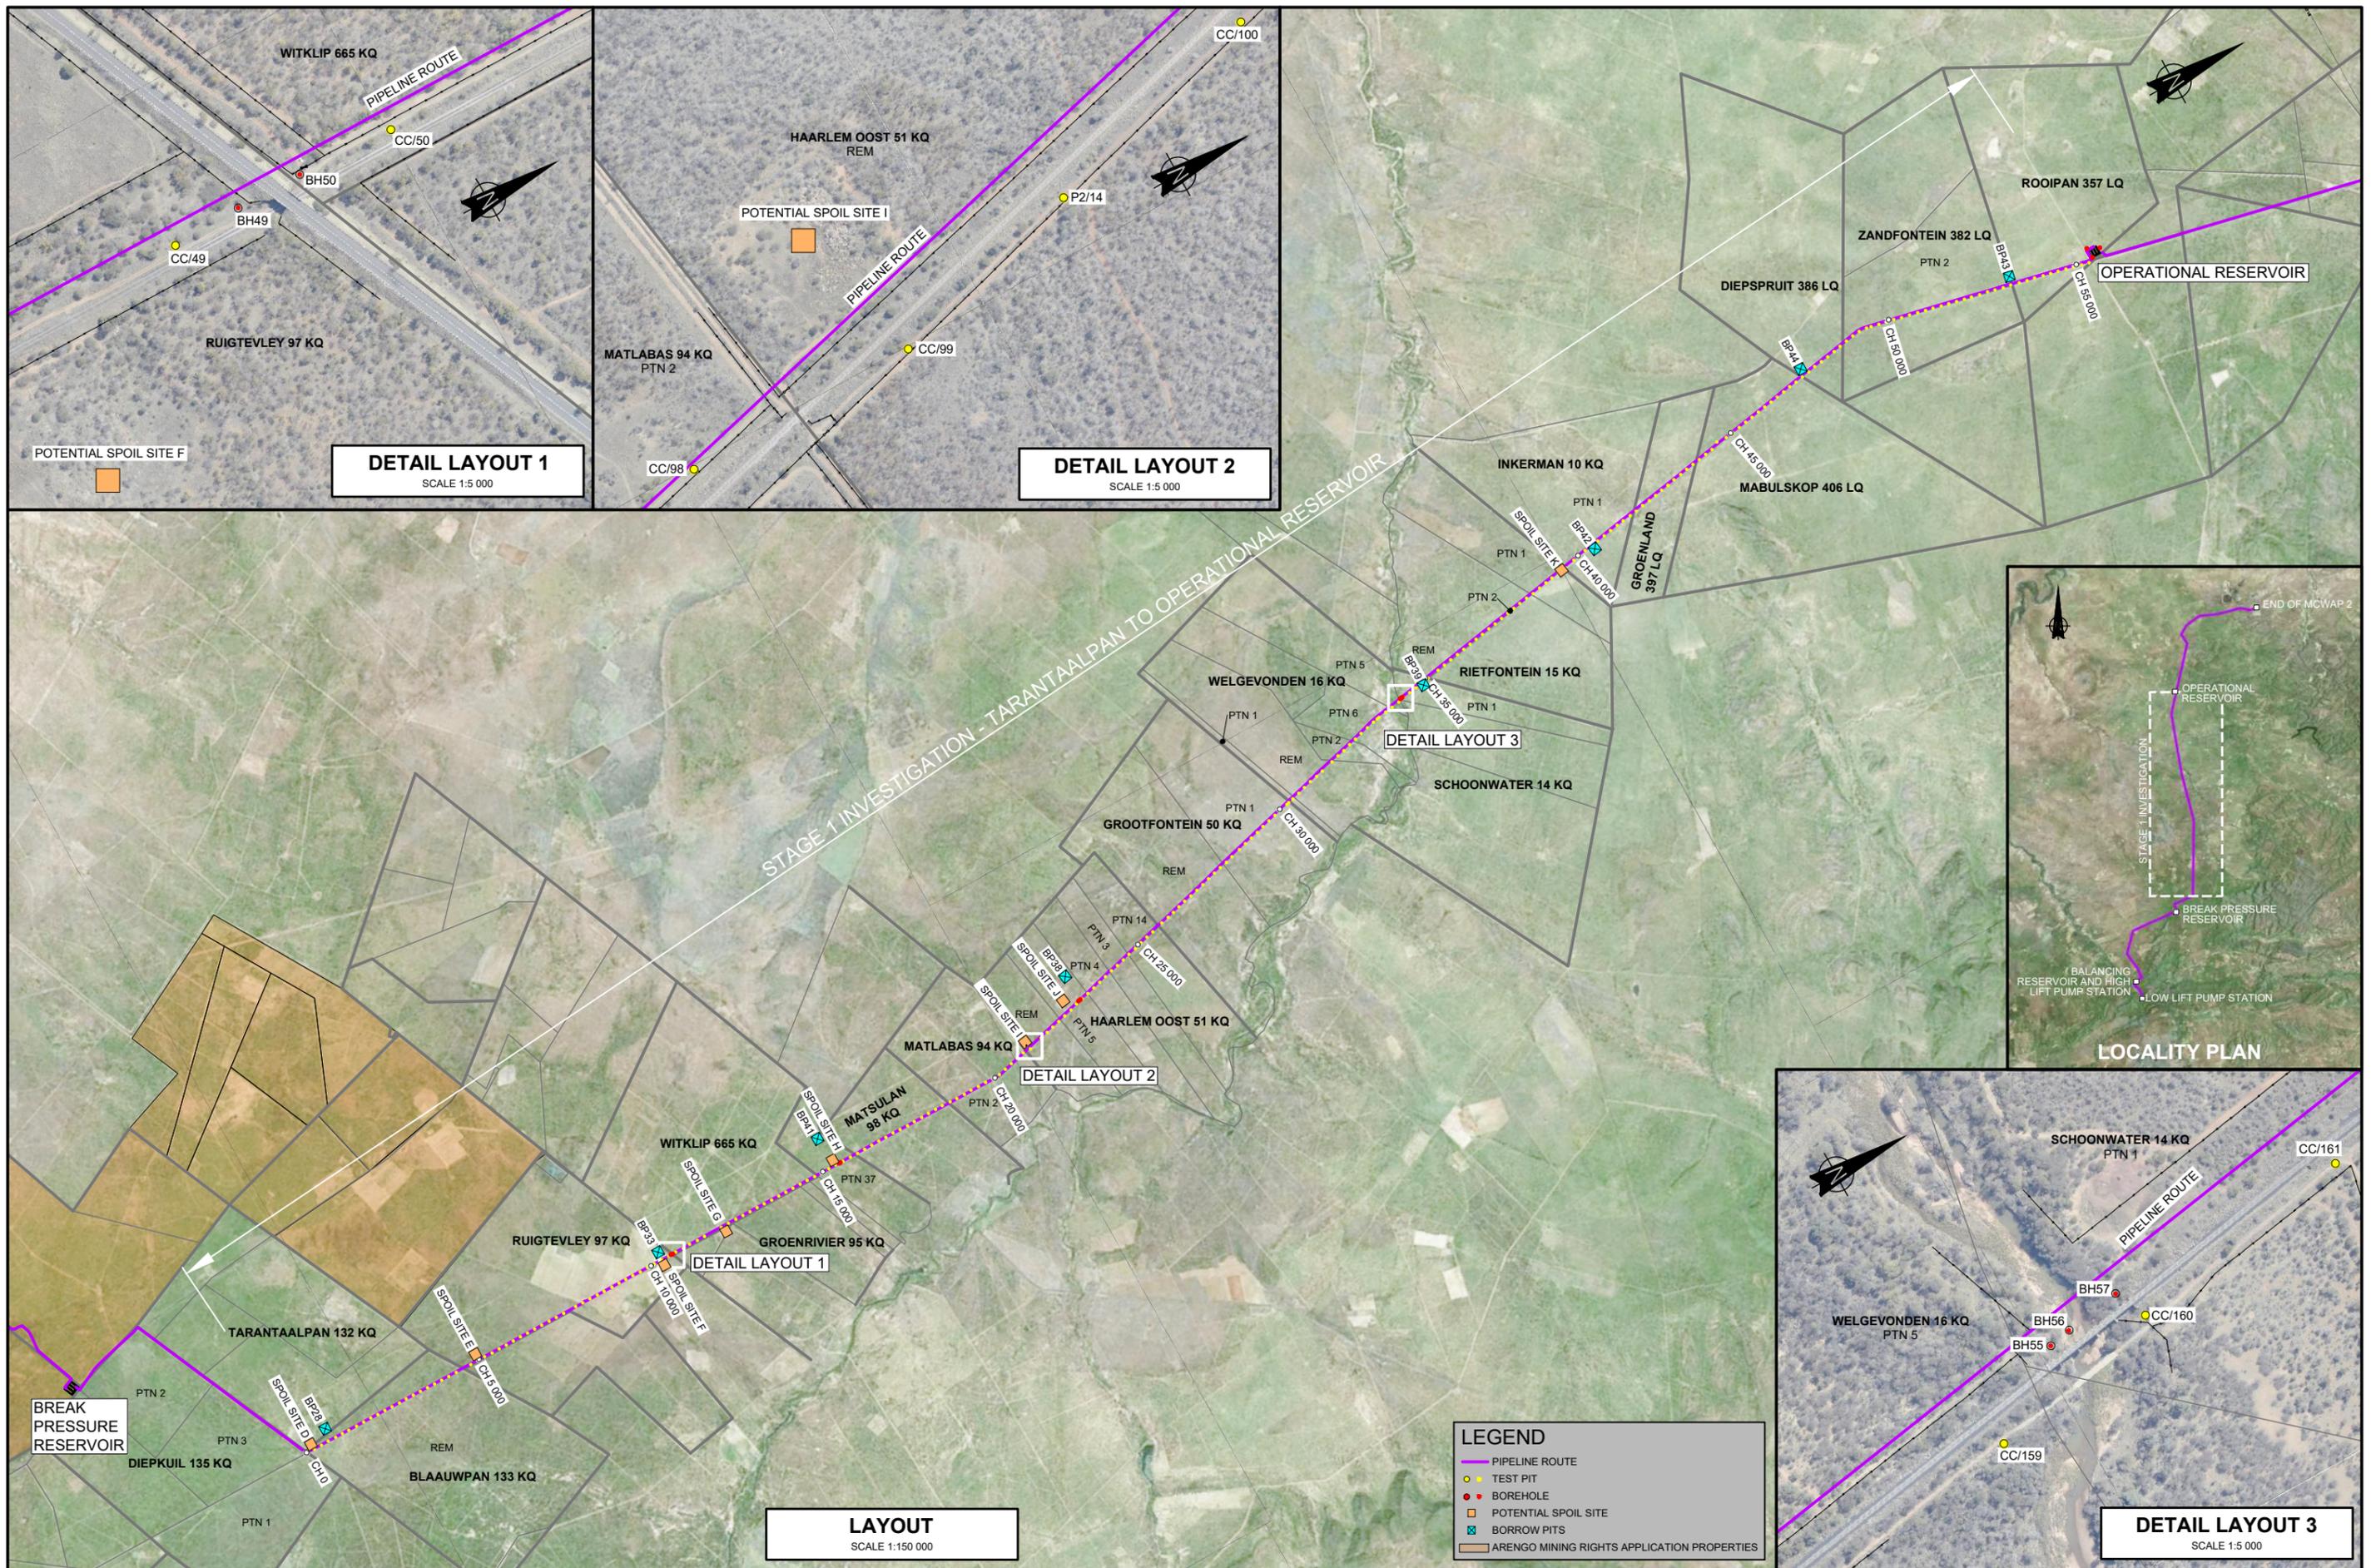
FIGURE 1: EXTENT OF PREVIOUS GEOTECHNICAL WORK - STAGE 1 INVESTIGATION - TARANTAALPAN TO OPERATIONAL RESERVOIR

From CH 21 000 m to CH 55 300 m the test pits were dug within the rail reserve on the eastern side of the rail way line approximately 50 m to 55 m away from the pipeline centreline. Refer to **Detail Layout 2 in Figure 1** that reflects the typical test pit positions along this section.

Boreholes were drilled at the Road R510, railway overpass, Road D2701 and Matlabas River crossings along the pipeline route. Boreholes were located within the rail reserve on the western side of the railway line approximately 15 m to 20 m away from the pipeline centreline. Refer to **Detail Layout 1 and Detail Layout 3 in Figure 1** that reflects the typical borehole positions along Stage 1.

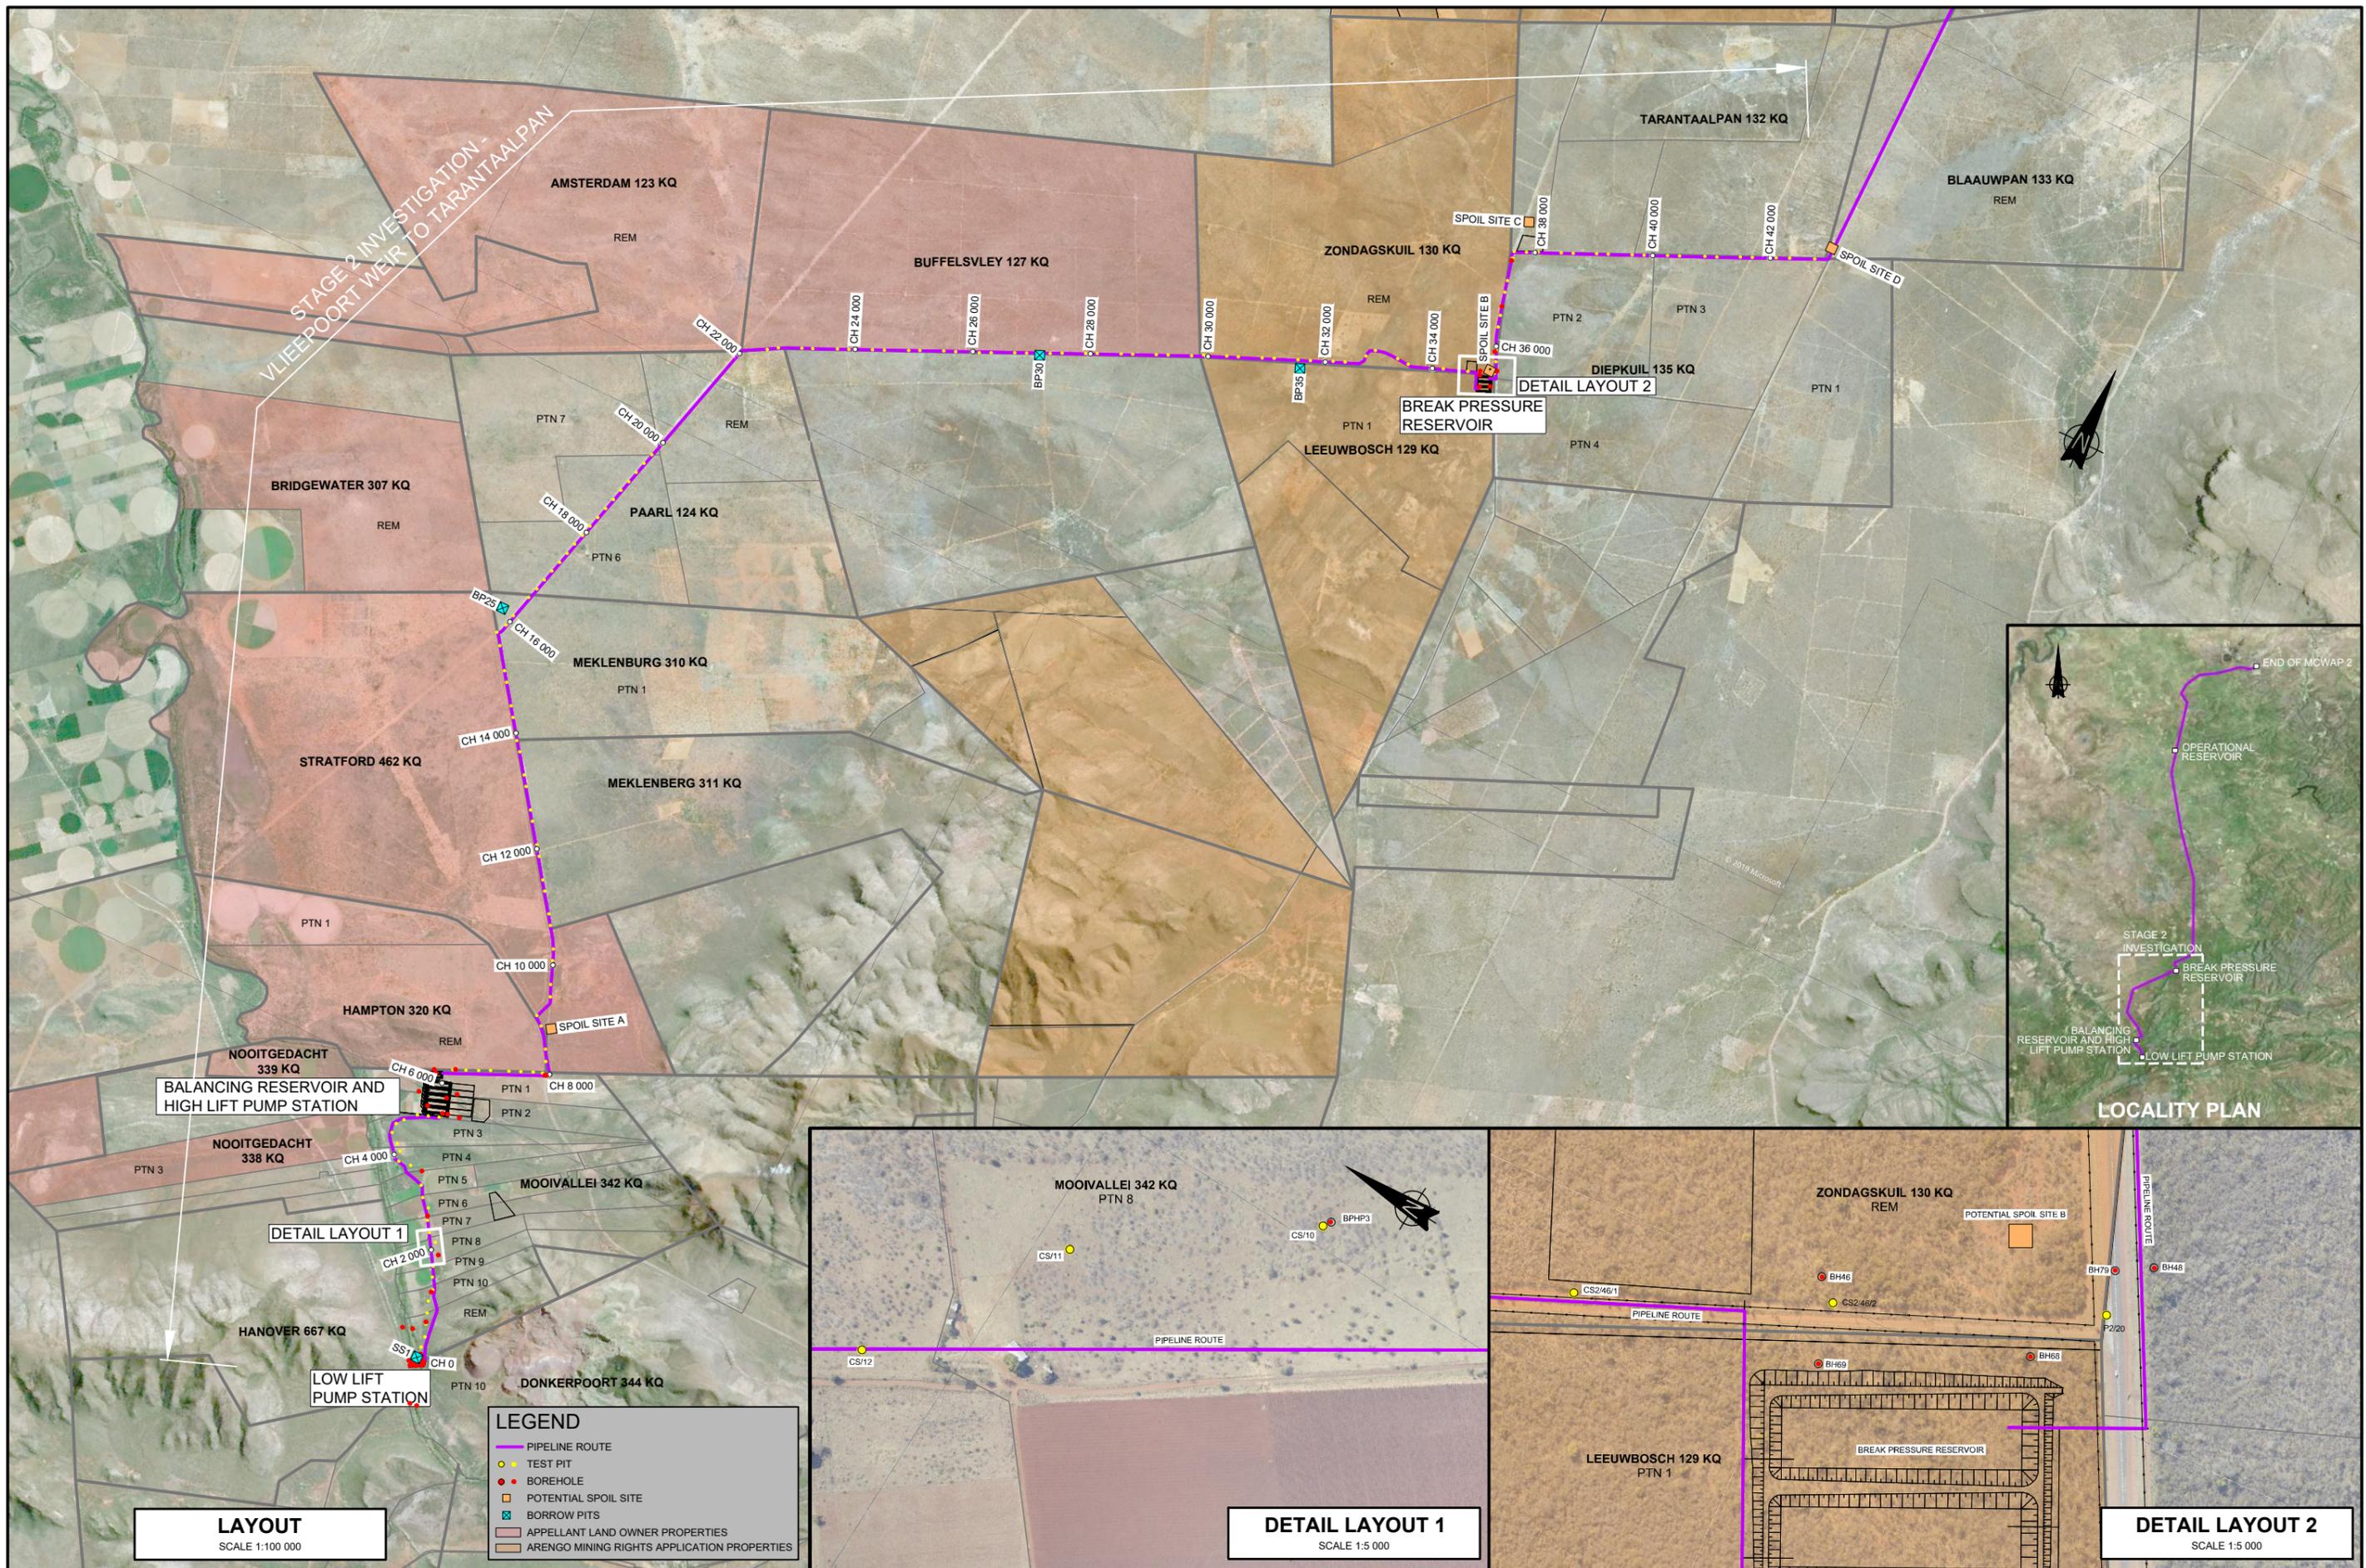
FIGURE 2: EXTENT OF PREVIOUS GEOTECHNICAL WORK - STAGE 2 INVESTIGATION - VLIEEPOORT WEIR TO TARANTAALPAN

The Stage 2 pipeline alignment is reflected in **Annexure A, Figure 2**. The extent of geotechnical investigations that were undertaken includes test pits, boreholes, identification of potential spoil sites, borrow pit investigations and a dolomitic stability investigation. The locations of these investigations are also reflected in **Annexure A, Figure 2**. EA appellant land owner properties and Arengo mining right application properties are also indicated.

From CH 0 m to CH 5 500 m (low lift rising main) approximately 40% of the test pits are located some distance away from the pipeline alignment. As an example refer to **Detail Layout 1** in **Figure 2** that reflect two test pit positions respectively 80 m and 100 m away from the pipeline alignment. Also note the structure being traversed by the pipeline alignment. This matter will be investigated further, when servitude and reserve boundary cadastral data has been obtained, as part of the design studies task (optimise and refine pipeline routes).

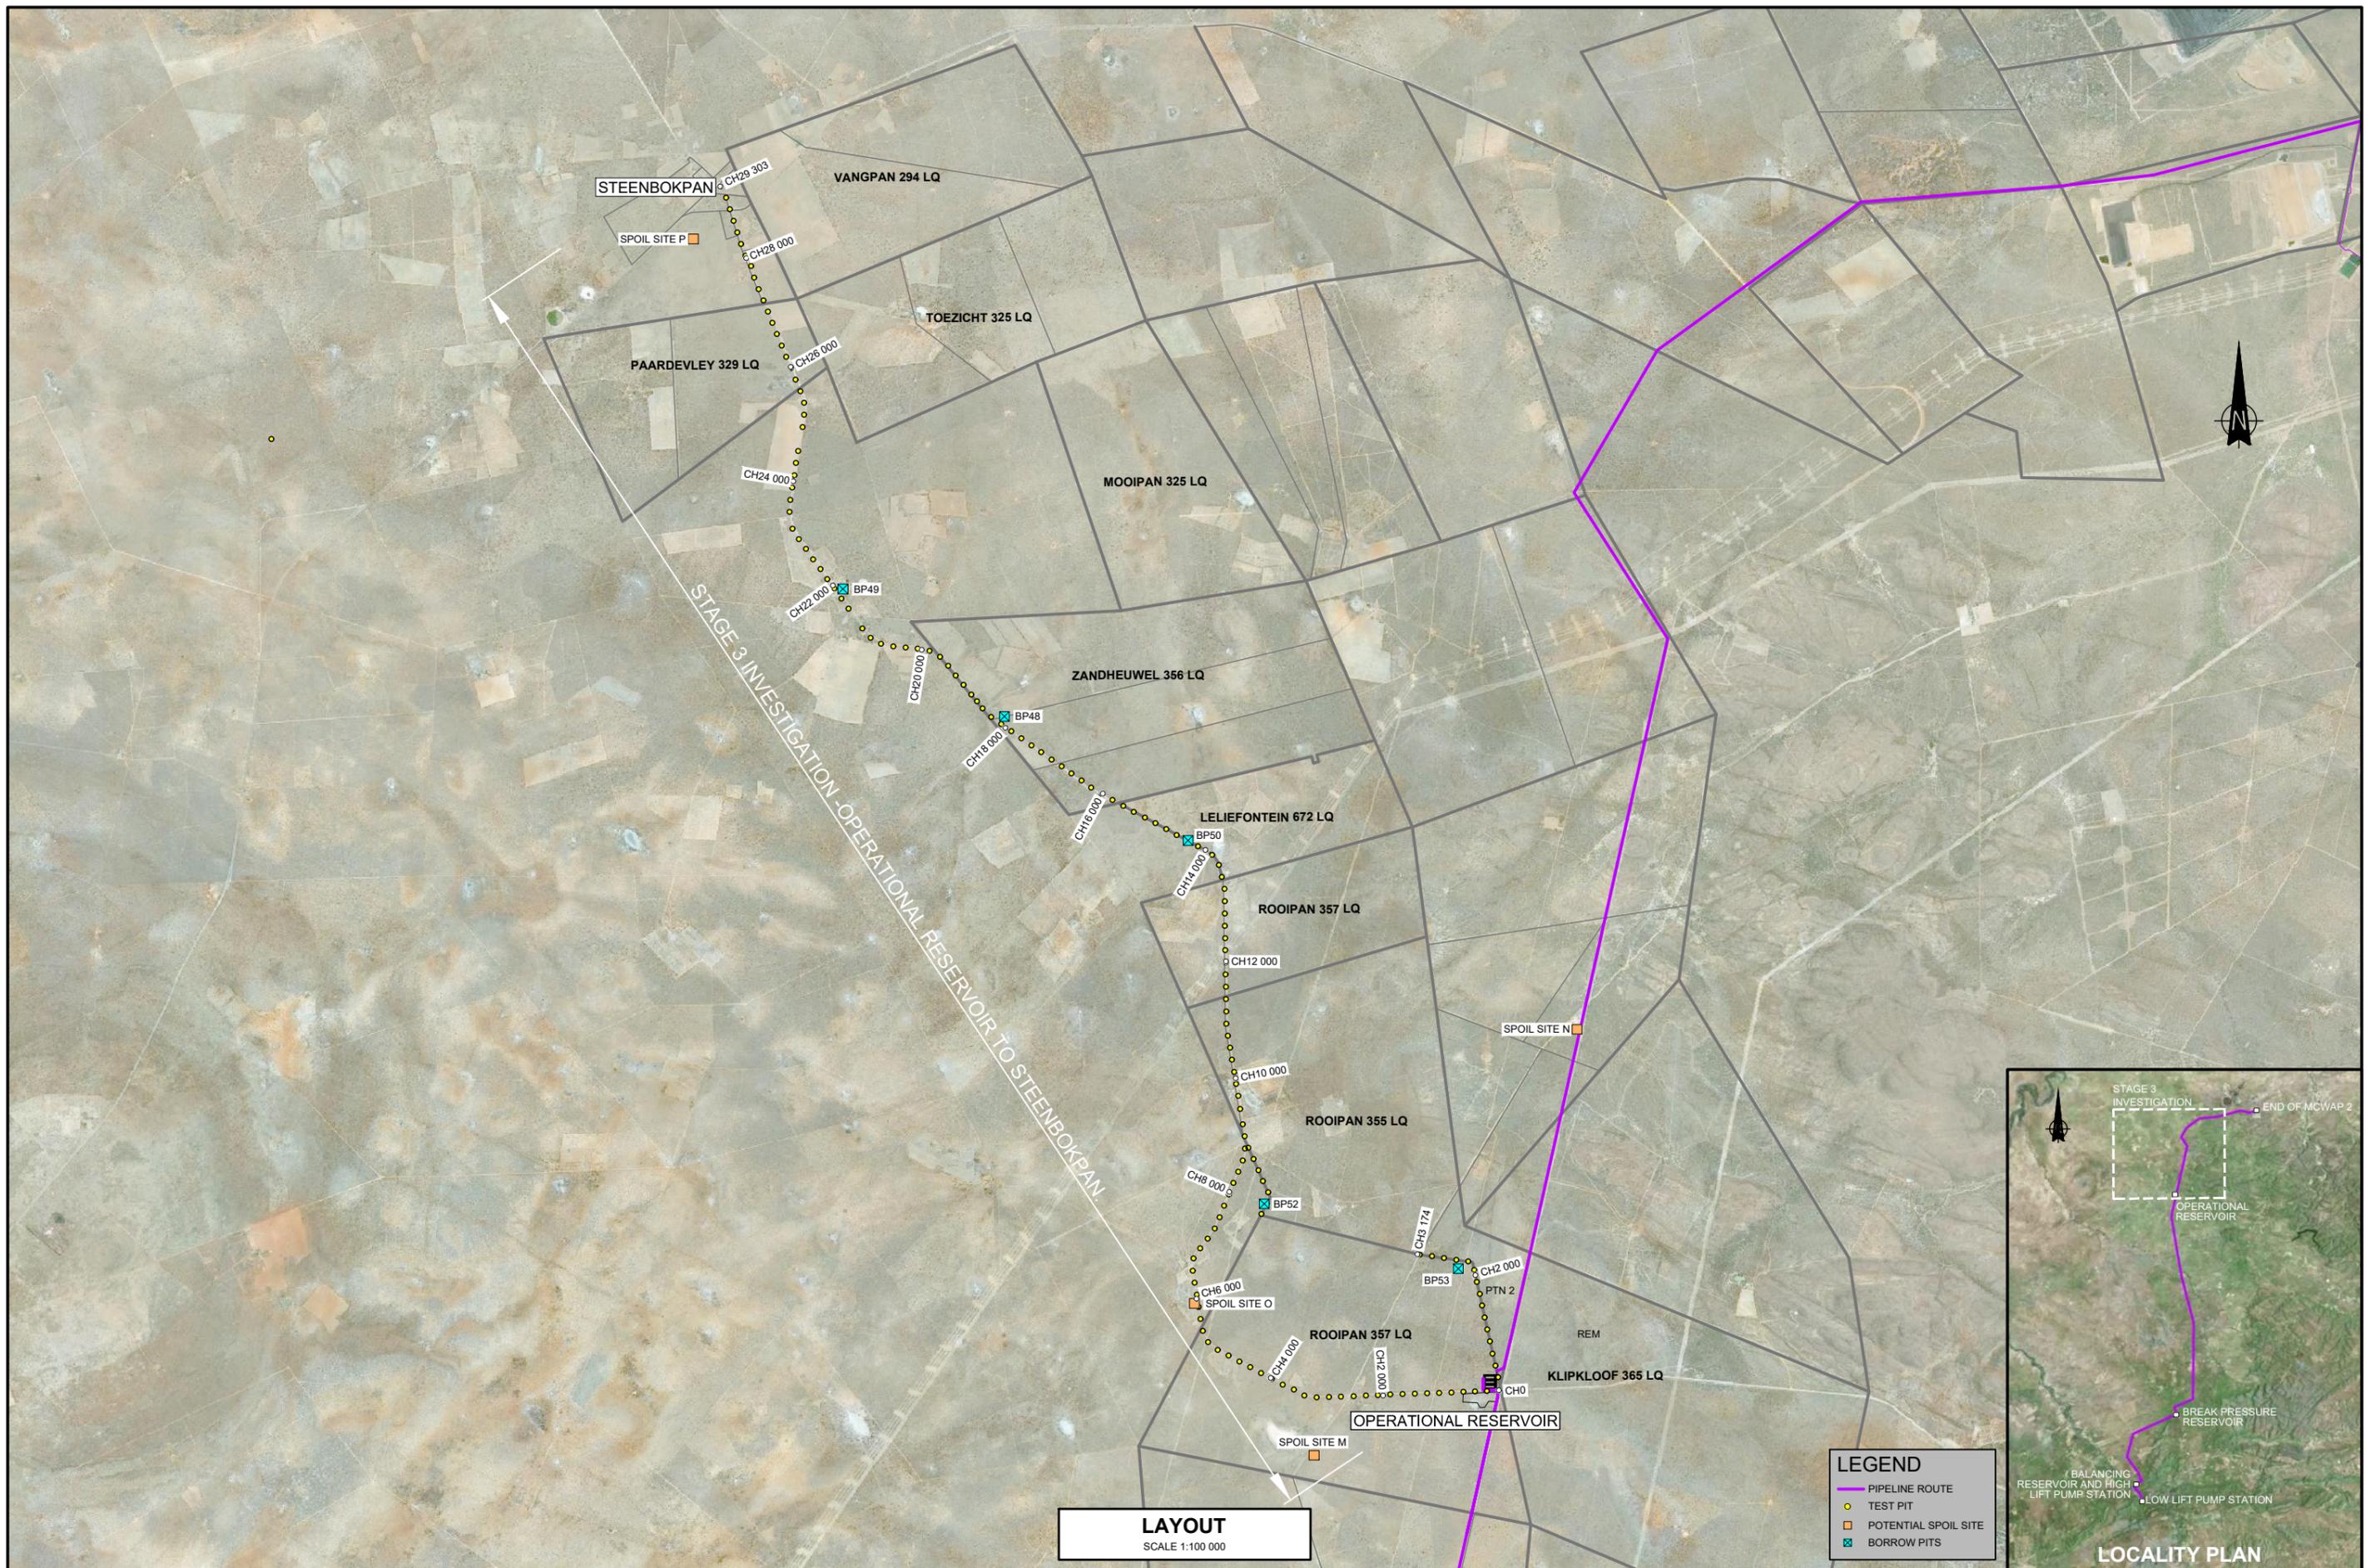
FIGURE 3: EXTENT OF PREVIOUS GEOTECHNICAL WORK - STAGE 3 INVESTIGATION - OPERATIONAL RESERVOIR TO STEENBOKPAN

The Stage 3 pipeline alignment is reflected in **Annexure A, Figure 3**. The extent of geotechnical investigations that were undertaken includes test pits, identification of potential spoil sites and borrow pit investigations. No boreholes were drilled as part of the Stage 3 investigation. The locations where investigations were done are reflected in **Annexure A, Figure 3**.

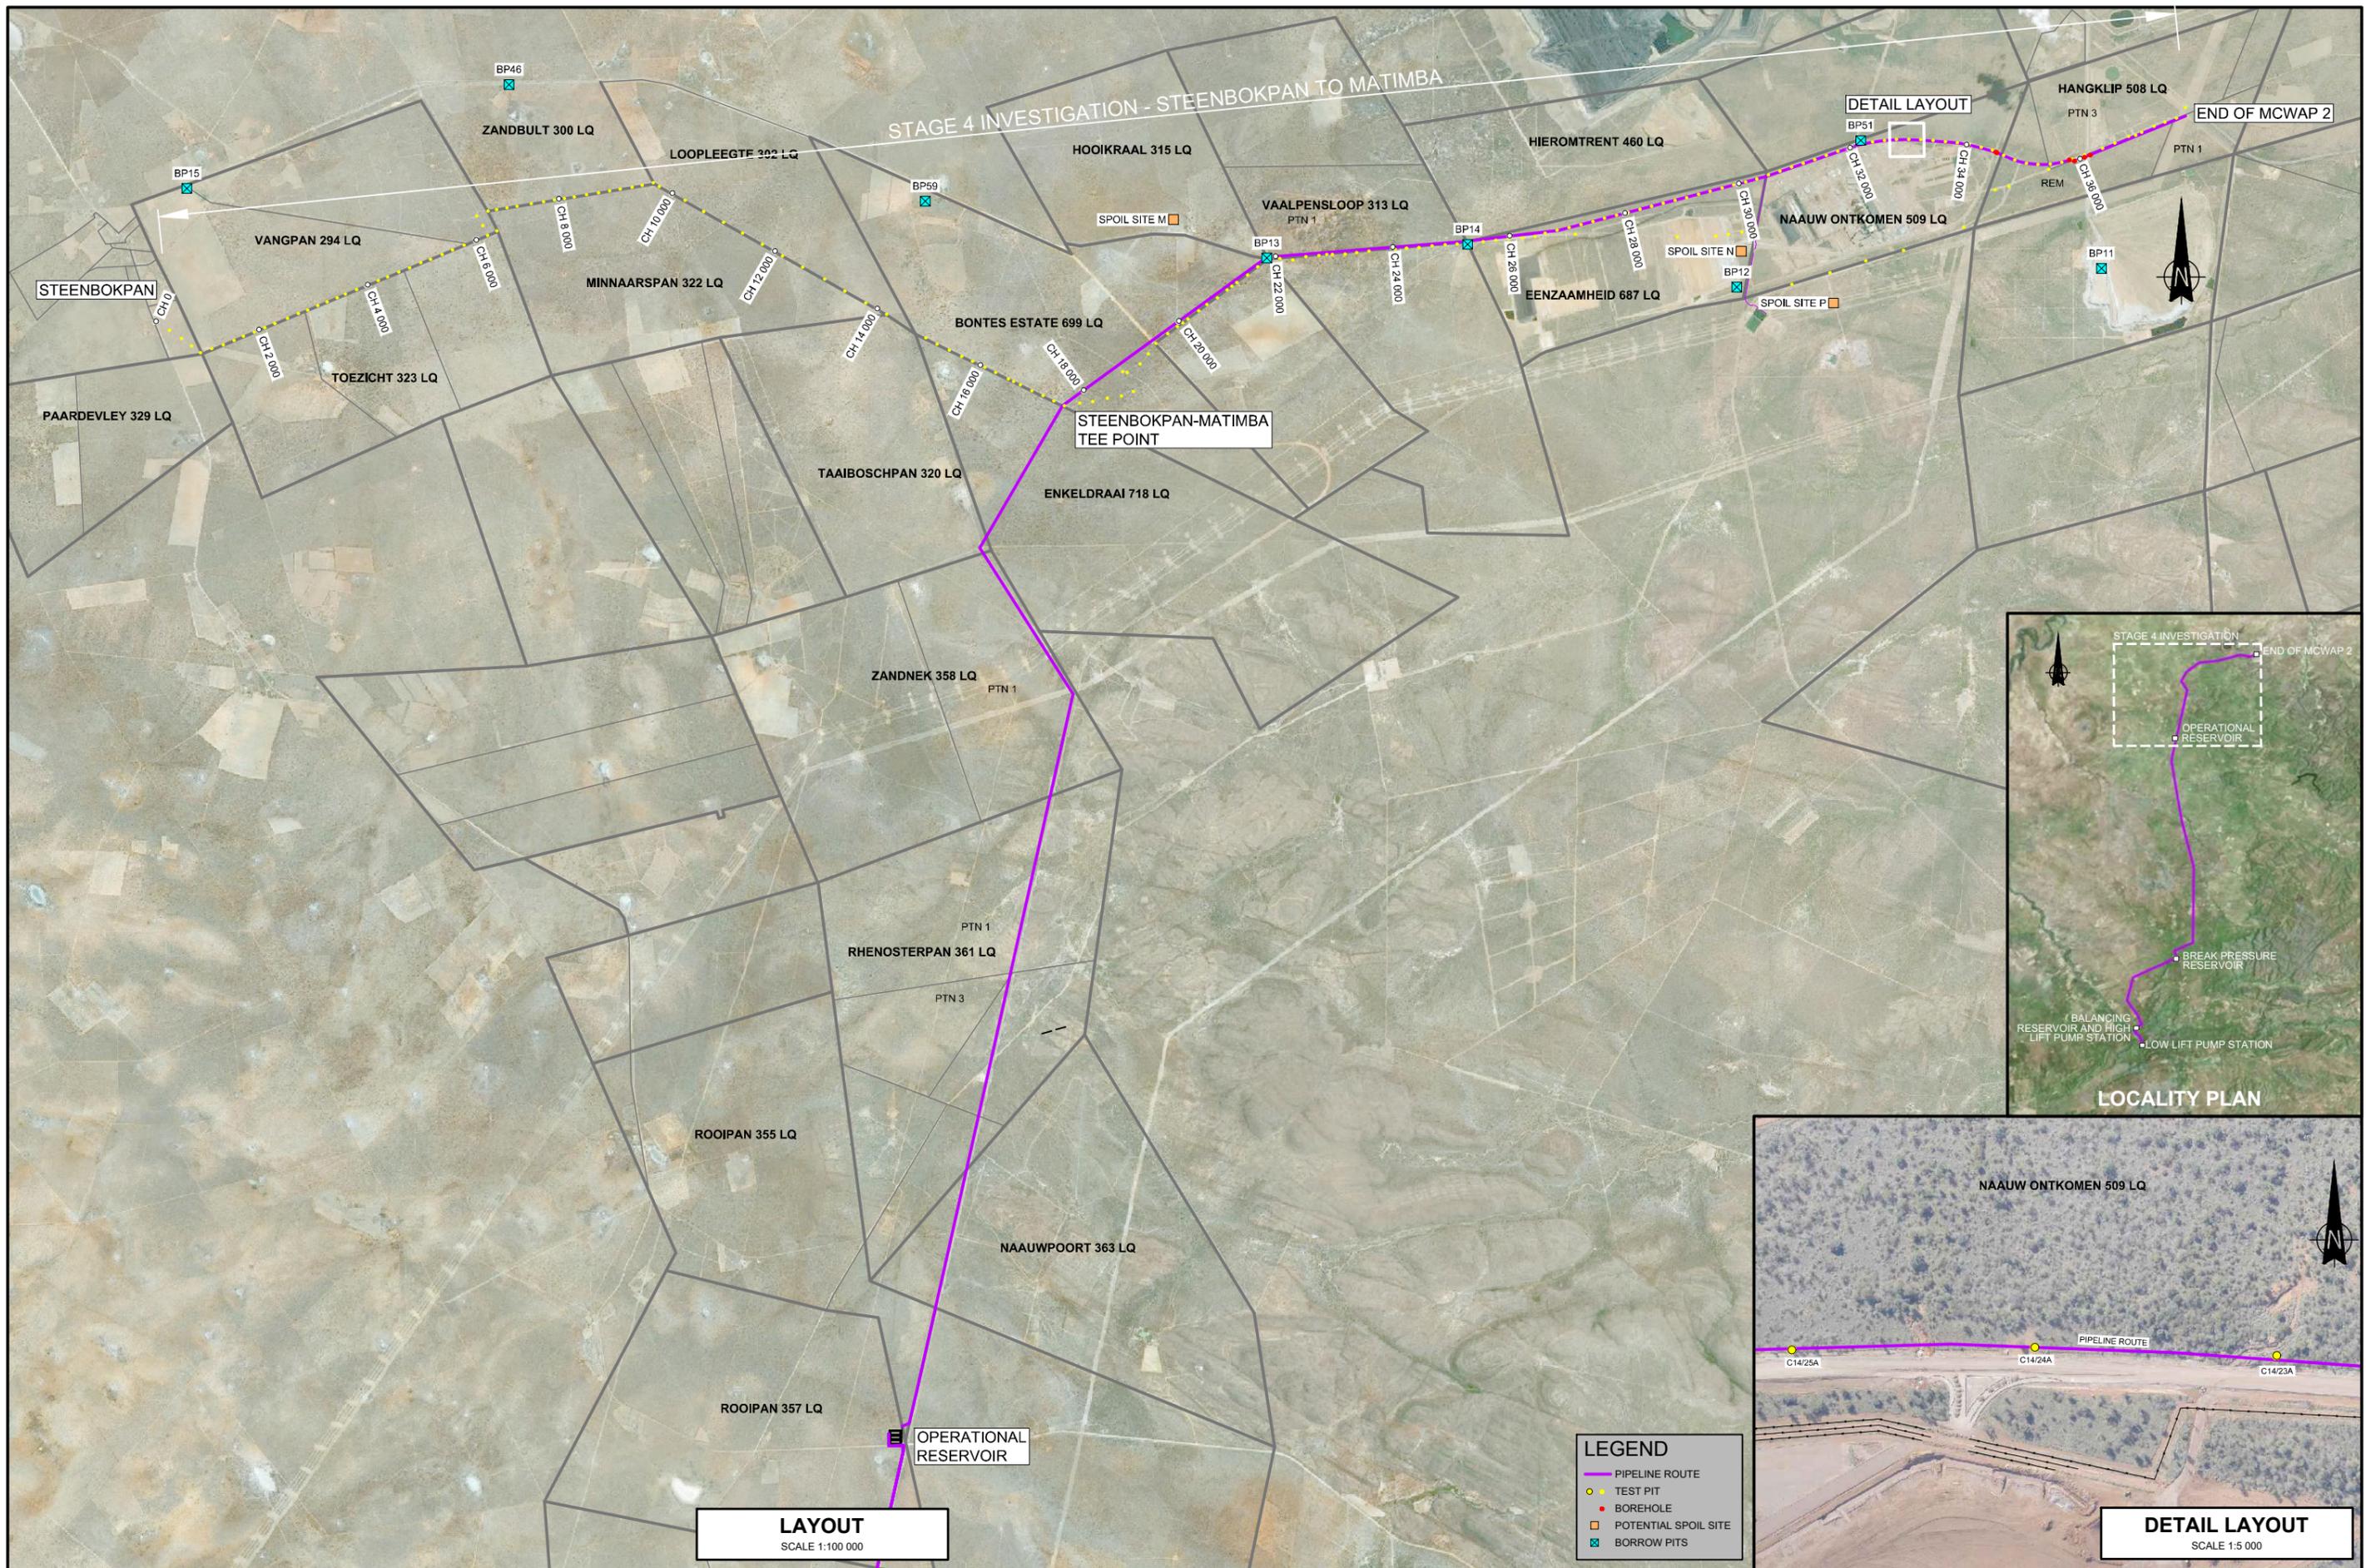
FIGURE 4: EXTENT OF PREVIOUS GEOTECHNICAL WORK - STAGE 4 INVESTIGATION - STEENBOKPAN TO MATIMBA

The Stage 4 pipeline alignment is reflected in **Annexure A, Figure 4**. The extent of geotechnical investigations that were undertaken includes test pits, boreholes, identification of potential spoil sites and borrow pit investigations. The locations of these investigations are also reflected in **Annexure A, Figure 4**.

Boreholes were drilled at the Road D1675 crossing, railway crossing and conveyor crossing. All three these crossings are located between the Medupi and Matimba Power Stations as reflected in **Figure 4**
