Business Management System Inspection Report Gourikwa – GT21 Minor Inspection	Document Identifier	195/453	Rev	0
		Date	24/01/2023		
		Page	1 of 110

Document Type	Inspection Report
Outage ID	24390
Scope of Activity	GT21 Minor Inspection at Gourikwa Peaking OCGT
Purpose	This is a technical report on the “as found” condition, remedial action performed and final condition of plant or components.

Gourikwa GT21 was removed from service on 1 August 2022 in order to carry out Minor Inspection activities as identified in 240-136723367. Limited disassembly, intervention and reassembly activities were performed by site maintenance personnel, and inspections were performed internally by Eskom and ERI personnel, and were carried out from August 1st until August 5th. Areas inspected included: Filter house, Compressor Inlet, Compressor Exhaust, Combustion Chambers, Turbine Inlet and the Turbine Exhaust.

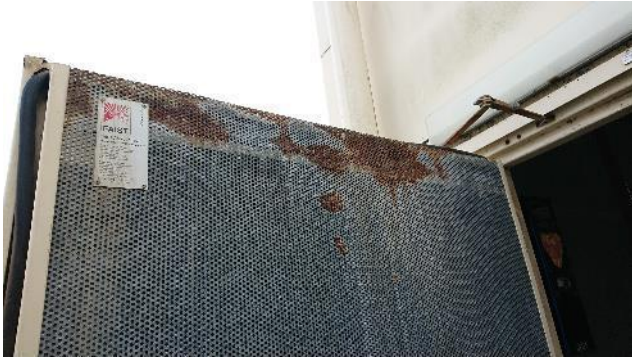
Figure 1: Door rusted

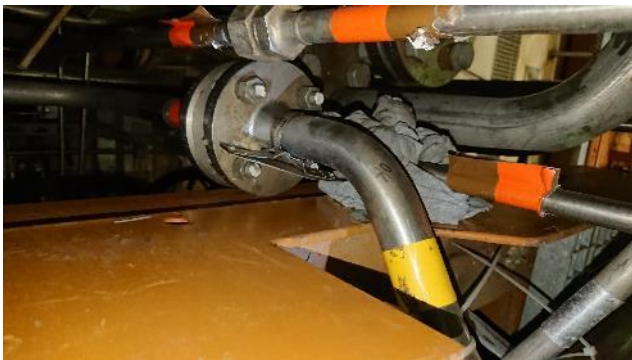
Figure 40: Material used to prevent pipe contact

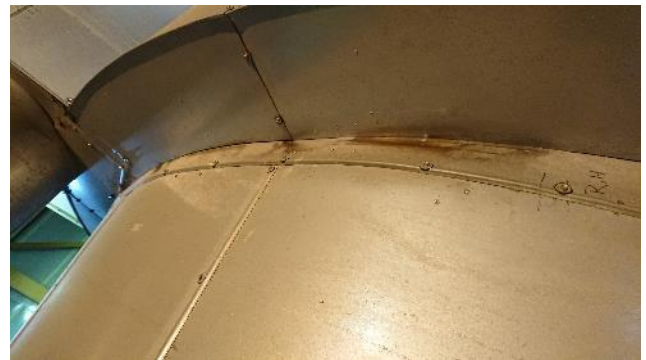
Figure 44: Cladding

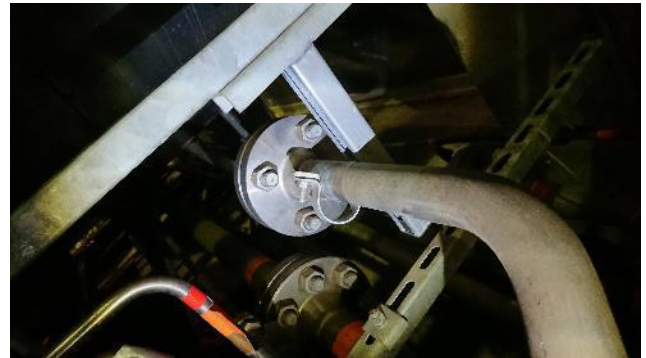
Figure 59: Loose pipe support

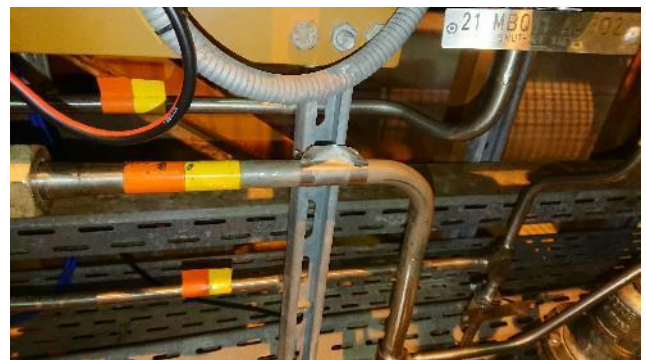
Figure 60: Loose pipe support

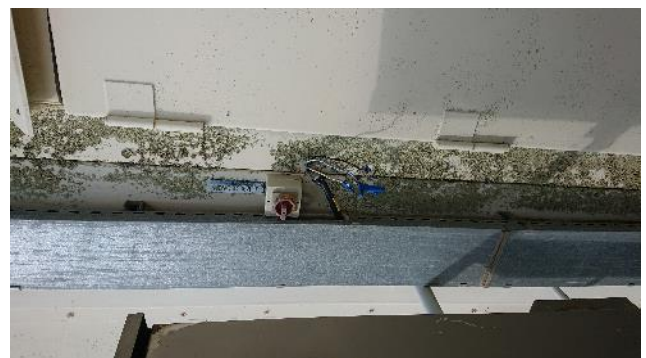
Figure 62: Exposed electrical wires

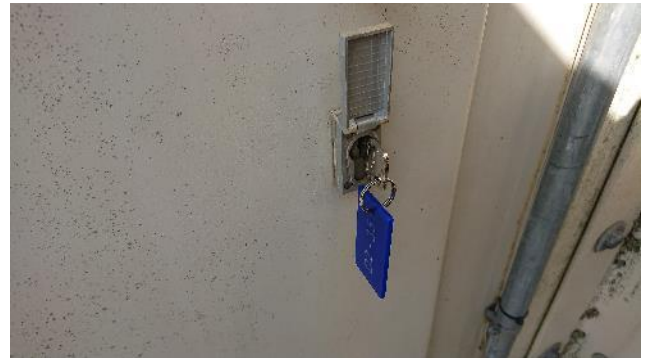
Figure 75: Door lock different

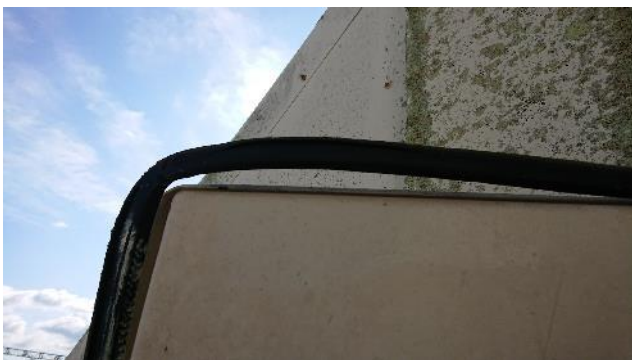
Figure 72: Door seal

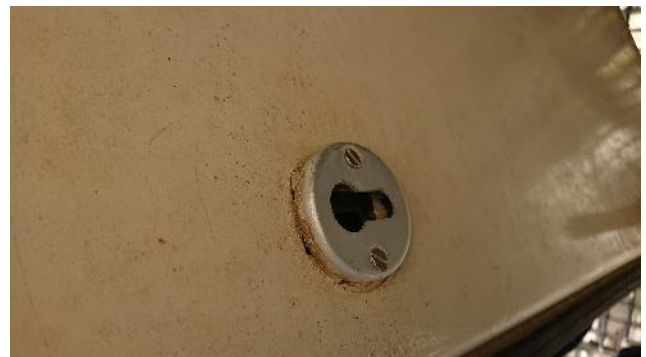
Figure 77: Missing door lock

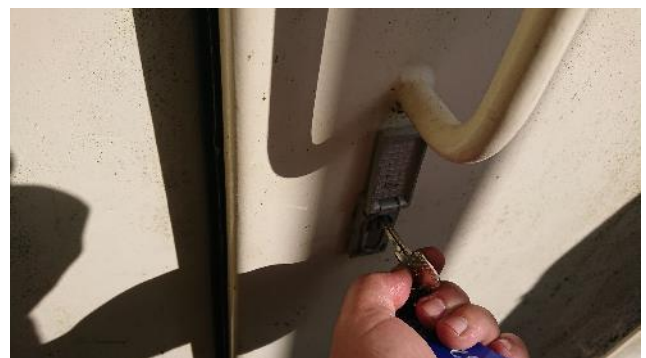
Figure 78: Door doesn't unlock

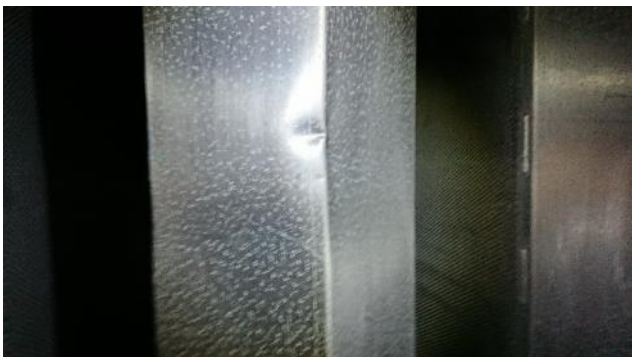
Figure 97: Dent on silencer

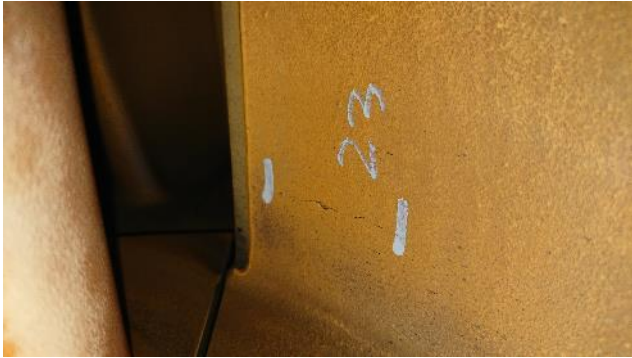
Figure 271: Turbine 1st stage vane #23

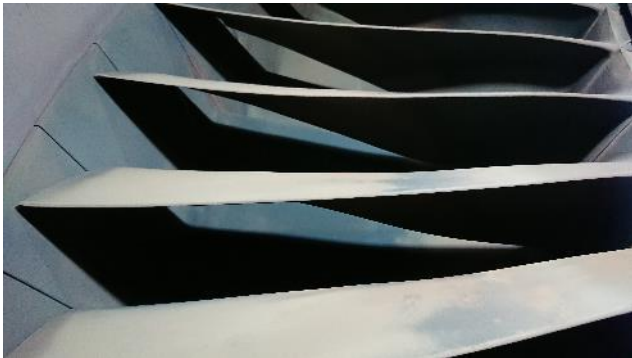
Figure 279: Turbine 4th stage blades

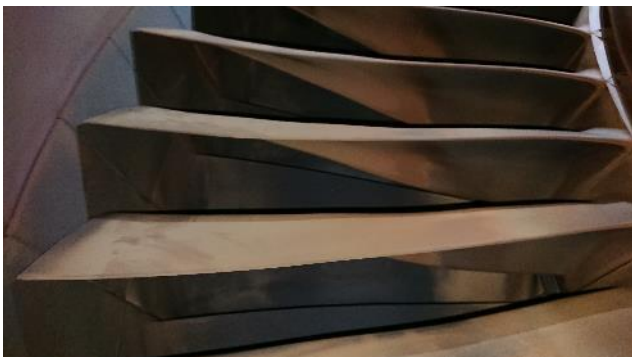
Figure 281: Turbine 4th stage blades & vanes

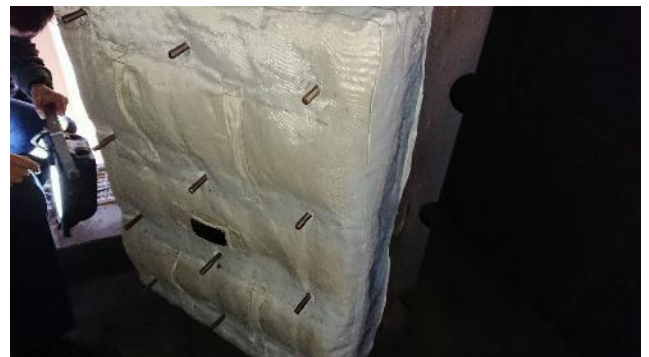
Figure 285: Exhaust cushion

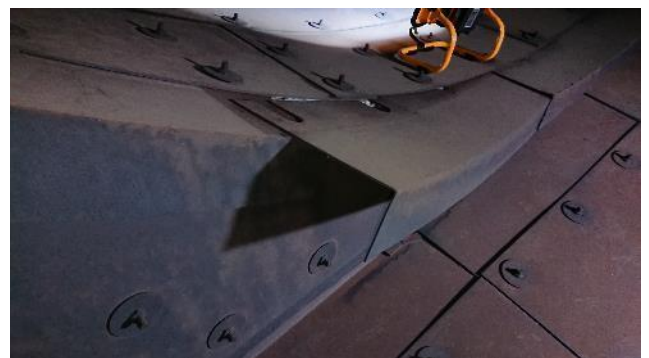
Figure 286: Loose cladding

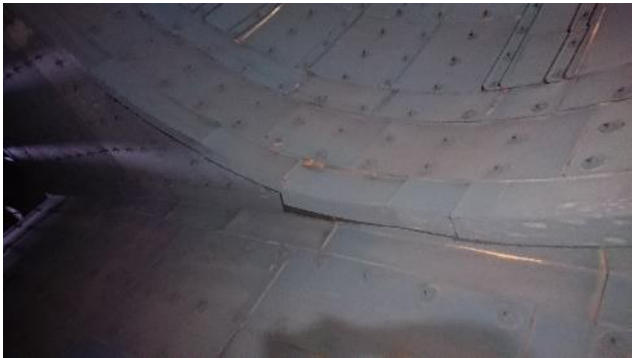
Figure 287: loose cladding

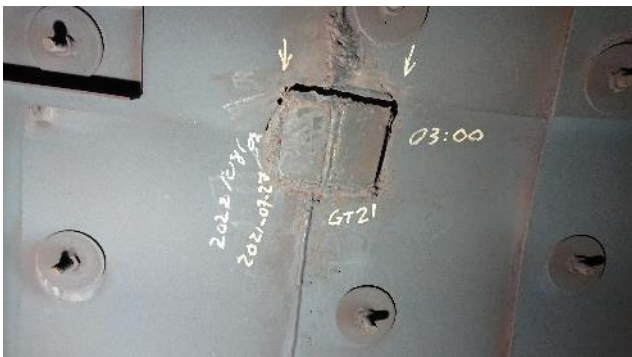
Figure 289: Exhaust – example of crack

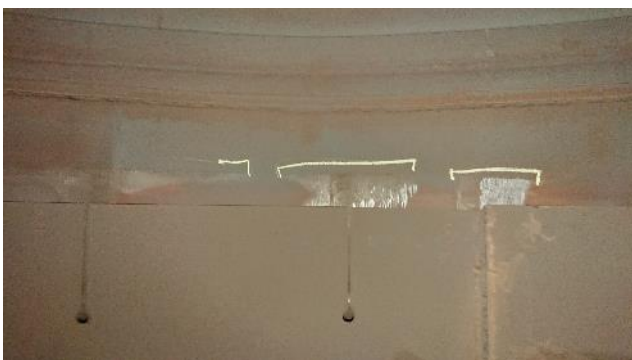
Figure 290: Exhaust – example of rubbing

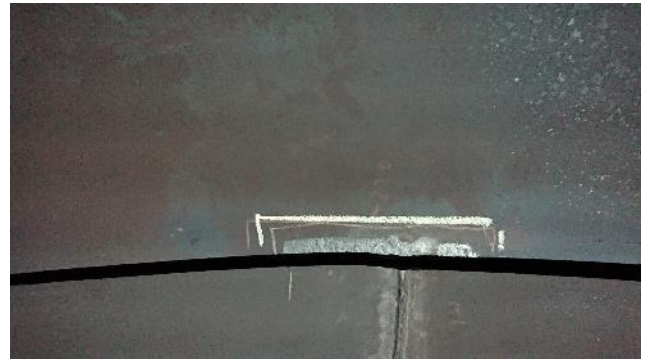
Figure 299: Exhaust – example of rubbing

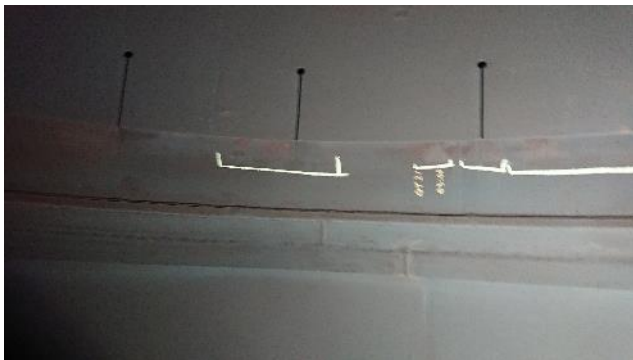
Figure 296: Exhaust – example of rubbing

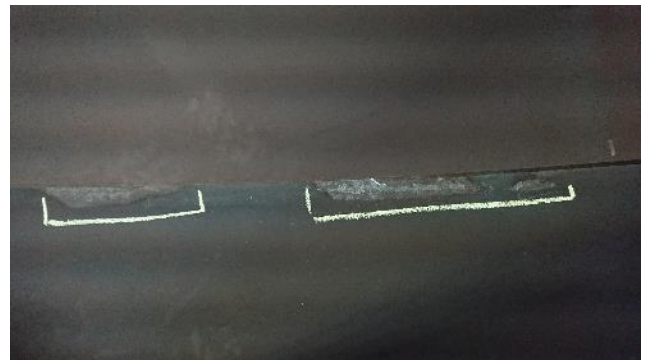
Figure 300: Exhaust – example of rubbing

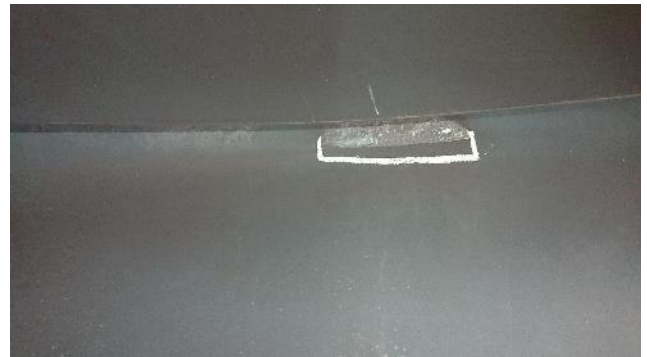
Figure 301: Exhaust – example of rubbing

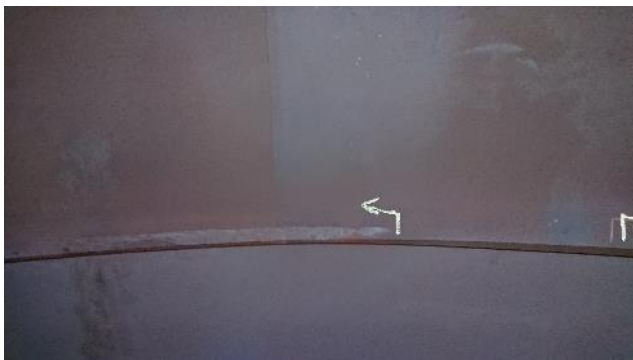
Figure 298: Exhaust – example of rubbing

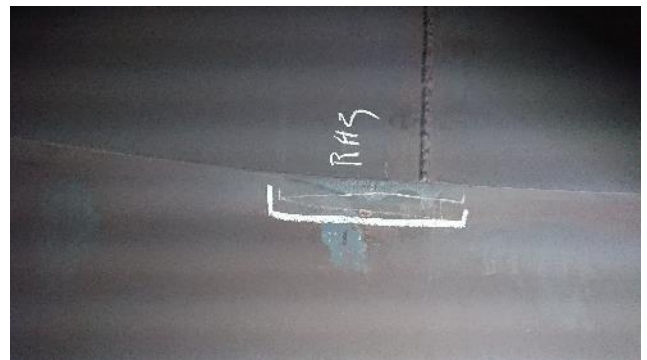
Figure 302: Exhaust – example of rubbing

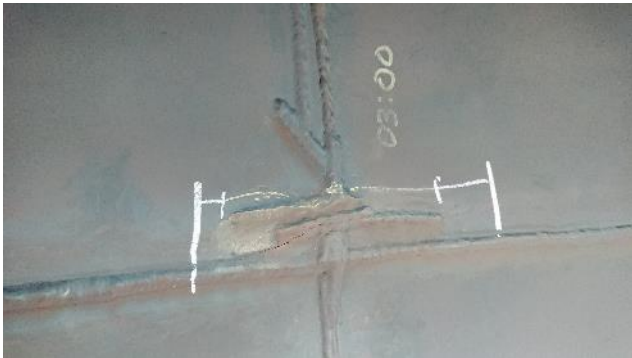
Figure 303: Exhaust – example of crack

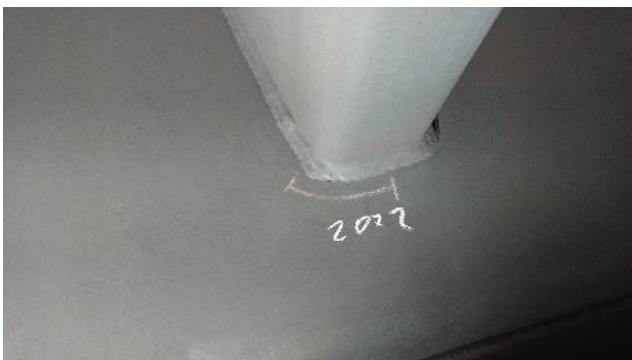
Figure 304: Exhaust – example of crack
