Business Management System Inspection Report Gourikwa – GT12 Minor Inspection	Document Identifier	194/1352	Rev	0
		Date	23/01/2023		
		Page	1 of 96

Document Type	Inspection Report
Outage ID	23480
Scope of Activity	GT12 Minor Inspection at Gourikwa Peaking OCGT
Purpose	This is a technical report on the “as found” condition, remedial action performed and final condition of plant or components.

Gourikwa GT12 was removed from service on 12 September 2022 at 06:19 in order to carry out Minor Inspection activities as identified in 240-136723367. Limited disassembly, intervention and reassembly activities were performed by site maintenance personnel, and inspections were performed internally by Eskom and ERI personnel and were carried out from September 13th until September 16th. Areas inspected included: Filter house, Compressor Inlet, Compressor Exhaust, Combustion Chambers, Turbine Inlet and the Turbine Exhaust.

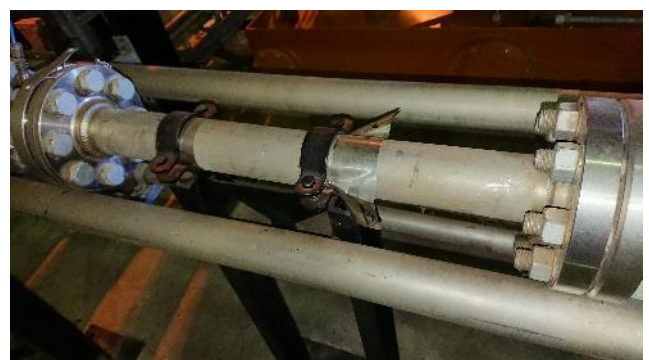
Figure 8: Incorrect pipe support

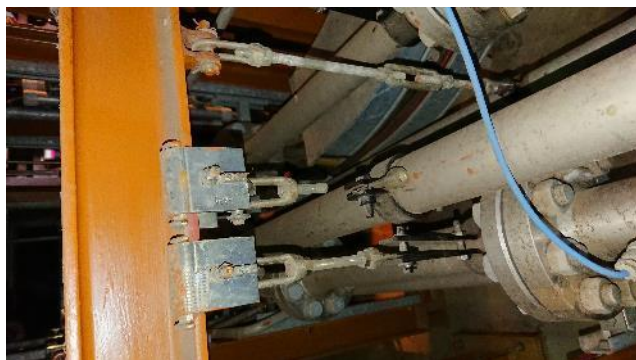
Figure 9: Losse pipe support

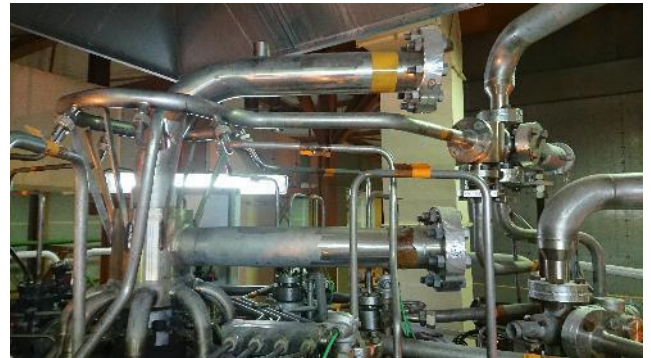
Figure 22: Resonating pipework

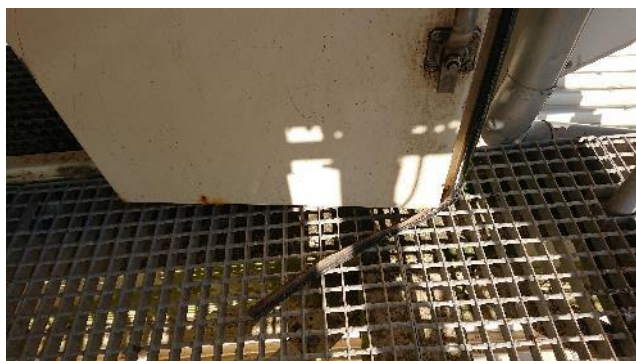
Figure 46: Corroded drain support

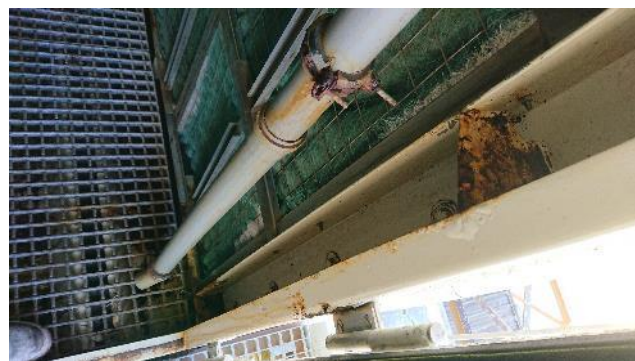
Figure 43: Loose door seal

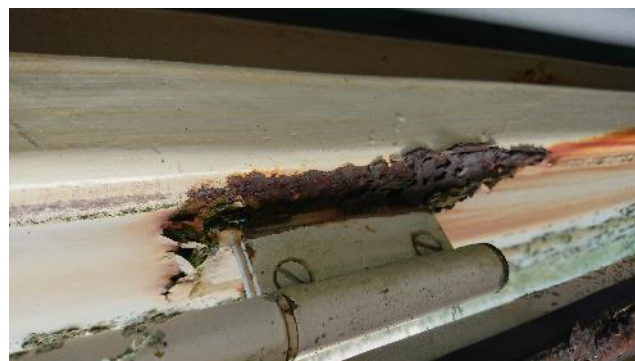
Figure 44: Filter house - corrosion

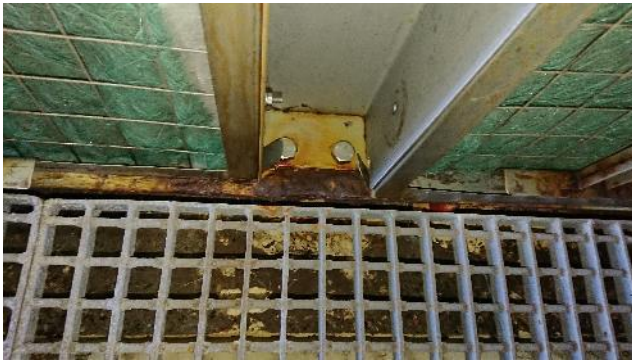
Figure 49: Filter house - corrosion

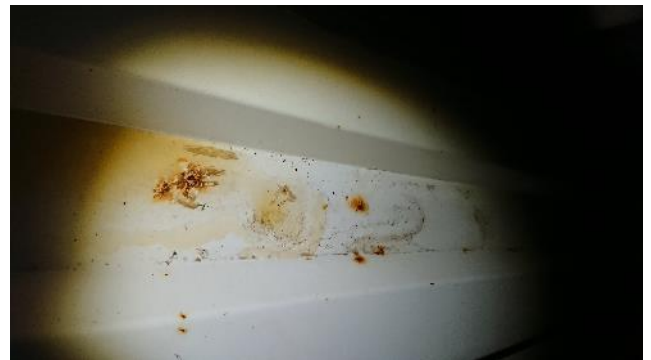
Figure 51: Filter house - corrosion

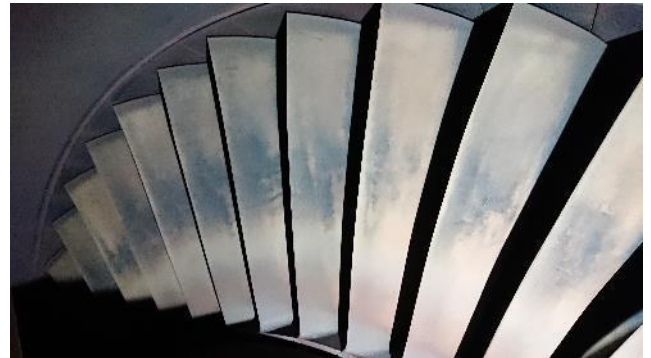
Figure 246: Turbine 4th stage blades

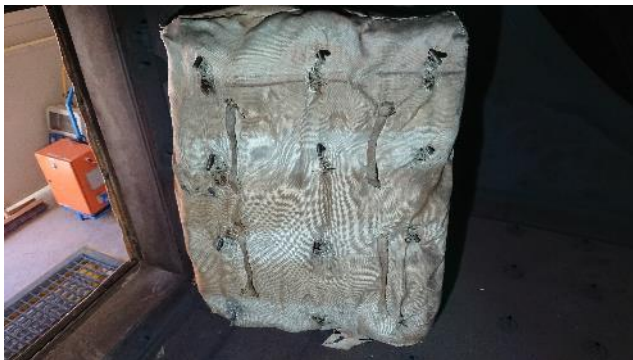
Figure 253: Forgein object in exhaust

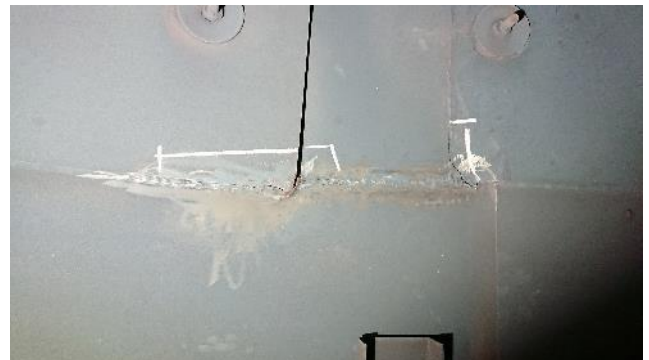
Figure 255: Exhaust – example of crack

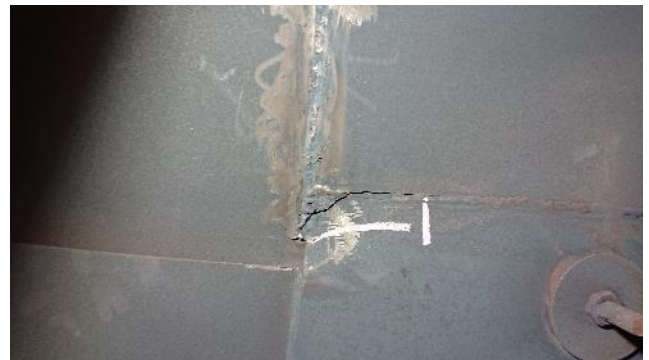
Figure 256: Exhaust – example of crack

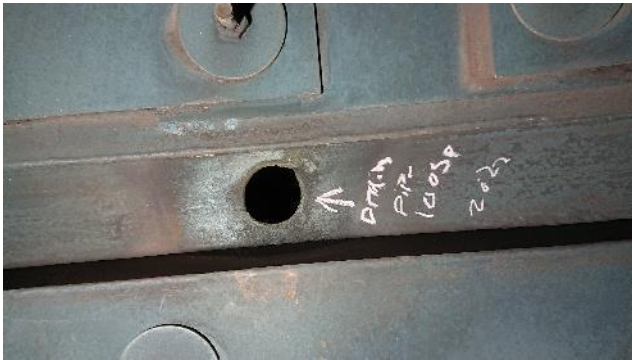
Figure 257: Loose drain pipe

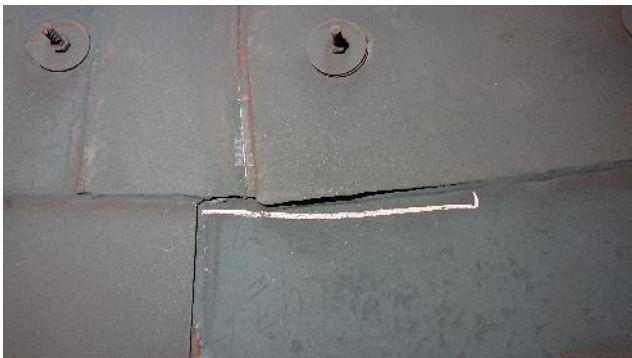
Figure 259: Exhaust – example of crack

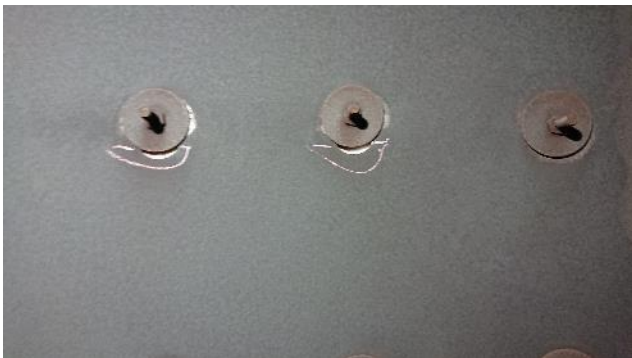
Figure 260: Exhaust – visible insulation

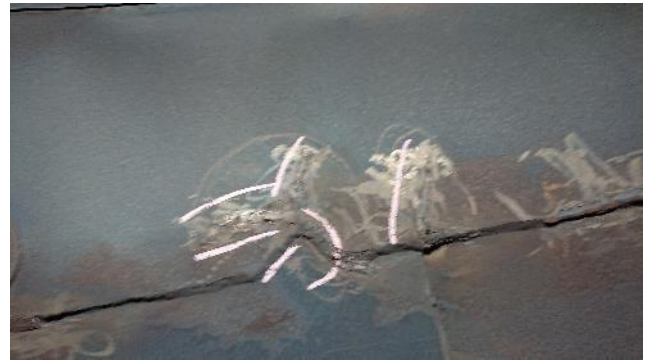
Figure 261: Exhaust – example of crack

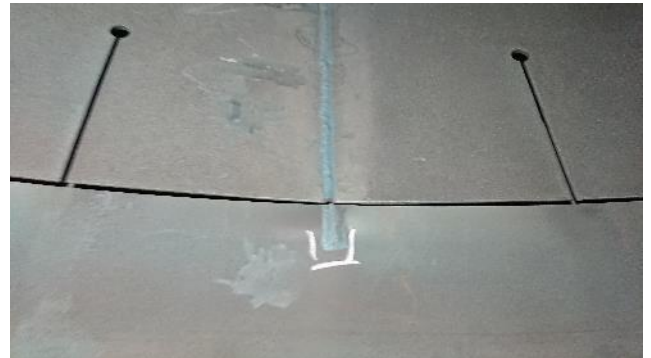
Figure 262: Exhaust – example of rubbing

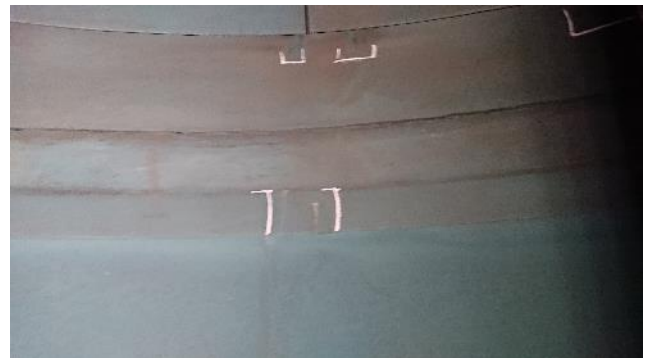
Figure 264: Exhaust – example of crack & rubbing

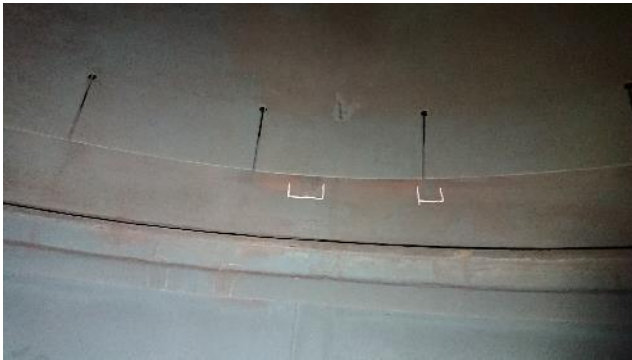
Figure 265: Exhaust – example of rubbing

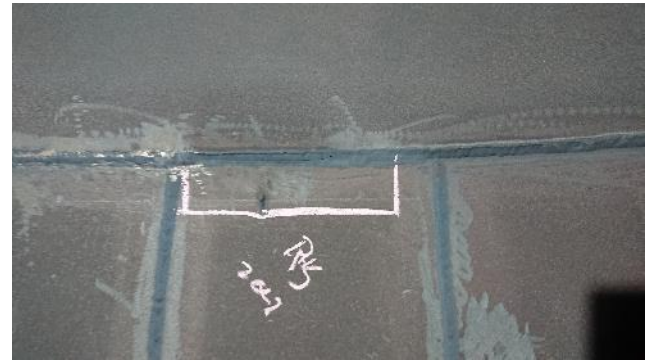
Figure 269: Exhaust – example of crack

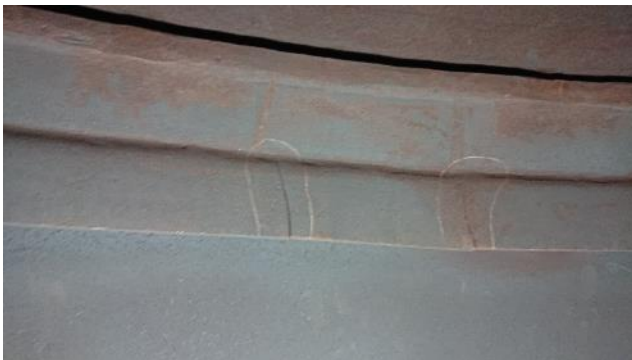
Figure 266: Exhaust – example of crack

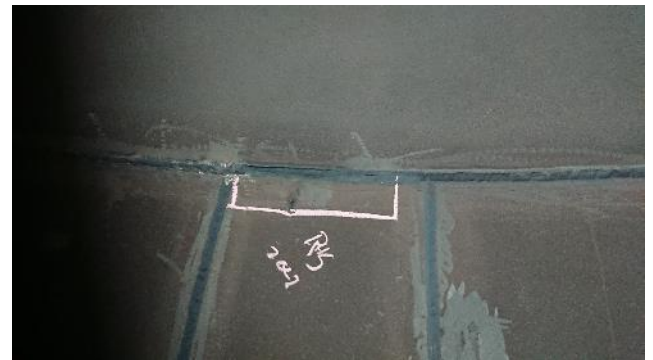
Figure 270: Exhaust – example of crack

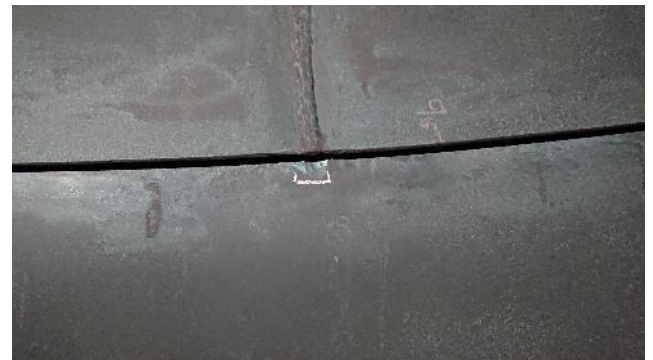
Figure 271: Exhaust – example of crack

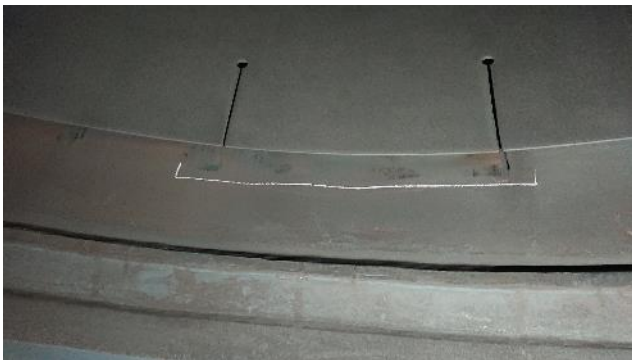
Figure 268: Exhaust – example of rubbing

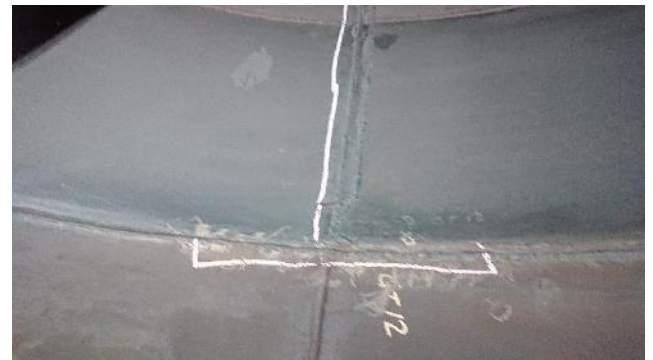
Figure 272: Exhaust – example of crack

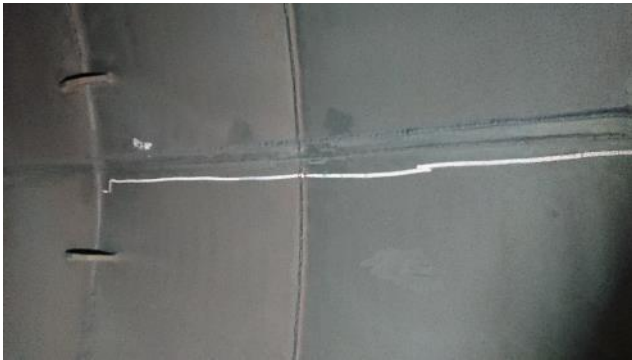
Figure 273: Exhaust – example of crack

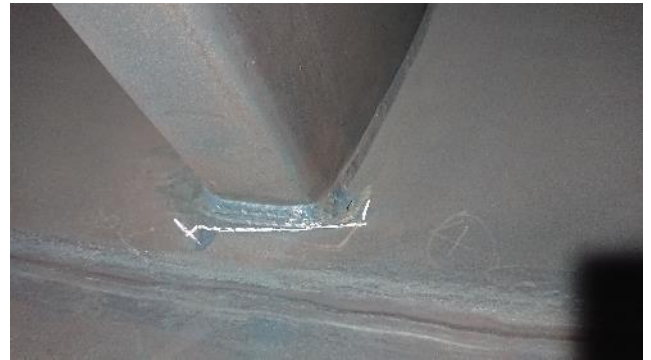
Figure 277: Exhaust – example of crack

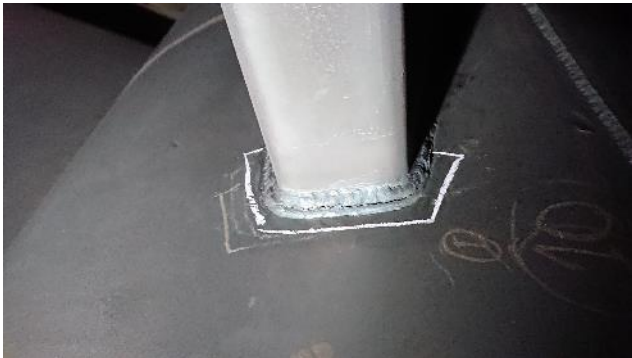
Figure 274: Exhaust – example of crack

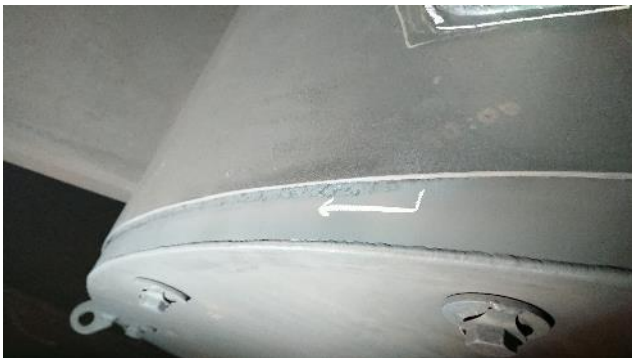
Figure 275: Exhaust – example of hammering

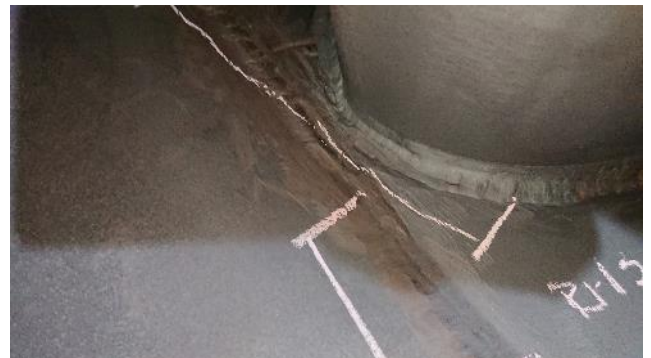
Figure 279: Exhaust – example of crack

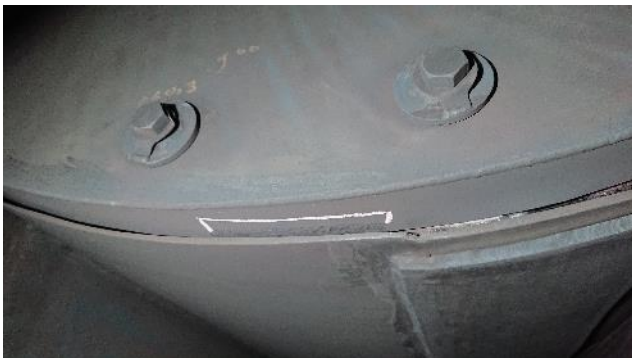
Figure 276: Exhaust – example of hammering

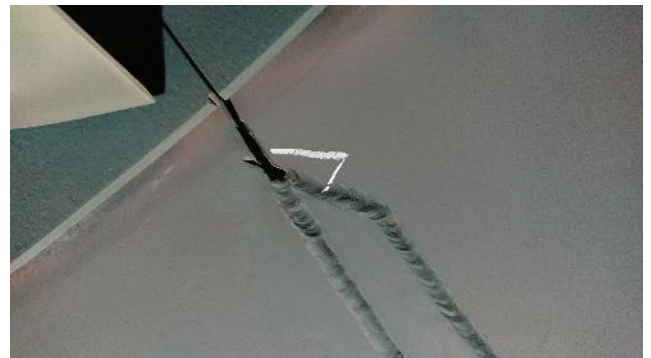
Figure 280: Exhaust – example of crack

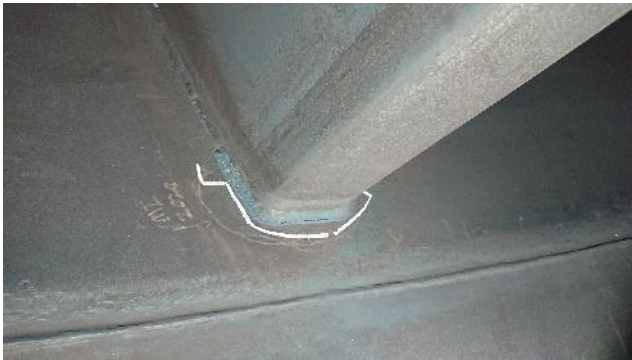
Figure 281: Exhaust – example of crack

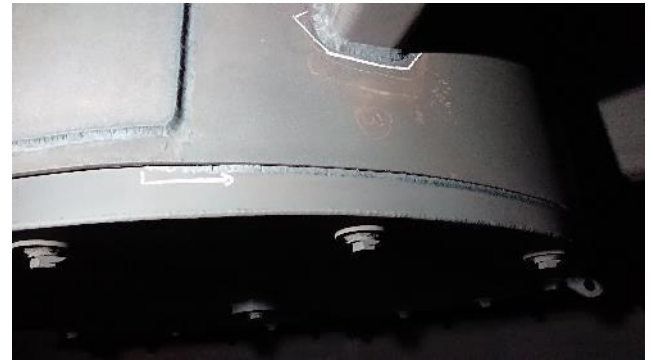
Figure 285: Exhaust – example of hammering

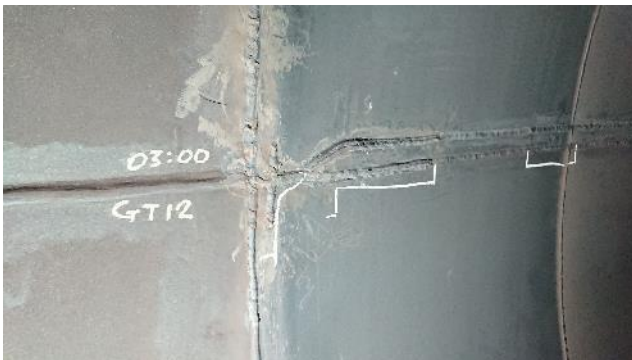
Figure 282: Exhaust – example of crack

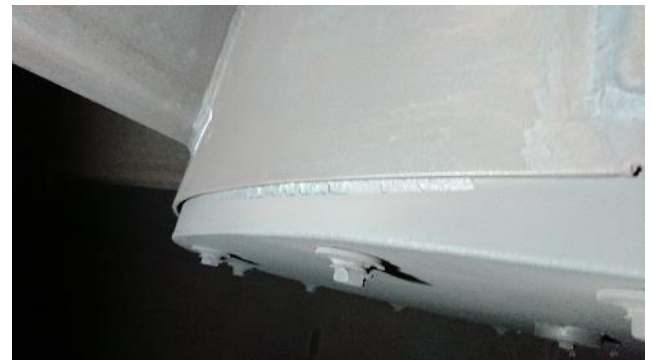
Figure 286: Exhaust – example of hammering

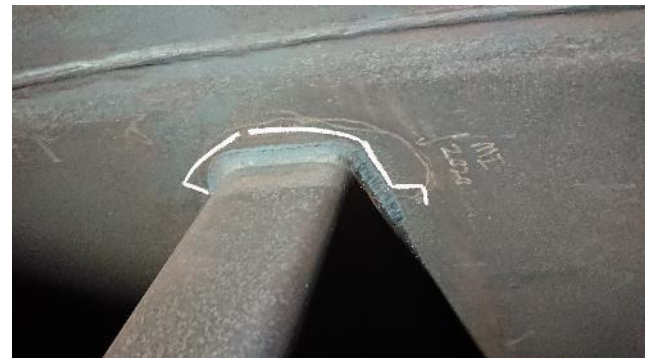
Figure 283: Exhaust – example of crack

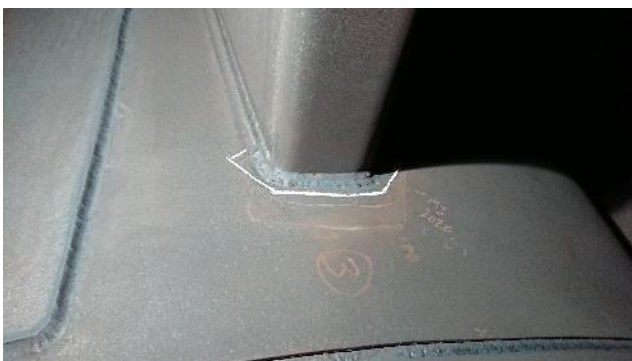
Figure 287: Exhaust – example of crack

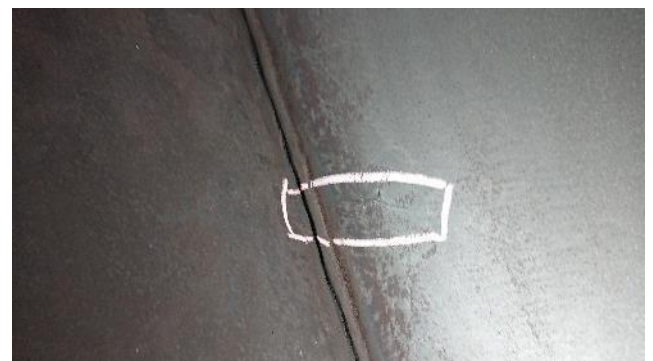
Figure 284: Exhaust – example of crack

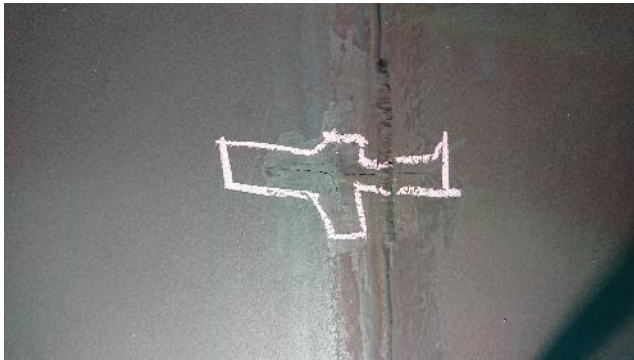
Figure 289: Exhaust – example of crack

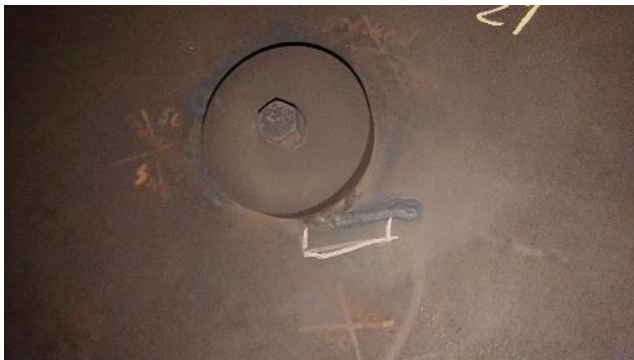
Figure 290: Exhaust – example of crack
