Business Management System Inspection Report Gourikwa – GT13 Minor Inspection	Document Identifier	194/1354	Rev	0
		Date	30/01/2023		
		Page	1 of 120

Document Type	Inspection Report
Outage ID	24387
Scope of Activity	GT13 Minor Inspection at Gourikwa Peaking OCGT
Purpose	This is a technical report on the “as found” condition, remedial action performed and final condition of plant or components.

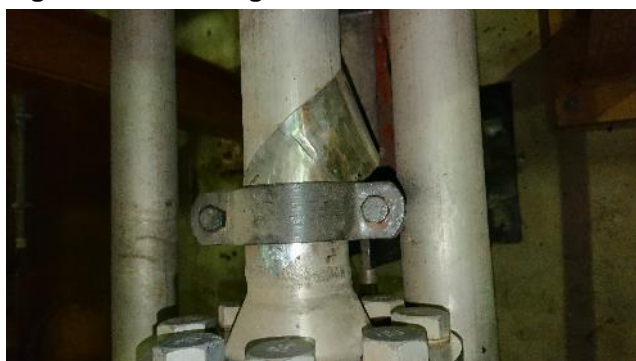
Figure 10: Poorly supported pipe

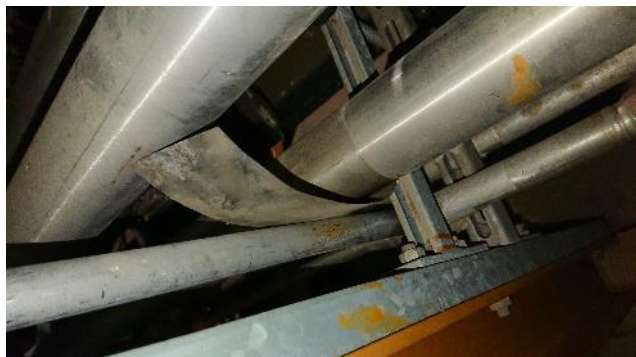
Figure 11: Poorly supported pipe

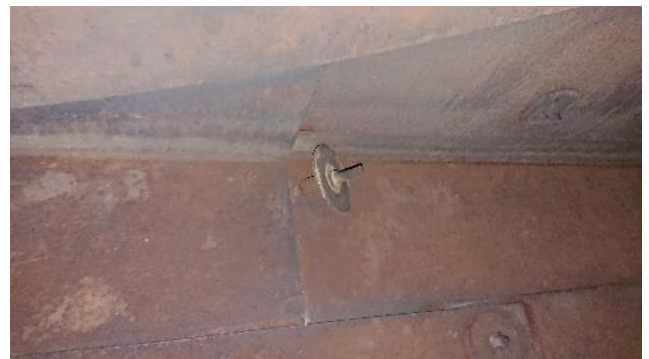
Figure 281: TLa4 & TLe4

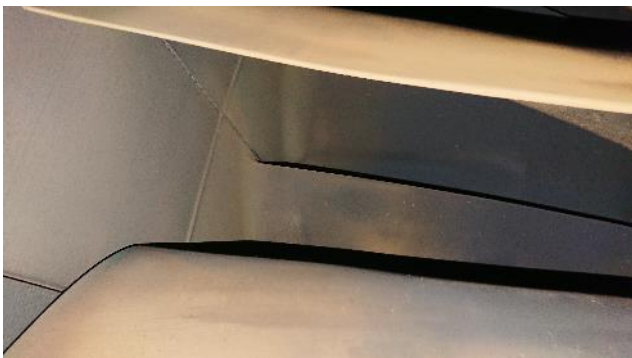
Figure 285: FO in exhaust

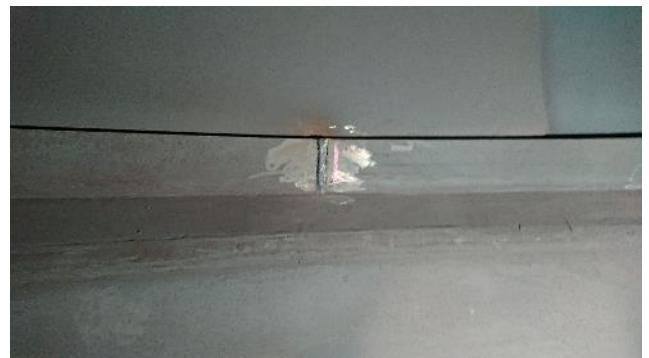
Figure 282: TLe4

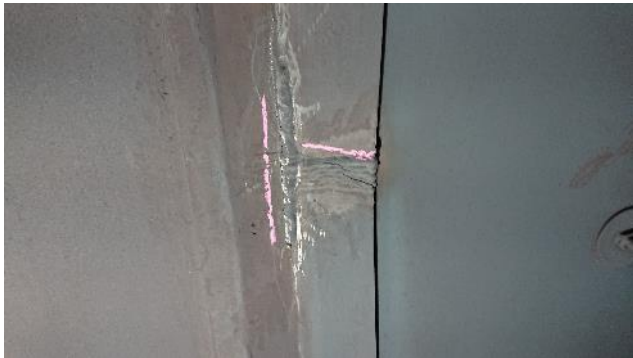
Figure 286: Exhaust – example of crack

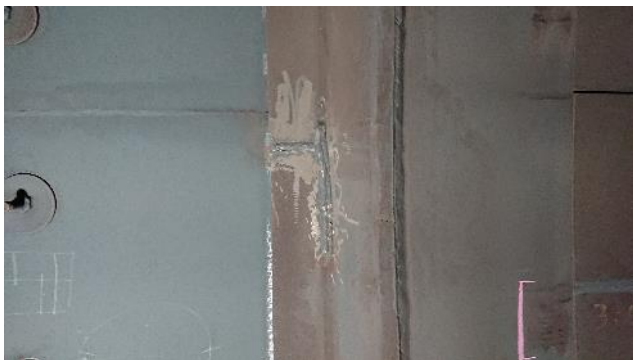
Figure 287: Exhaust – example of crack

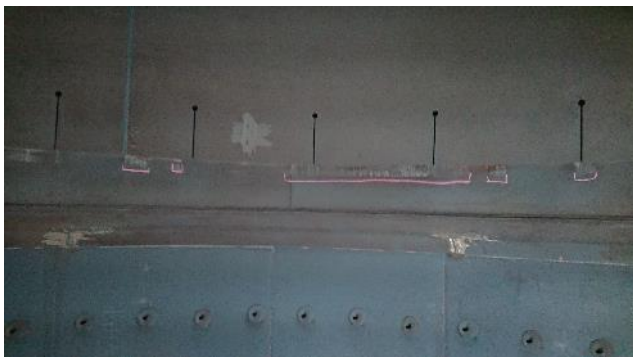
Figure 288: Exhaust – example of crack

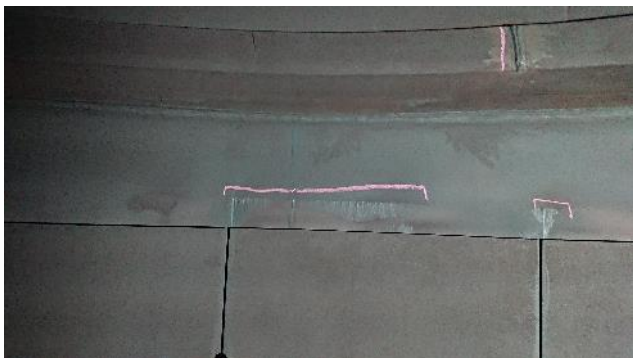
Figure 289: Exhaust – example of rubbing

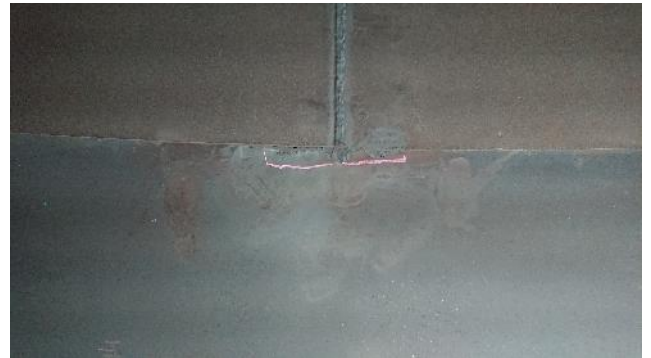
Figure 290: Exhaust – example of rubbing

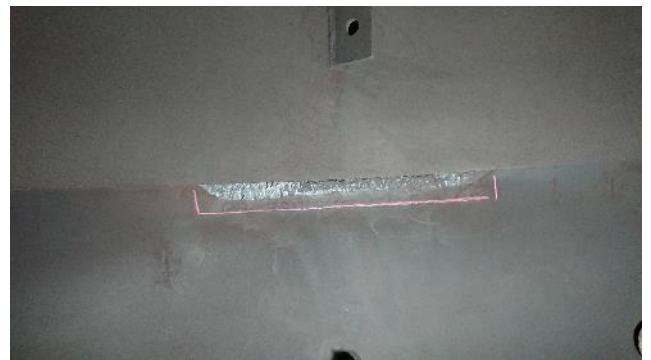
Figure 291: Exhaust – example of rubbing

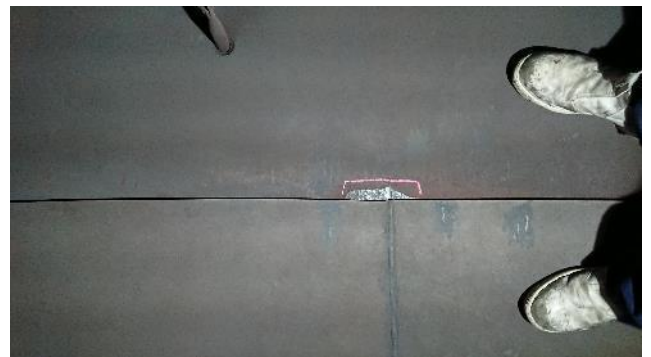
Figure 292: Exhaust – example of rubbing

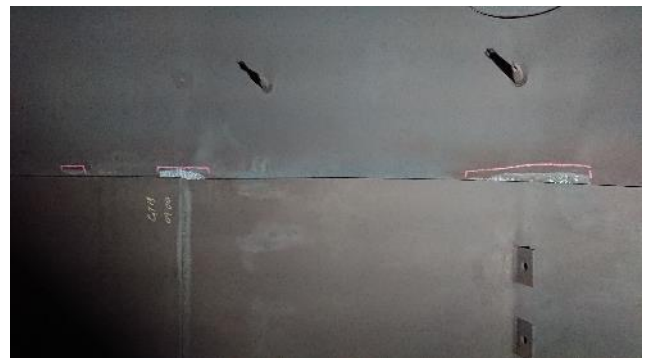
Figure 293: Exhaust – example of rubbing

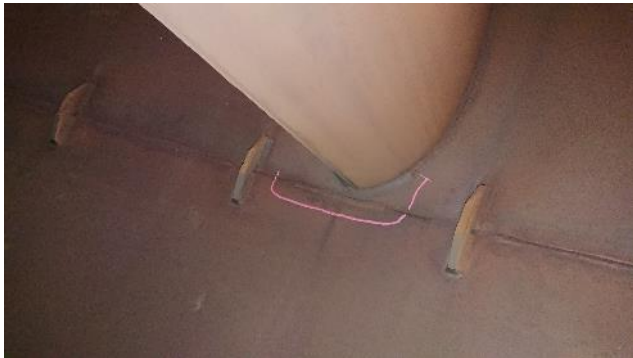
Figure 294: Exhaust – example of rubbing

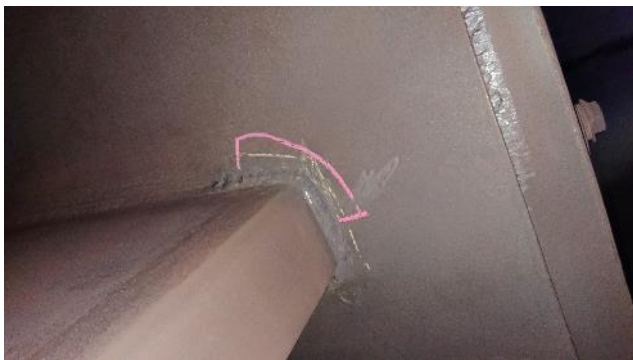
Figure 295: Exhaust – example of crack

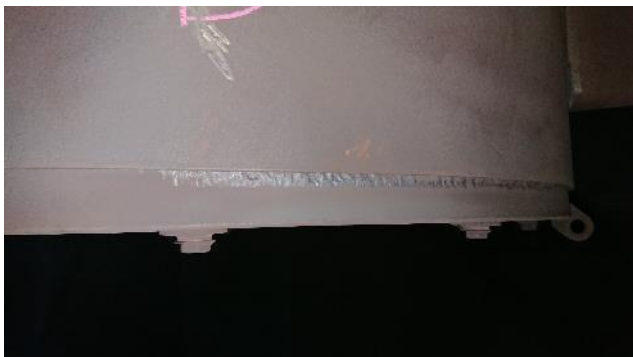
Figure 296: Exhaust – example of crack

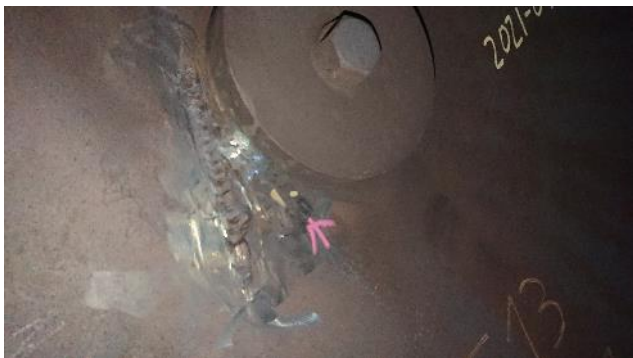
Figure 297: Exhaust – example of hammering

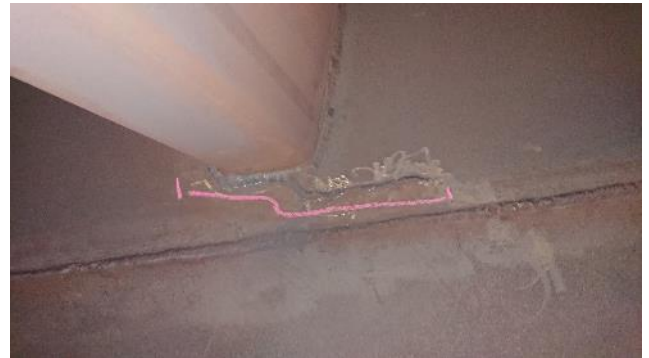
Figure 298: Exhaust – example of crack

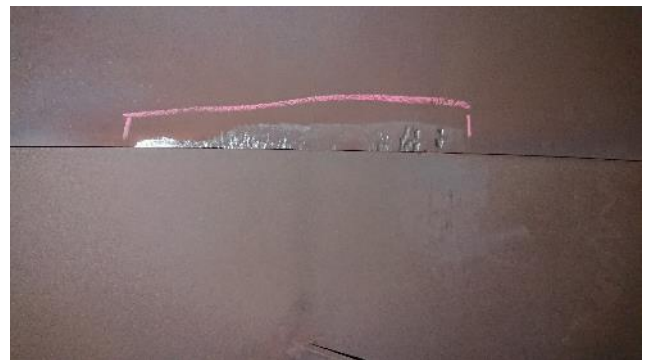
Figure 299: Exhaust – example of crack

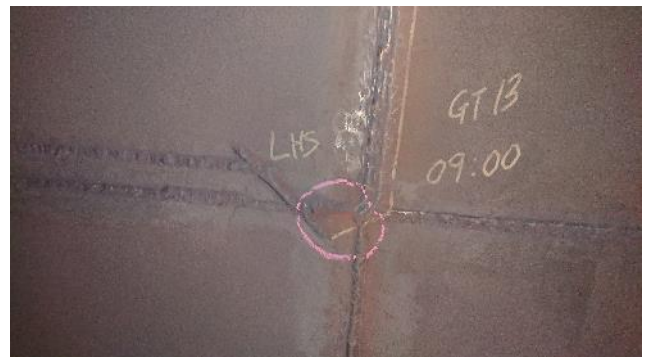
Figure 300: Exhaust – example of rubbing
