Business Management System Inspection Report Gourikwa – GT22 Minor Inspection	Document Identifier	195/454	Rev	0
		Date	30/01/2023		
		Page	1 of 101

Document Type	Inspection Report
Outage ID	24393
Scope of Activity	GT22 Minor Inspection at Gourikwa Peaking OCGT
Purpose	This is a technical report on the “as found” condition, remedial action performed and final condition of plant or components.

Gourikwa GT22 was removed from service on 10 October 2022 at 06:00 in order to carry out Minor Inspection activities as identified in 240-136723367. Limited disassembly, intervention and reassembly activities were performed by site maintenance personnel, and inspections were performed internally by Eskom and ERI personnel, and were carried out from 2022/10/11 until 2022/10/14. Areas inspected included: Filter house, Compressor Inlet, Compressor Exhaust, Combustion Chambers, Turbine Inlet and the Turbine Exhaust.

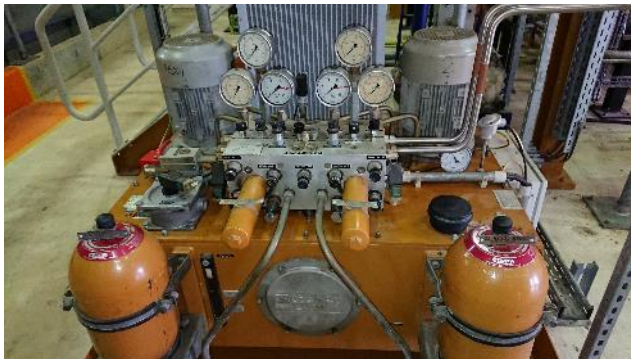
Figure 1: Control oil skid

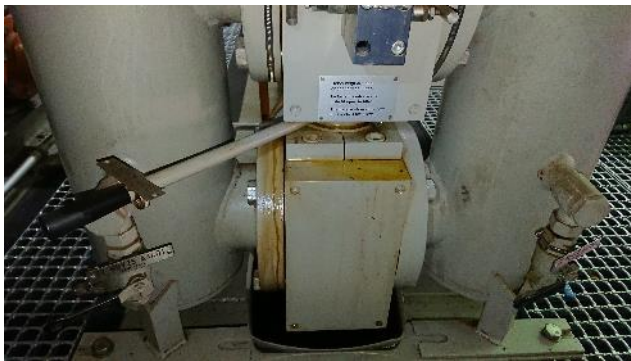
Figure 2: Lubricating oil skid

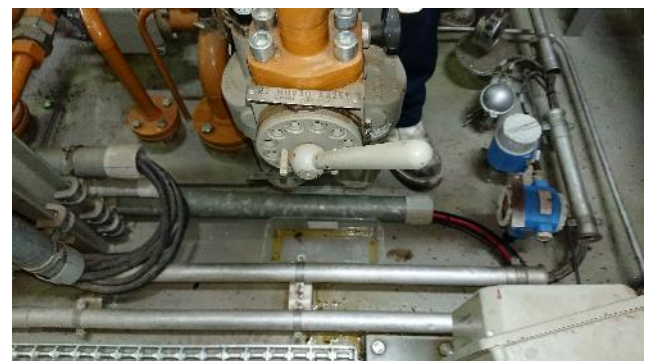
Figure 6: Lubricating oil skid

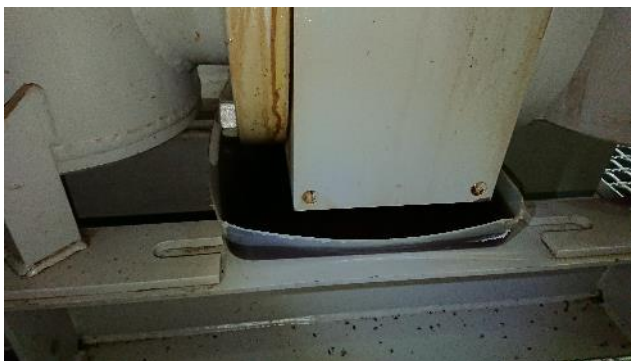
Figure 3: Lubricating oil skid

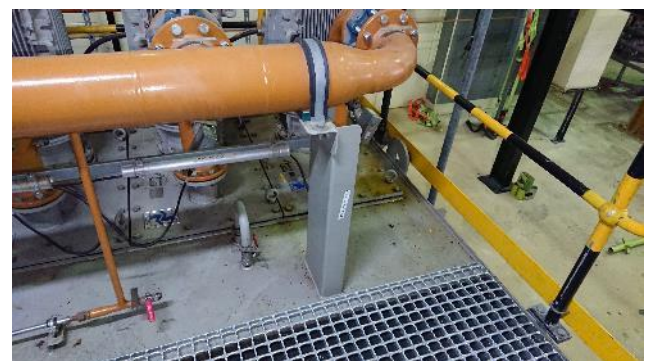
Figure 7: Lubricating oil skid

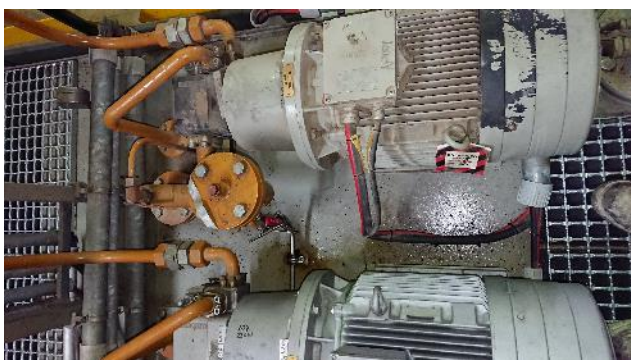
Figure 4: Lubricating oil skid

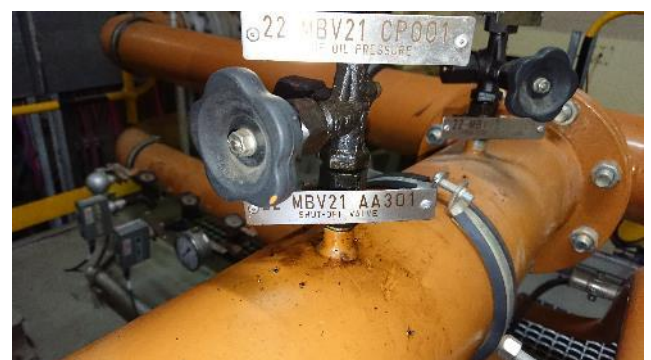
Figure 8: Lubricating oil skid

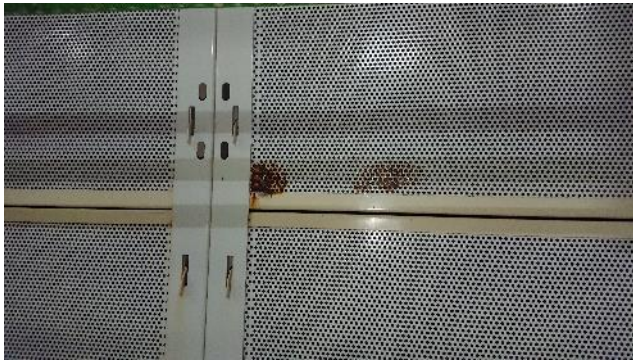
Figure 9: Structure

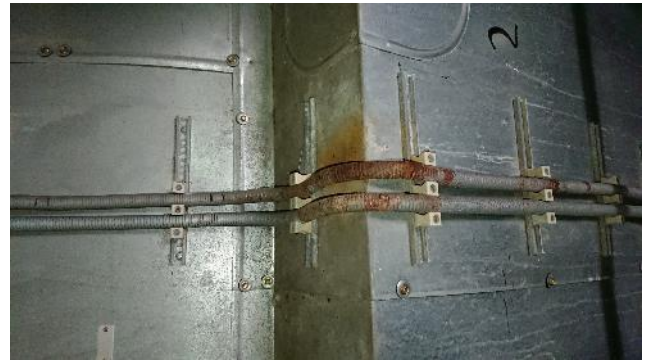
Figure 13: Cladding

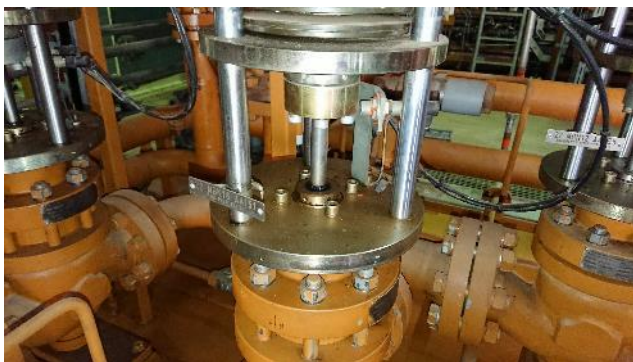
Figure 10: Fuel oil skid

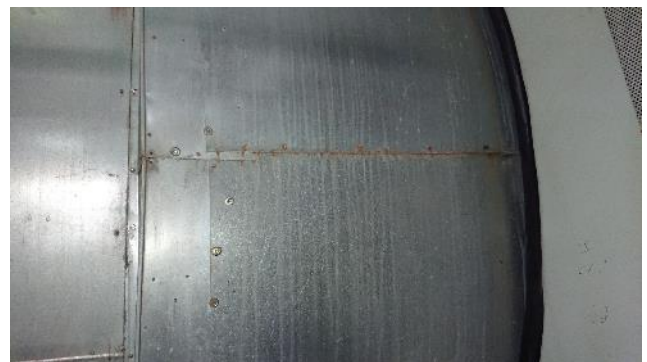
Figure 14: Cladding

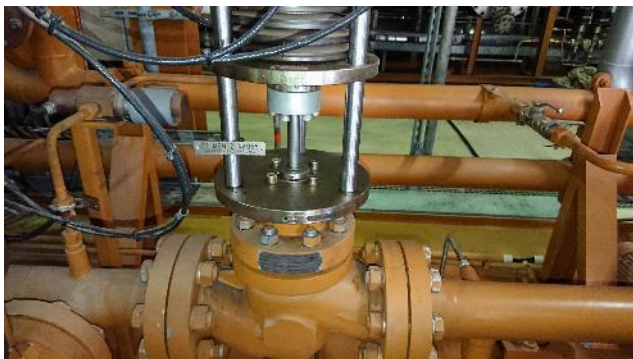
Figure 11: Fuel oil skid

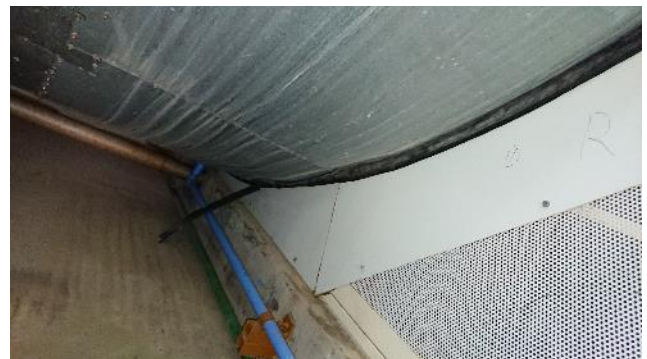
Figure 15: Cladding

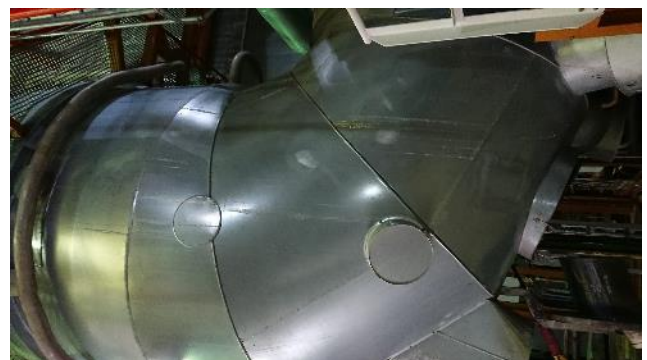
Figure 16: Cladding

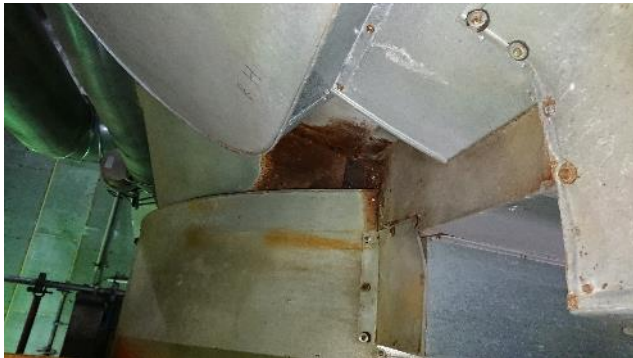
Figure 17: Cladding

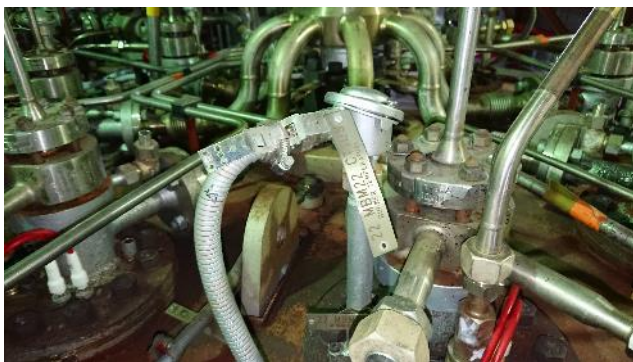
Figure 18: Burners

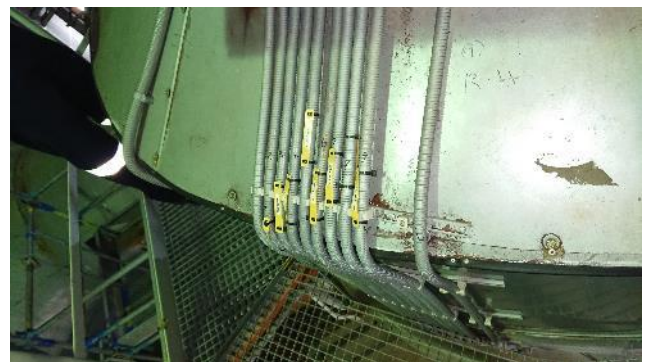
Figure 22: Burners

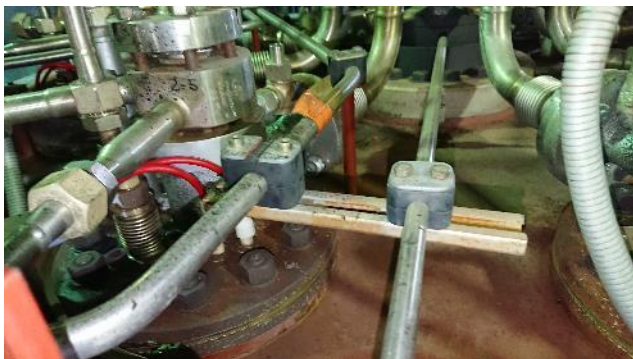
Figure 19: Burners

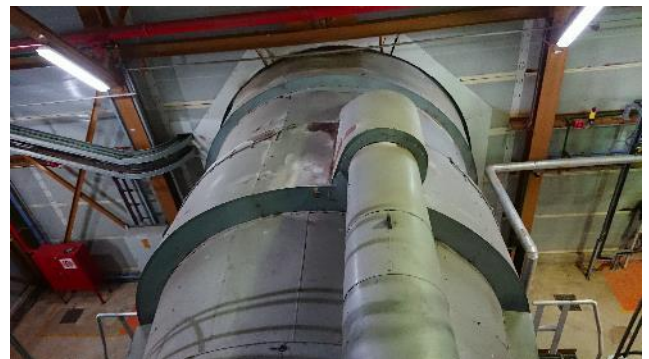
Figure 23: Burners

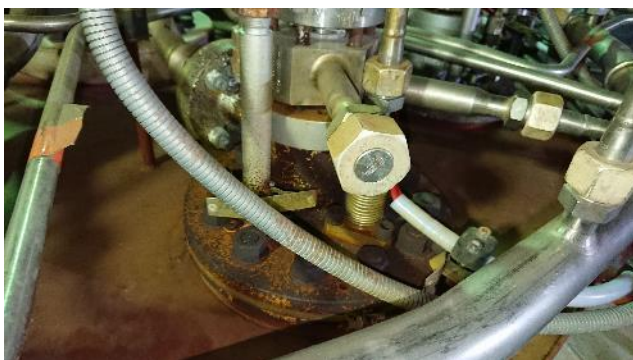
Figure 20: Burners

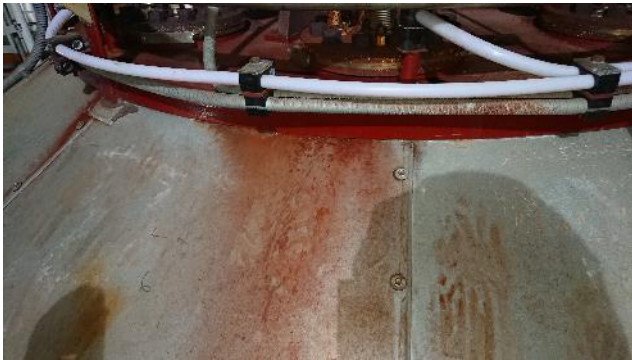
Figure 25: Dome cladding

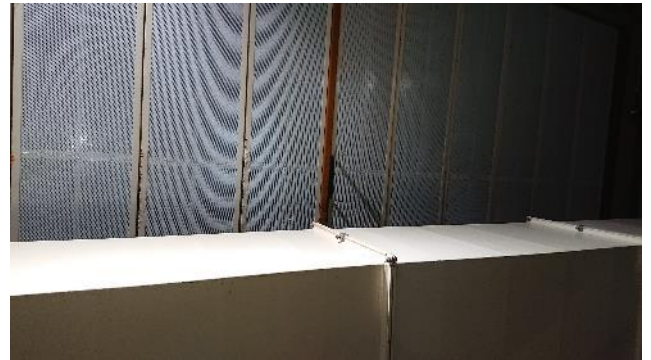
Figure 29: Structure

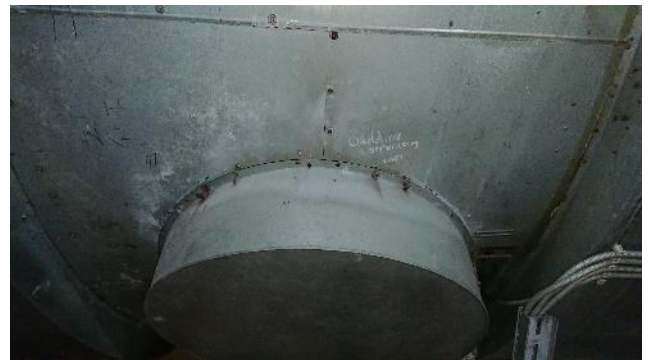
Figure 30: Cladding

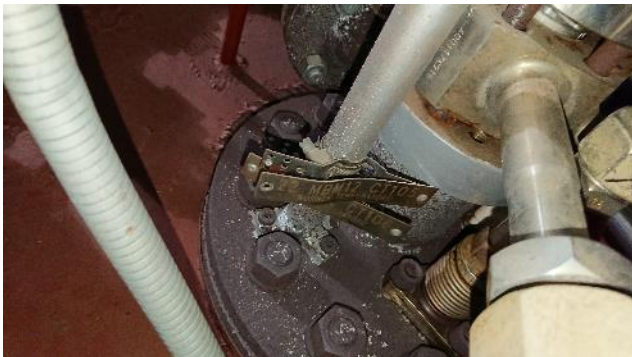
Figure 27: Burners

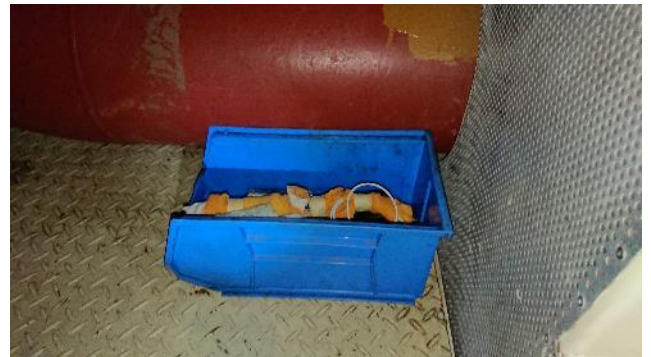
Figure 31: Compressor inlet cone - housekeeping

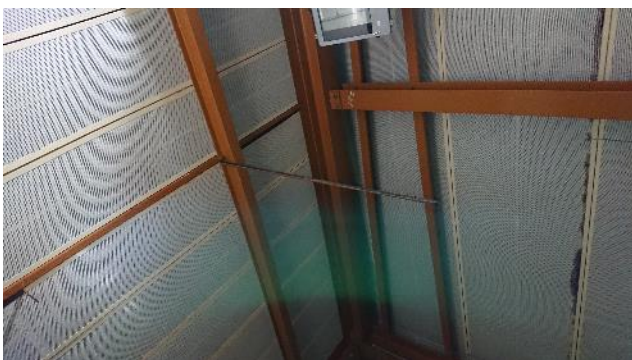
Figure 28: Structure

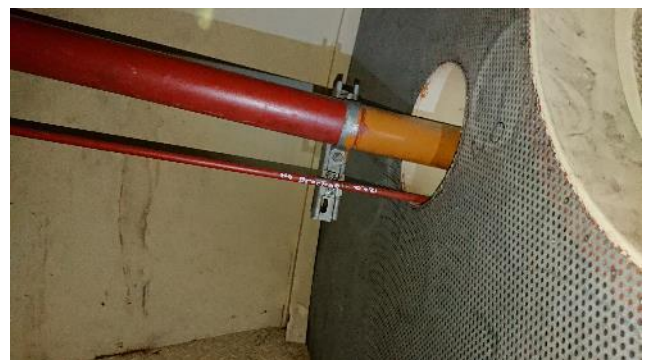
Figure 32: Compressor inlet cone (internal)

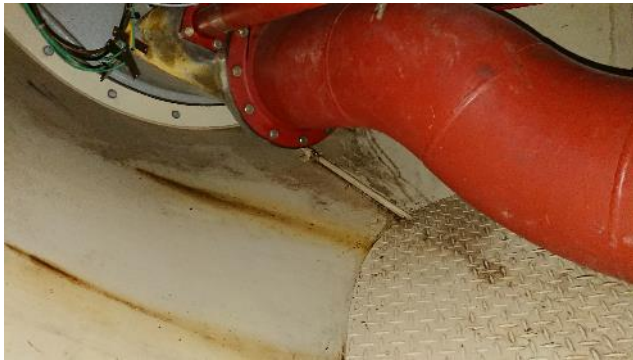
Figure 33: Compressor inlet cone (internal)

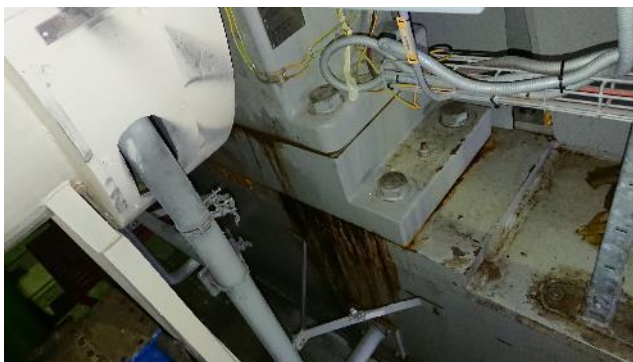
Figure 34: Generator TE bearing

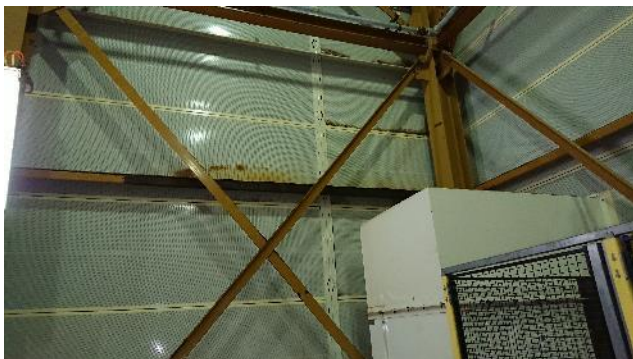
Figure 35: Structure

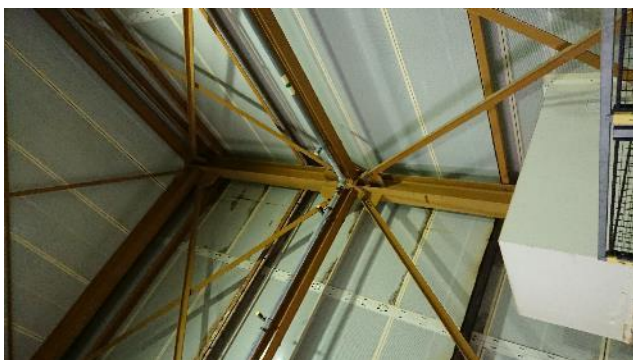
Figure 36: Structure

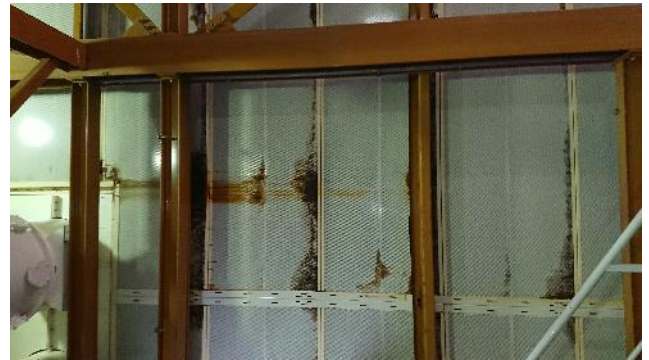
Figure 37: Structure

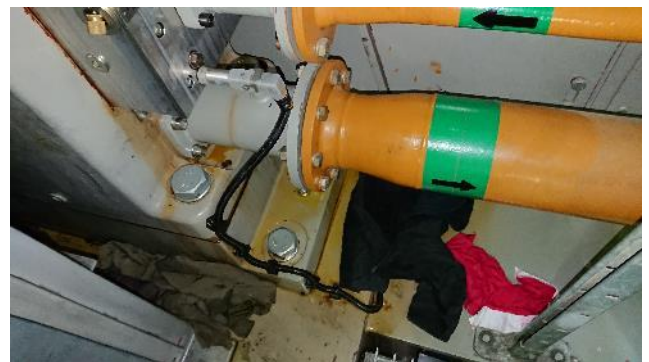
Figure 38: Generator EE bearing

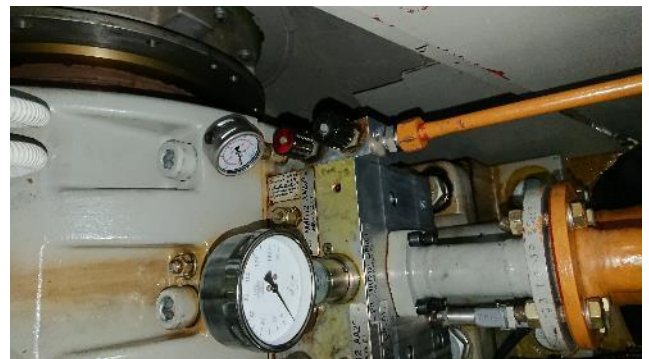
Figure 39: Generator EE bearing

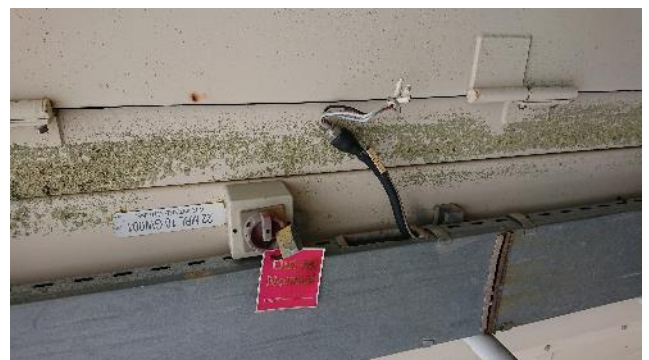
Figure 40: Filter house

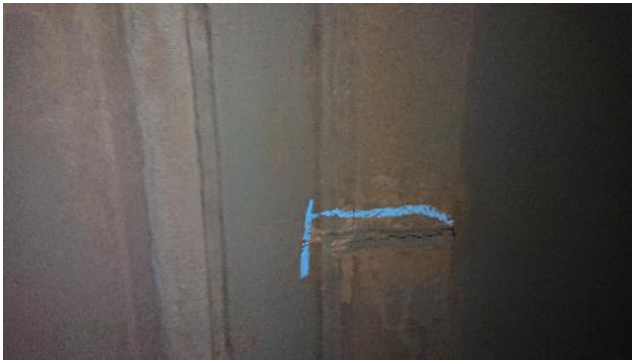
Figure 273: Exhaust – example of crack

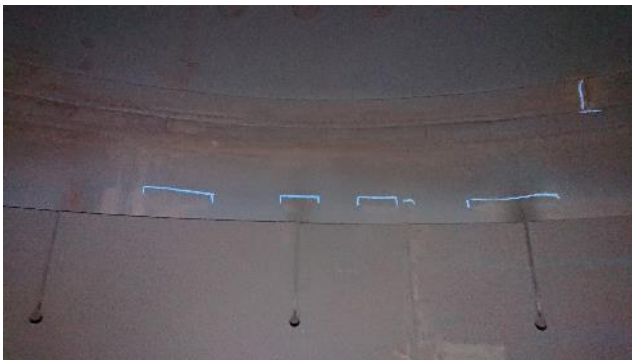
Figure 274: Exhaust – example of rubbing

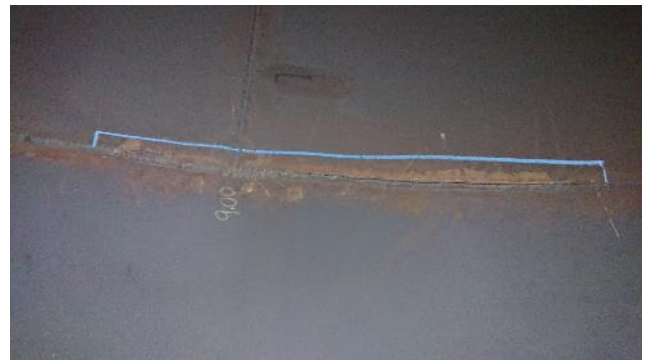
Figure 278: Exhaust – example of rubbing

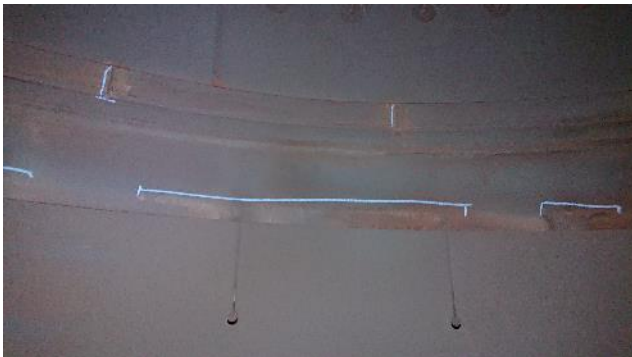
Figure 275: Exhaust – example of rubbing

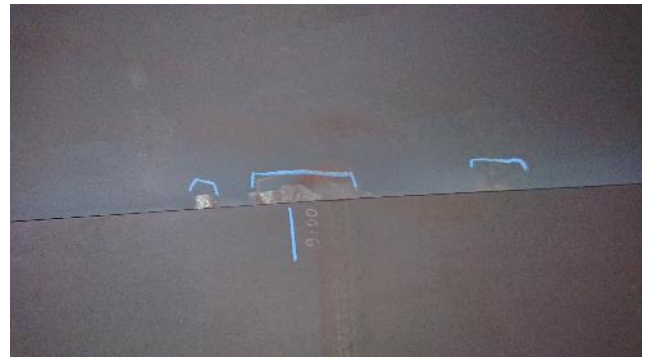
Figure 279: Exhaust – example of rubbing

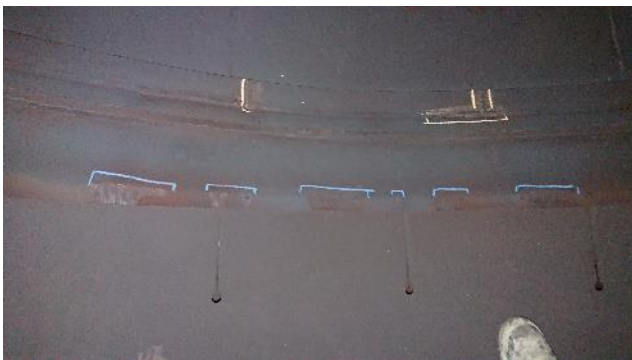
Figure 276: Exhaust – example of rubbing

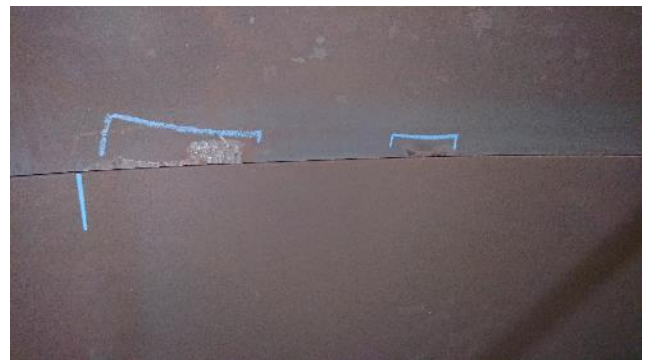
Figure 280: Exhaust – example of rubbing

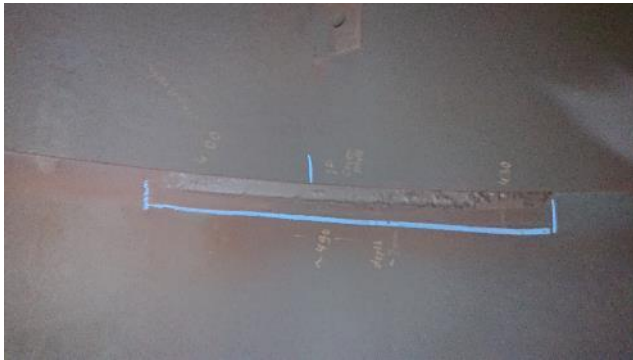
Figure 281: Exhaust – example of rubbing

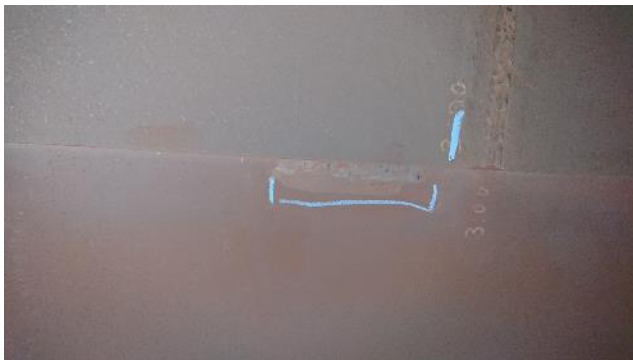
Figure 282: Exhaust – example of rubbing

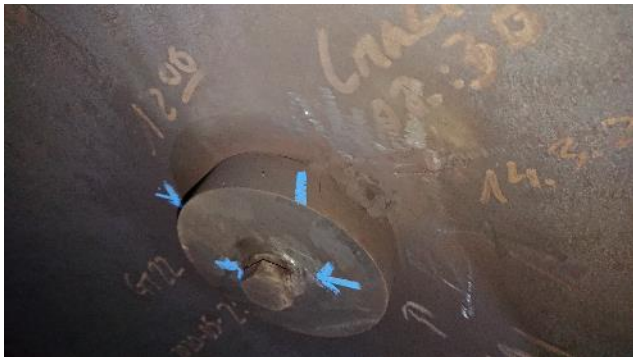
Figure 283: Exhaust – example of crack

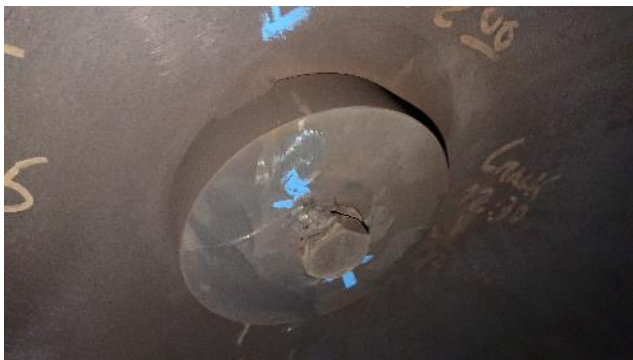
Figure 284: Exhaust – example of crack

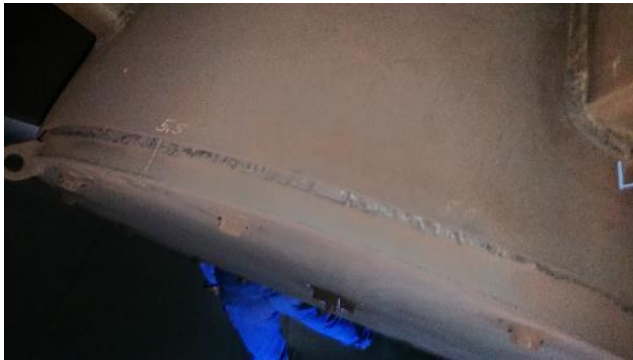
Figure 289: Exhaust – example of hammering

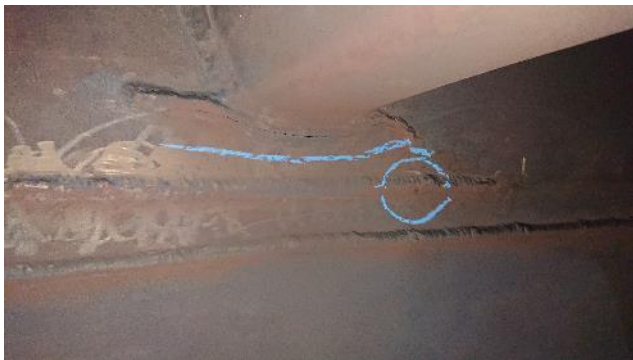
Figure 290: Exhaust – example of crack

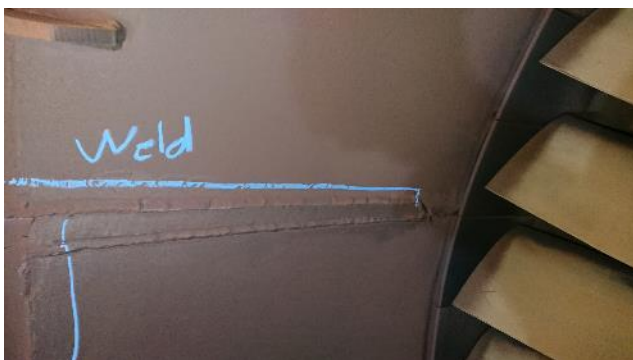
Figure 292: Exhaust – example of crack

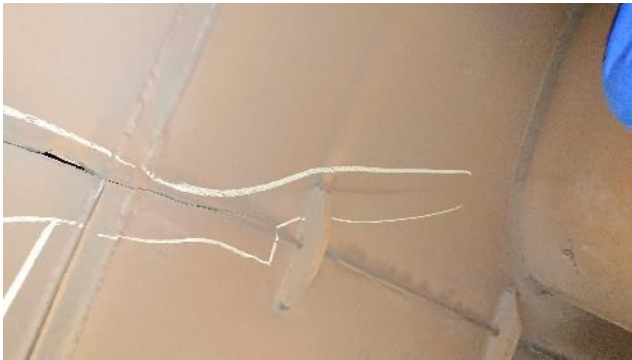
Figure 297: Exhaust – example of crack

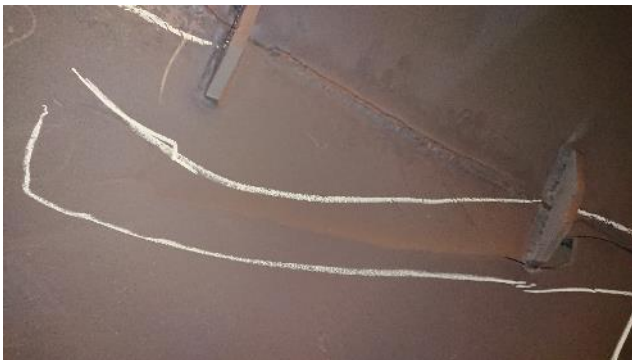
Figure 298: Exhaust – example of crack

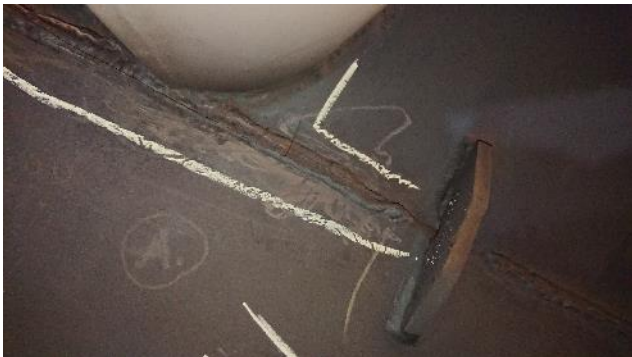
Figure 299: Exhaust – example of crack
