Business Management System
Inspection Report
Gourikwa – GT11 Minor
Inspection

Document Identifier	194/1353	Rev	0
Date	30/01/2023		
Page	1 of 113

Document Type	Inspection Report
Outage ID	24377
Scope of Activity	GT11 Minor Inspection at Gourikwa Peaking OCGT
Purpose	This is a technical report on the “as found” condition, remedial action performed and final condition of plant or components.

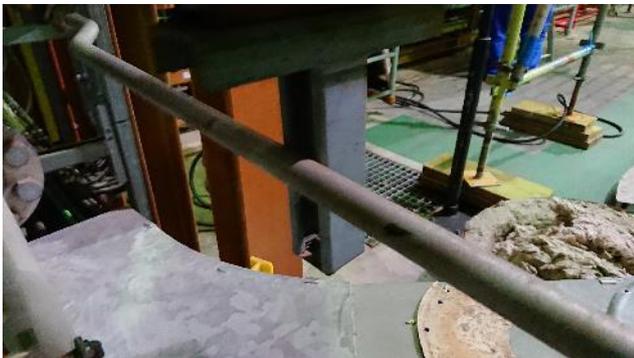
Figure 11: Unsupported pipe

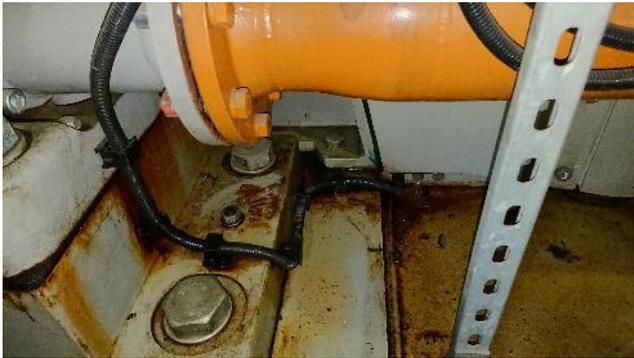
Figure 41: Generator EE bearing

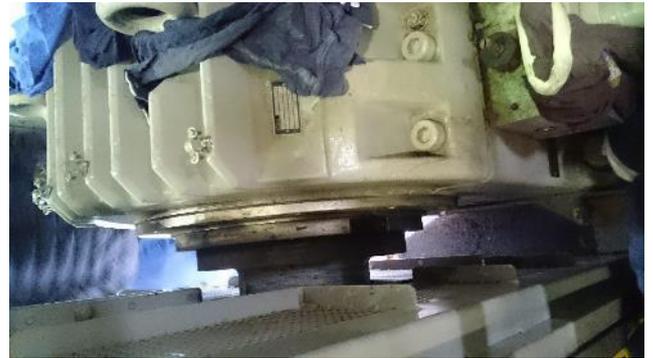
Figure 45: Generator EE bearing

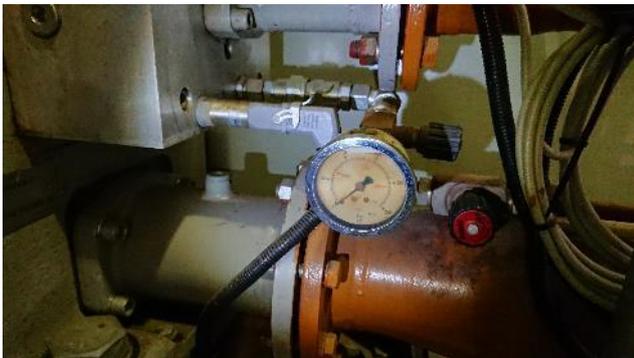
Figure 42: Generator EE bearing

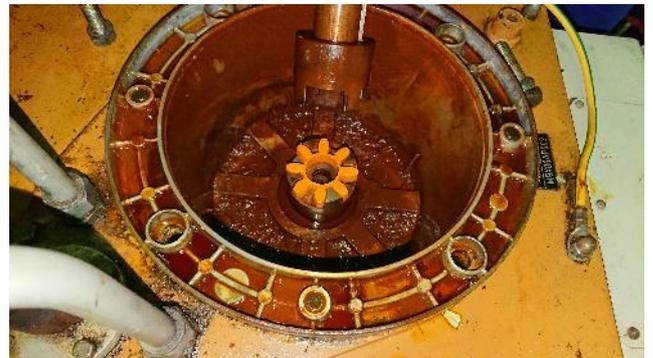
Figure 46: Control oil pump coupling spacer

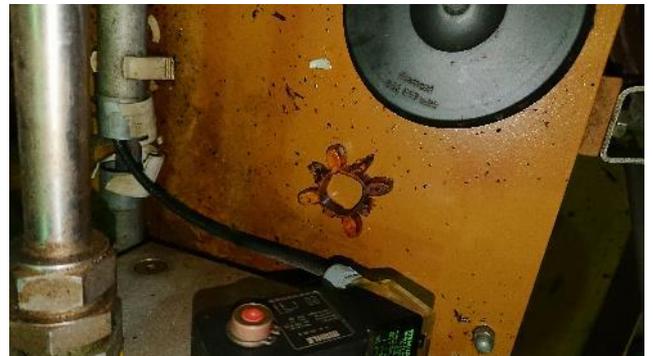
Figure 47: Old control oil pump coupling spacer

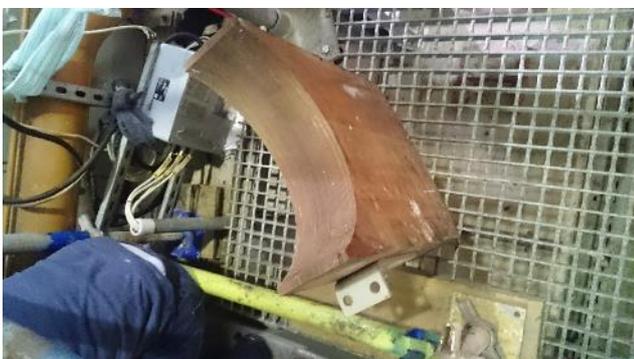
Figure 44: Tool used to raise shaft

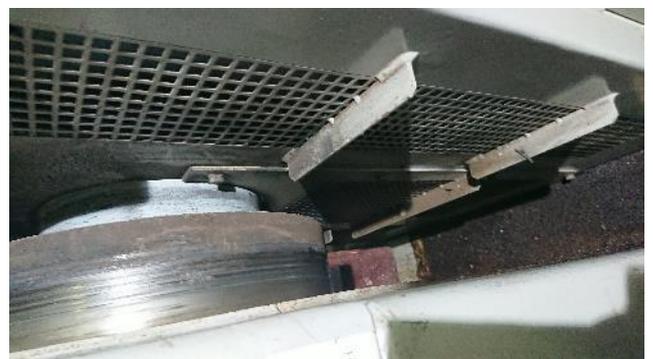
Figure 48: Exciter making shaft lift difficult

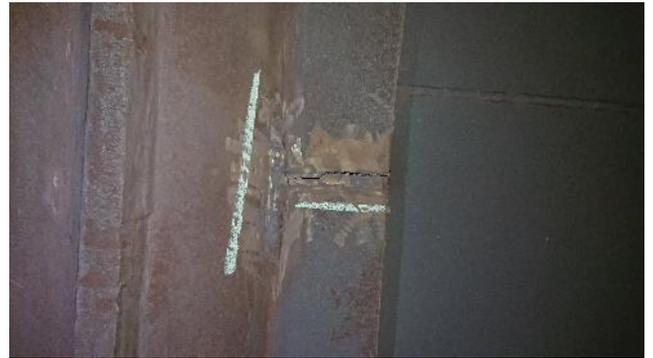
Figure 317: Exhaust – example of crack

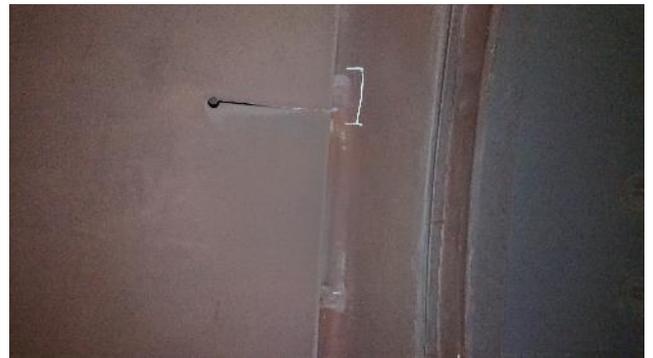
Figure 318: Exhaust – example of rubbing

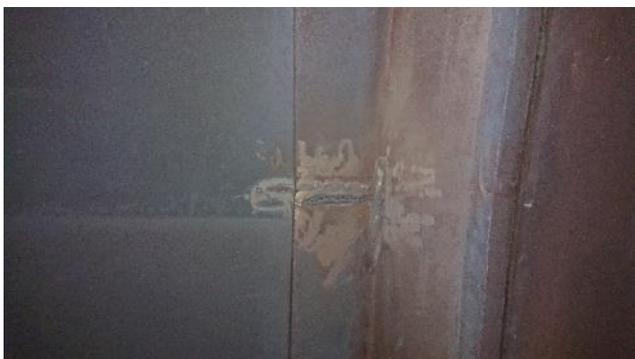
Figure 315: Exhaust – example of crack

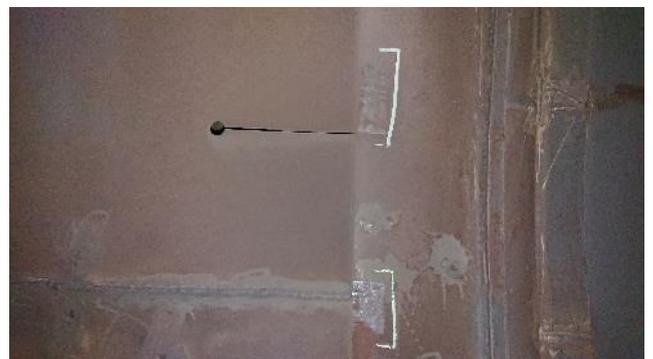
Figure 319: Exhaust – example of rubbing

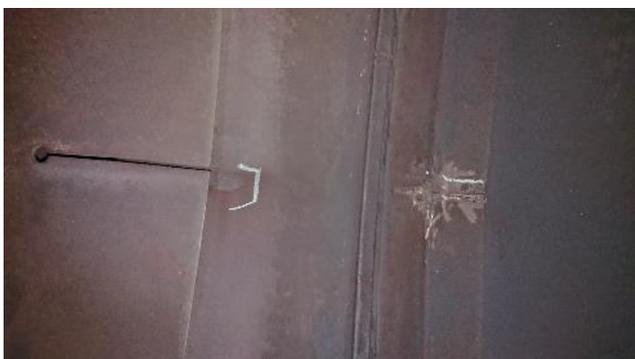
Figure 316: Exhaust – example of rubbing

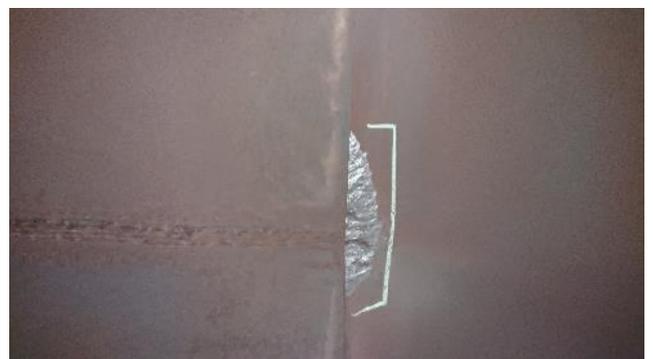
Figure 320: Exhaust – example of rubbing

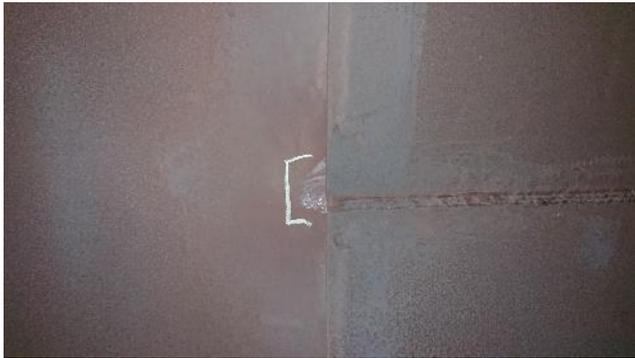
Figure 321: Exhaust – example of rubbing

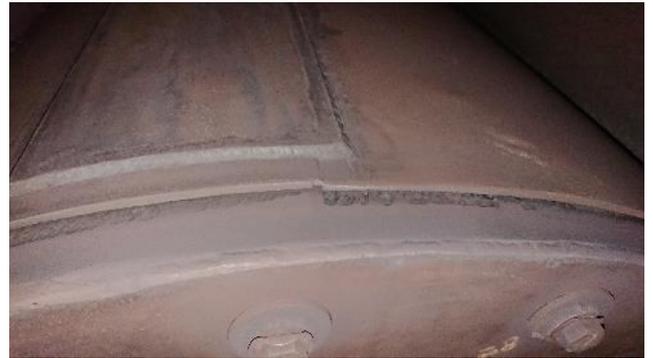
Figure 325: Exhaust – example of hammering

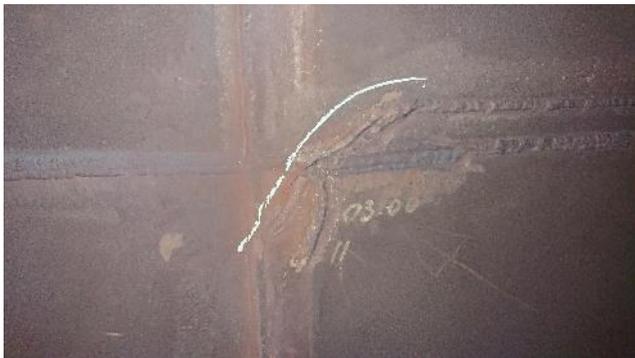
Figure 322: Exhaust – example of crack

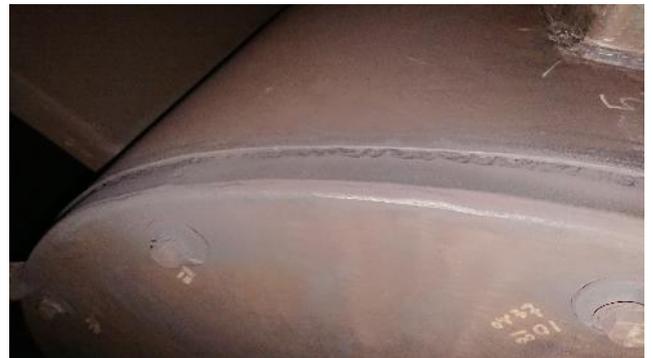
Figure 326: Exhaust – example of hammering

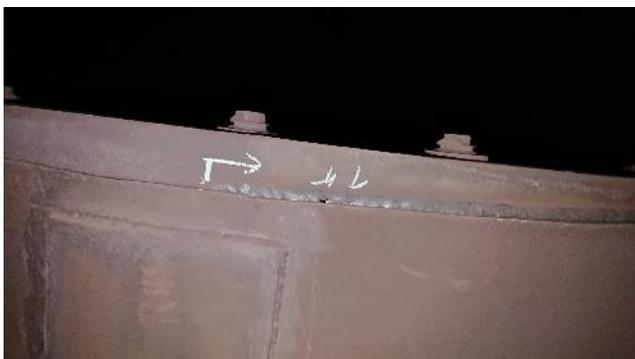
Figure 323: Exhaust – example of hammering

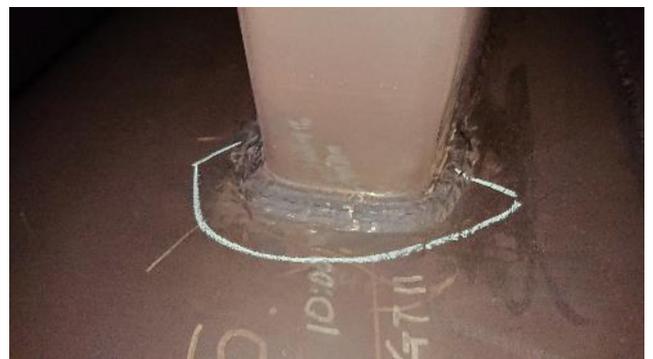
Figure 327: Exhaust – example of crack

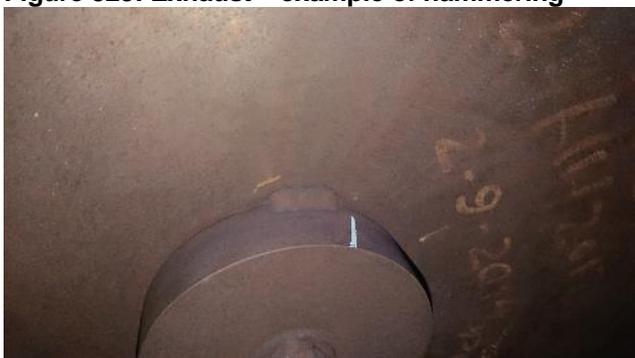
Figure 324: Exhaust – example of crack

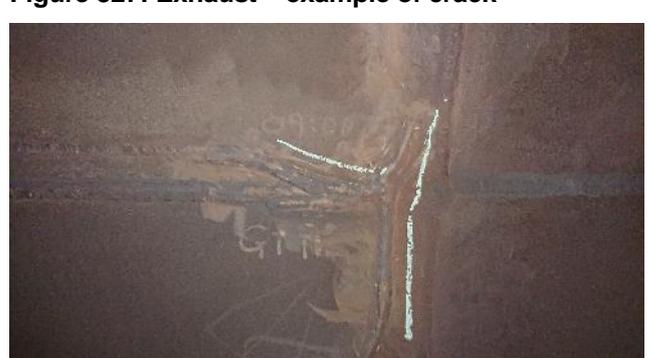
Figure 328: Exhaust – example of crack

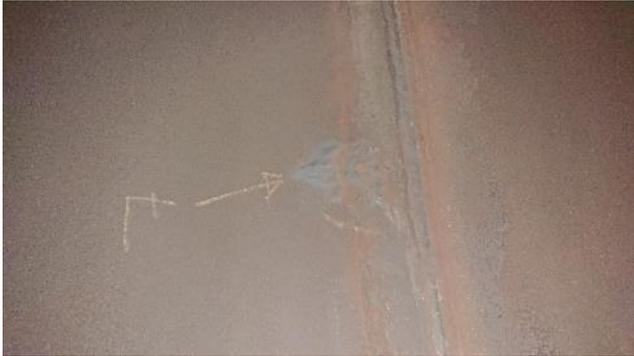
Figure 329: Exhaust – example of crack

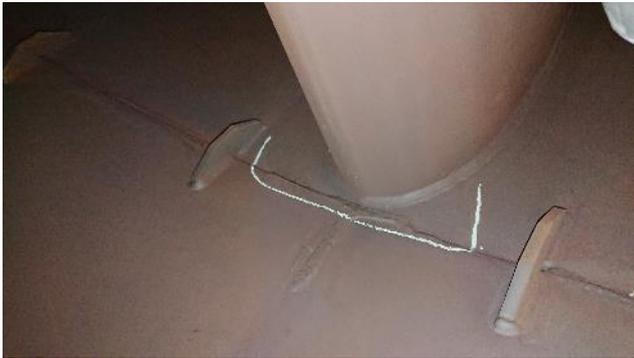
Figure 330: Exhaust – example of crack

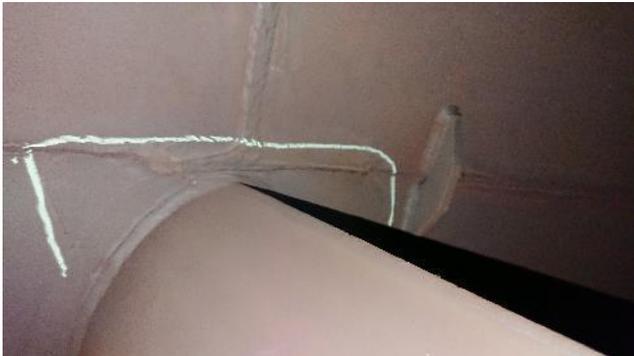
Figure 331: Exhaust – example of crack
